## #18-NA-073: Repair Guidelines for Engine Component Wear - (Jan 18, 2022)

**Subject: Repair Guidelines for Engine Component Wear**

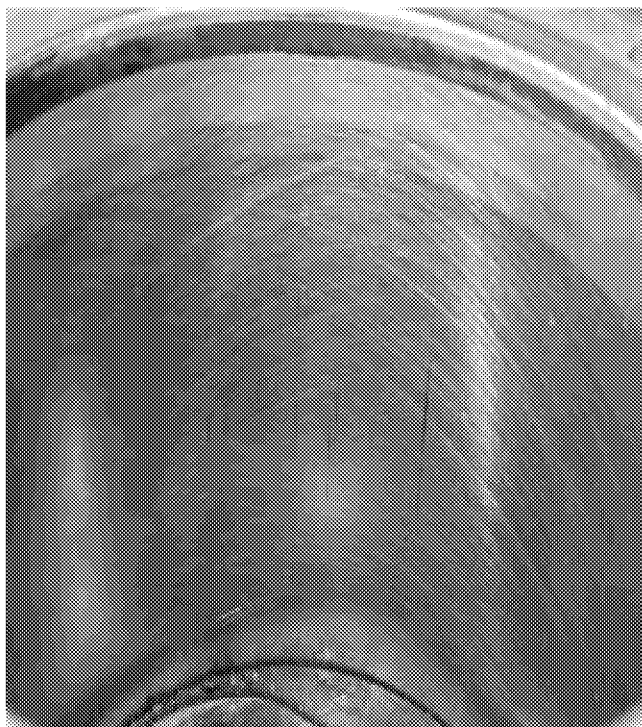
### **Cylinder Bore**

Example of minor scratching/scoring visible on cylinder wall. In this example, if you cannot catch a pick or fingernail on the scratch, the cylinder bore/engine block does not require replacement. If the piston is slightly scored, the scored piston can be replaced without need for engine assembly replacement.
