## #18-NA-073: Repair Guidelines for Engine Component Wear - (Jan 18, 2022)

**Subject: Repair Guidelines for Engine Component Wear**

Brand:	Model:	Model Year:		VIN:		Engine:	Transmission:
		from	to	from	to		
GM Passenger Cars and Trucks		2015	2022	All	All	All	—

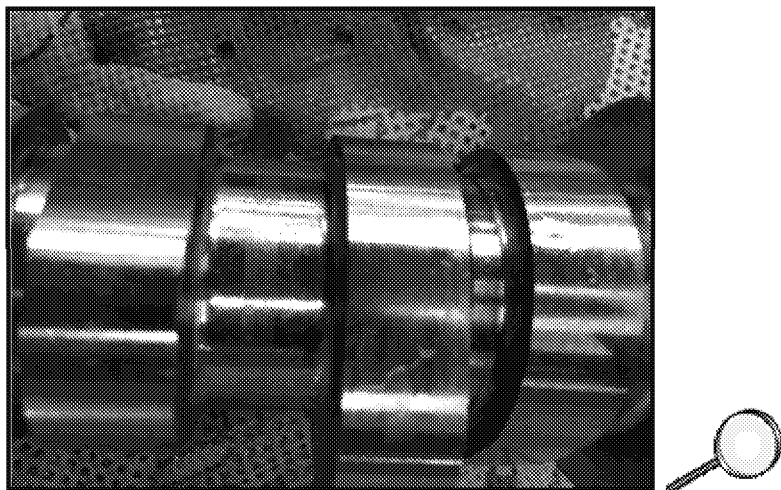
### Camshaft

Example of minor scratching/scoring visible on camshaft lobes and/or camshaft bearing journals. In this example, the scored components can be replaced without need for engine assembly replacement.

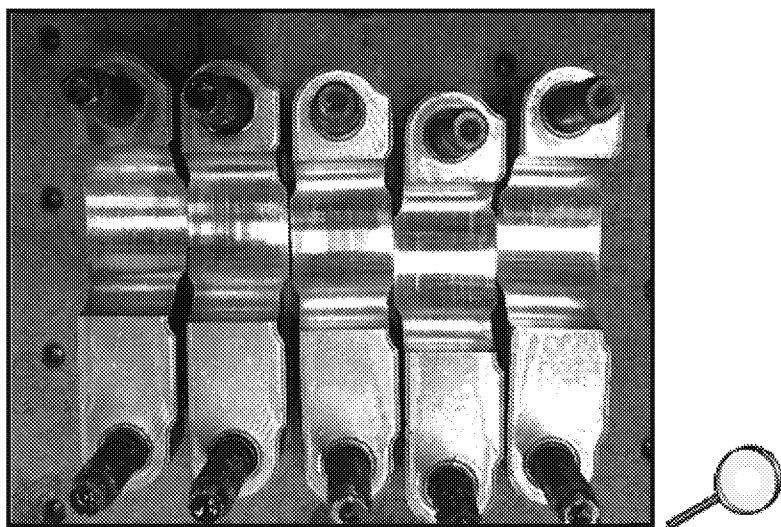
### Camshaft Bearing Caps

Example of minor scratching/scoring visible on camshaft bearing caps. In this example, the scored components can be replaced without need for engine assembly replacement.

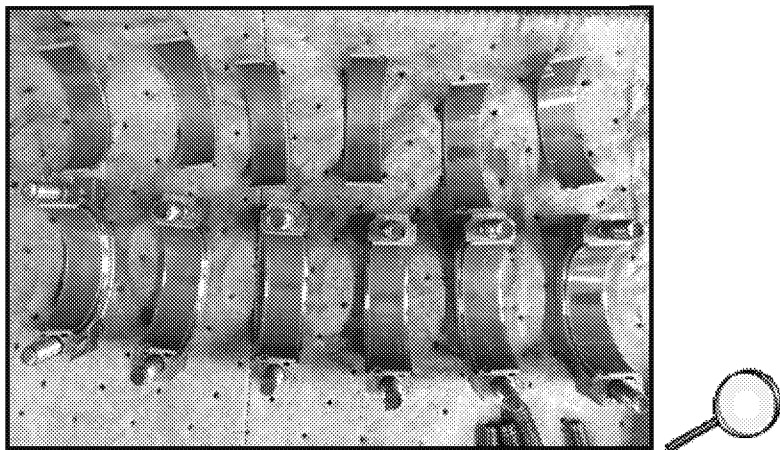
### Connecting Rod End Caps and Bearings

Example of minor scratching/scoring visible on connecting rod bearings. In this example, the scored components can be replaced without need for engine assembly replacement.

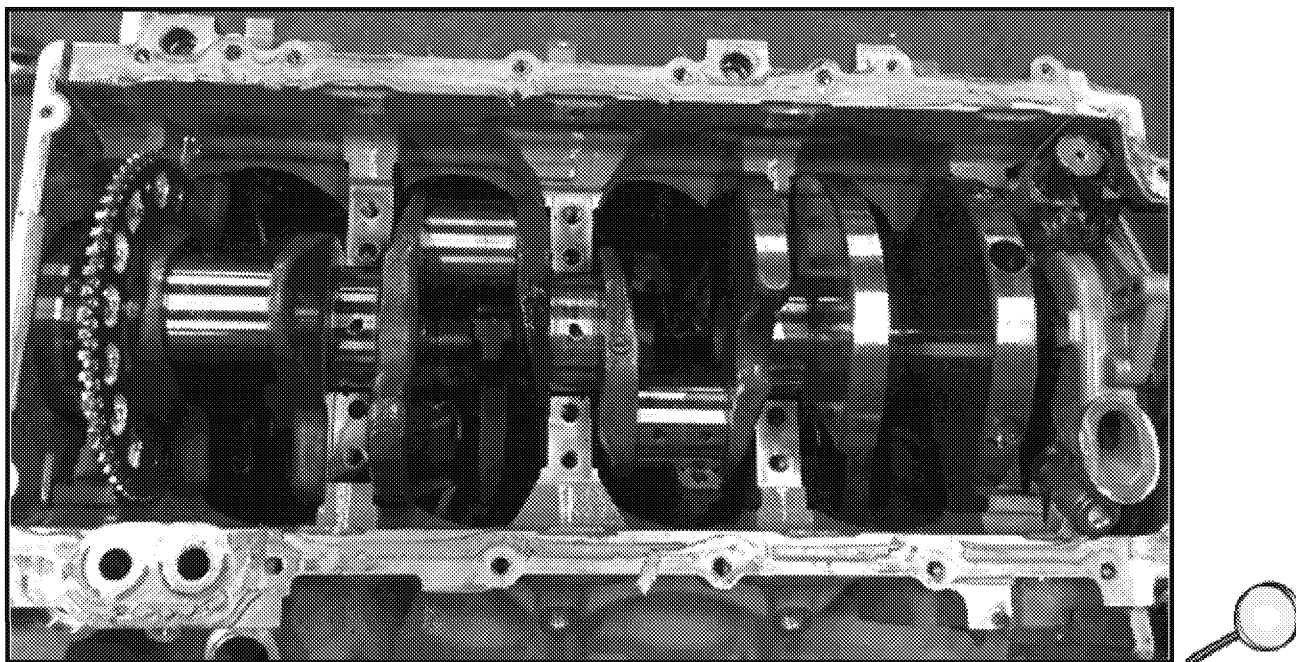
### **Crankshaft in Crankcase**

Example of minor scratching/scoring visible on crankshaft. In this example, the scored components can be replaced without need for engine assembly replacement.

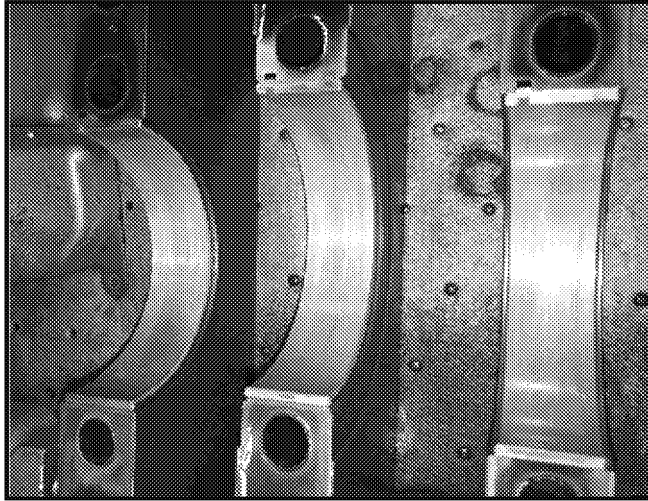
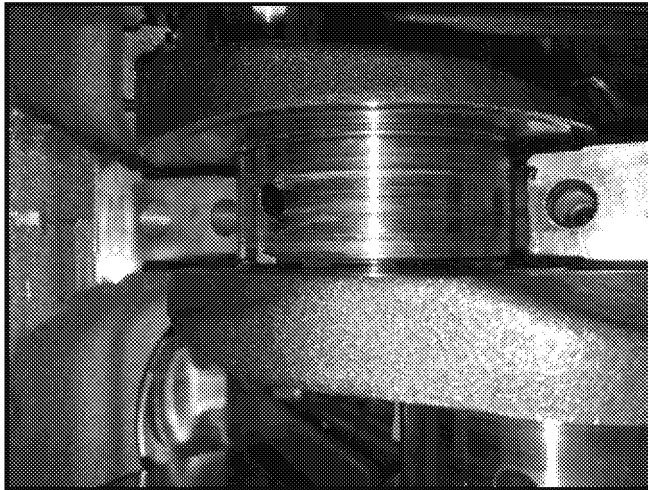
### **Crankshaft Main Bearings and Journal**

Example of minor scratching/scoring visible on crankshaft. In this example, the scored components can be replaced without need for engine assembly replacement.

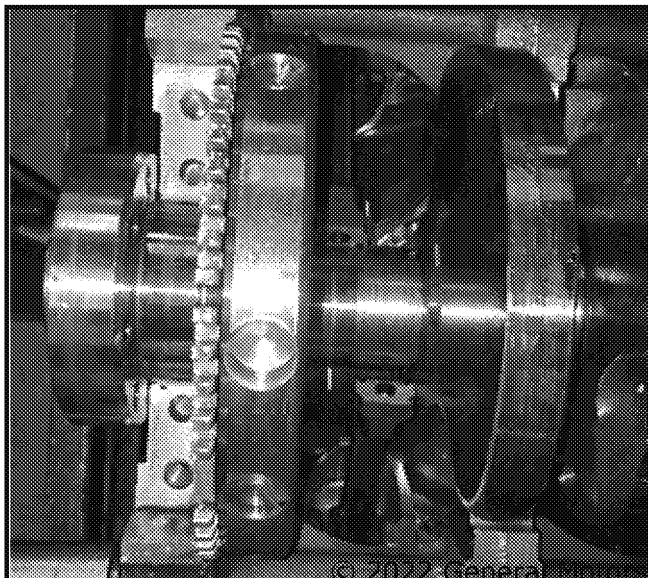
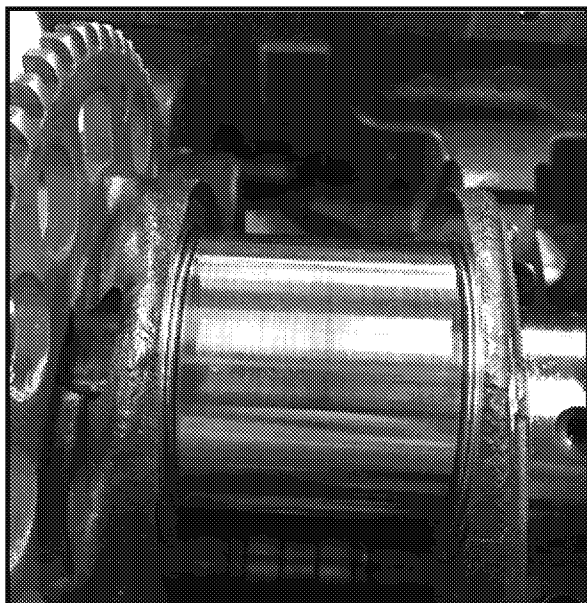
**Crankshaft, Reluctor Ring and Journal**

Example of minor scratching/scoring visible on crankshaft. In this example, the scored components can be replaced without need for engine assembly replacement.

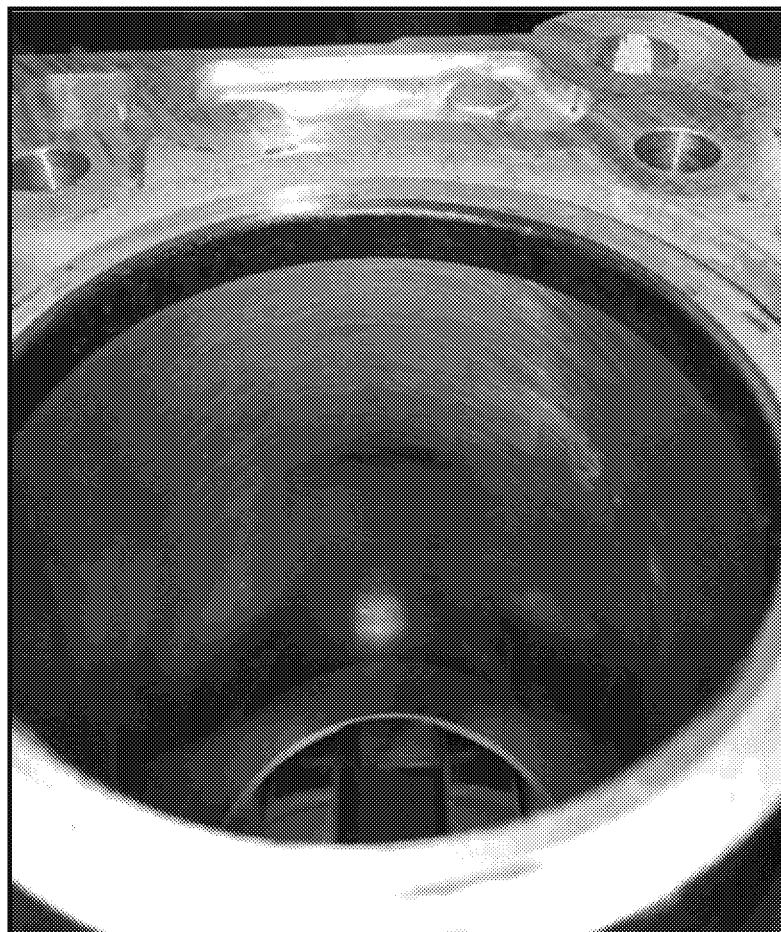
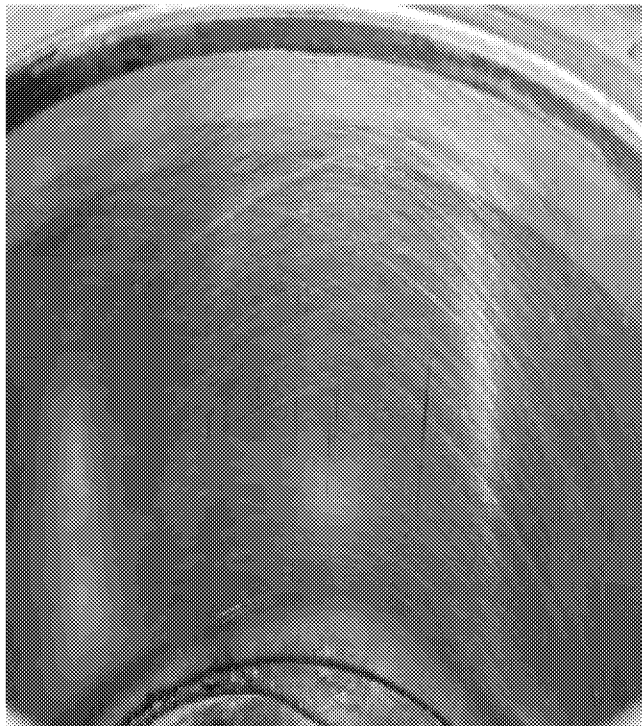
### **Cylinder Bore**

Example of minor scratching/scoring visible on cylinder wall. In this example, if you cannot catch a pick or fingernail on the scratch, the cylinder bore/engine block does not require replacement. If the piston is slightly scored, the scored piston can be replaced without need for engine assembly replacement.

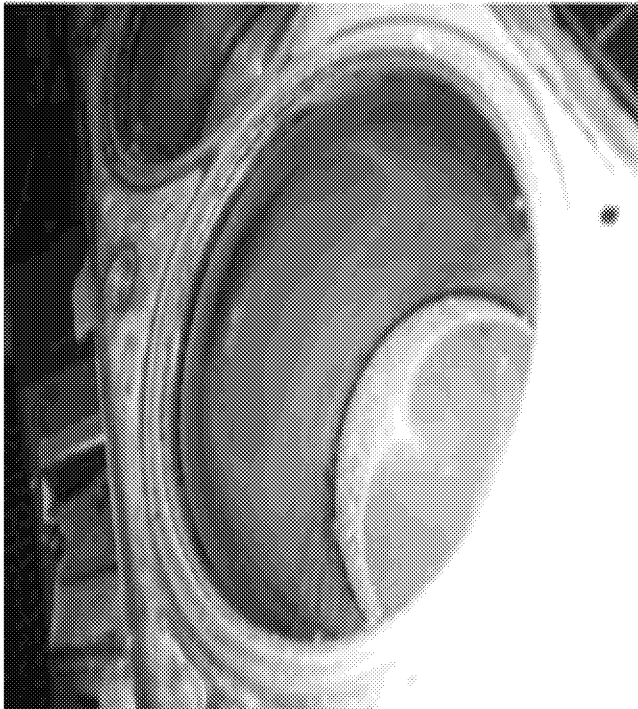
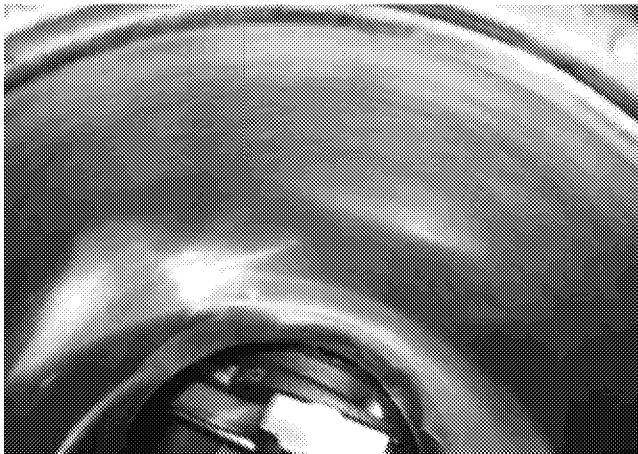
### **Cylinder Out-of-Round**

Suspecting an engine block of possible cylinder bore damage, scoring or out of round as the possible cause of engine oil consumption, misfire, cylinder leakage or blow by.

**Note:** The peak to valley suspecting an engine block of possible cylinder bore damage, scoring or out of round as the possible cause of engine oil consumption, misfire, cylinder leakage or blow by. spec for crosshatch is .65-2.8 microns. Any deviation and the crosshatch will be gone even if a cylinder is suspected of being oversize, we can only confirm that by checking with an air gauge at the engine plant.

1. Cylinder damage or scoring – The cylinder walls will contain grooves deep enough to catch with a fingernail.

2. Out of round cylinder bore – Contains areas where the crosshatch is missing or worn from different sections of the cylinder bore. If there is crosshatch all the way around the bore from top to bottom, the cylinder bore is not out of round.

3. Dirt intrusion – If the filtering system has been compromised, the engine will wear out very quickly. You will find grit in the intake runners and the cylinder bores will look lightly sand blasted. The crosshatch will be faint and there will not be sharpness. At high mileage this may not be Warrantable if the air filtering system has been opened numerous times for service in dusty climates.

4. Catalytic converter failure – If a converter fails and the brick is broken, the dust can be drawn back into the engine. A block showing this type of failure will have bores that look to be sand blasted. Back cylinders go first if caught early. Otherwise there will be no crosshatch and the engine will need to be replaced.

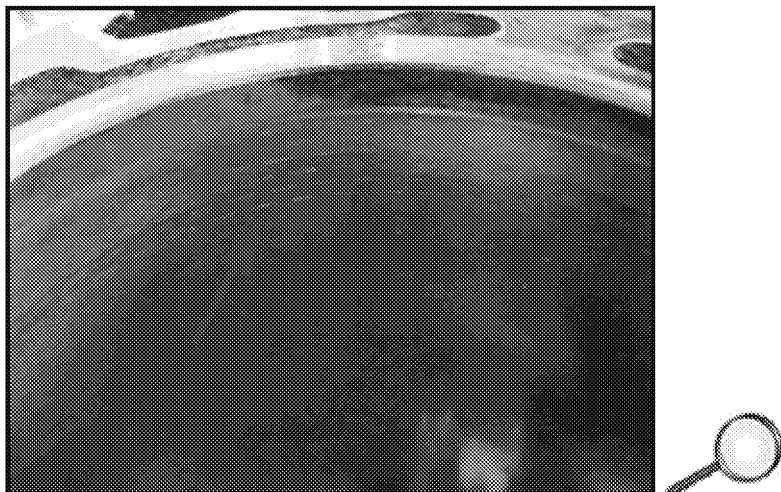
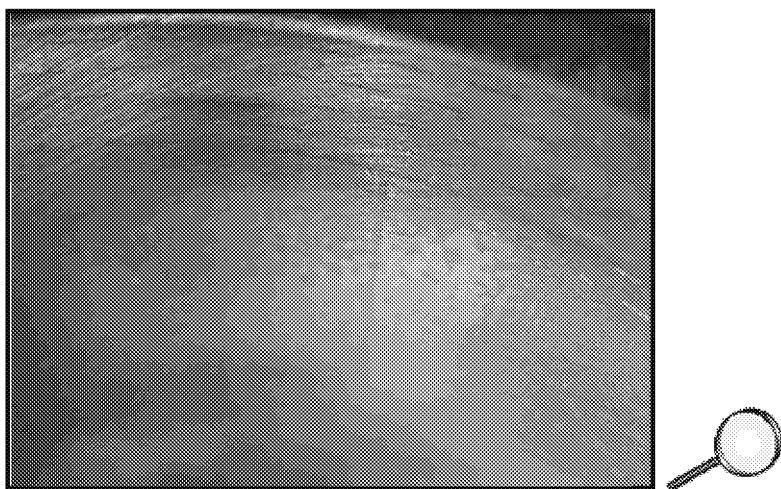
### Cylinder Bore Honing Marks

Some technicians may be replacing entire engine assemblies due to marks found at the top of the cylinder bore. These marks are considered normal and are left as a result of a manufacturing laser honing process. **DO NOT** replace the cylinder block or the engine for these normal laser honing marks (refer to PI0725B).

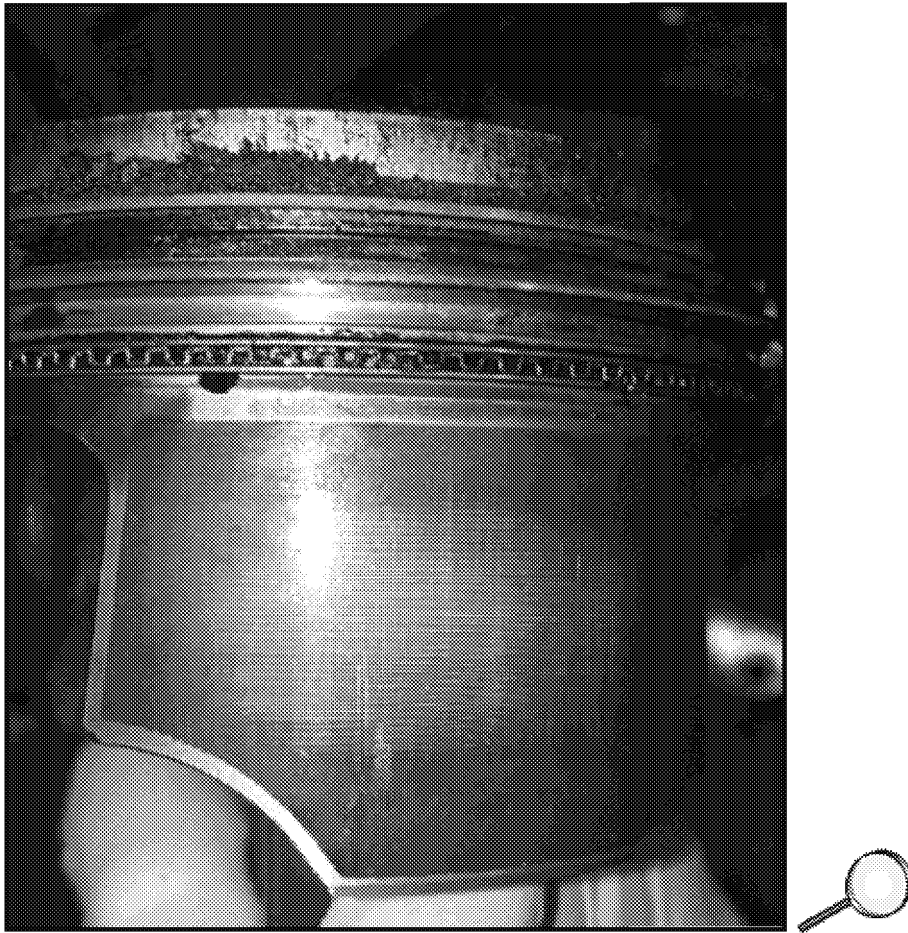
### Piston

Example of minor scratching/scoring visible on piston. In this example, inspect for broken and/or stuck rings and piston ring lands and cylinder wall for damage. If no cylinder wall damage or other significant damage, components can be replaced without requiring an engine assembly replacement.

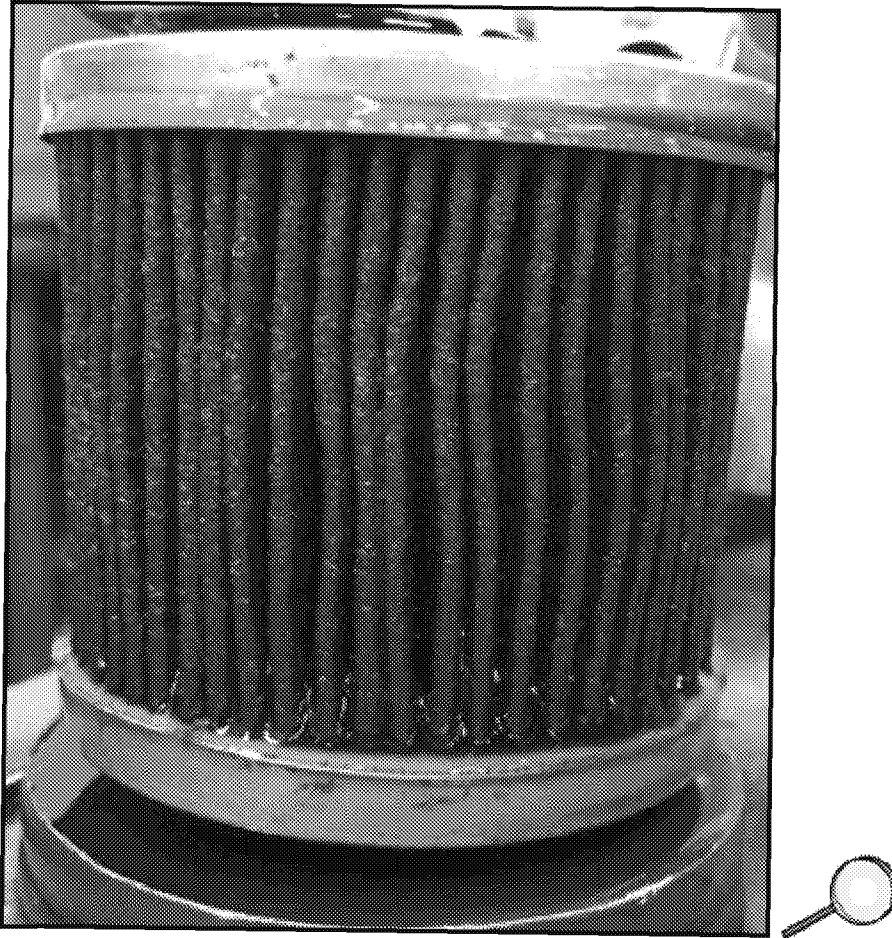
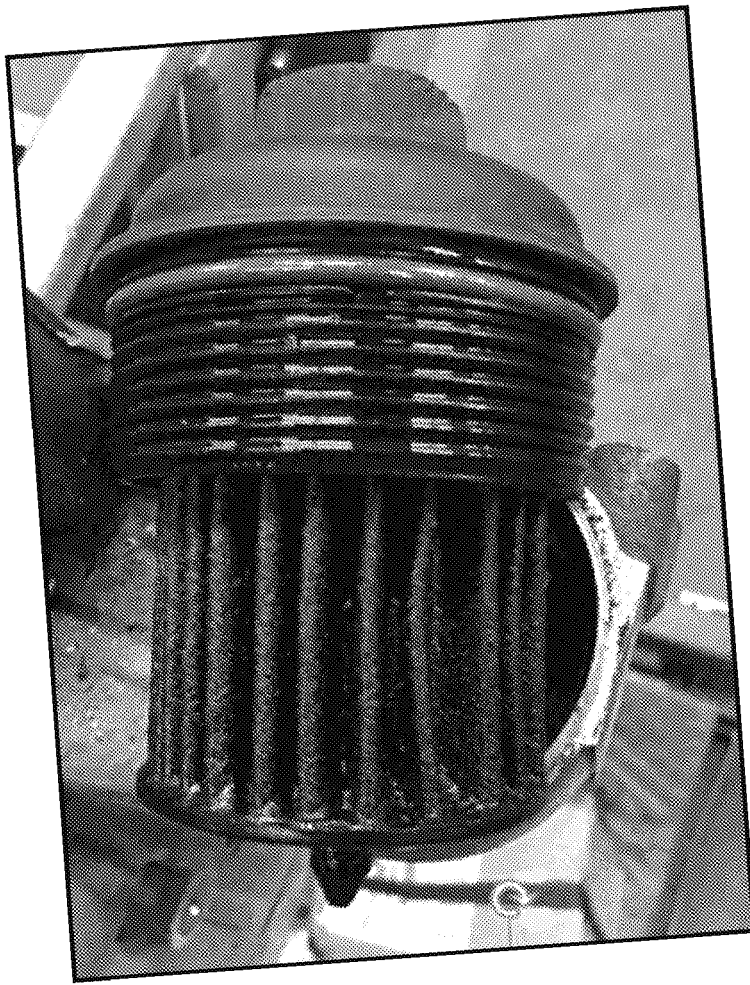
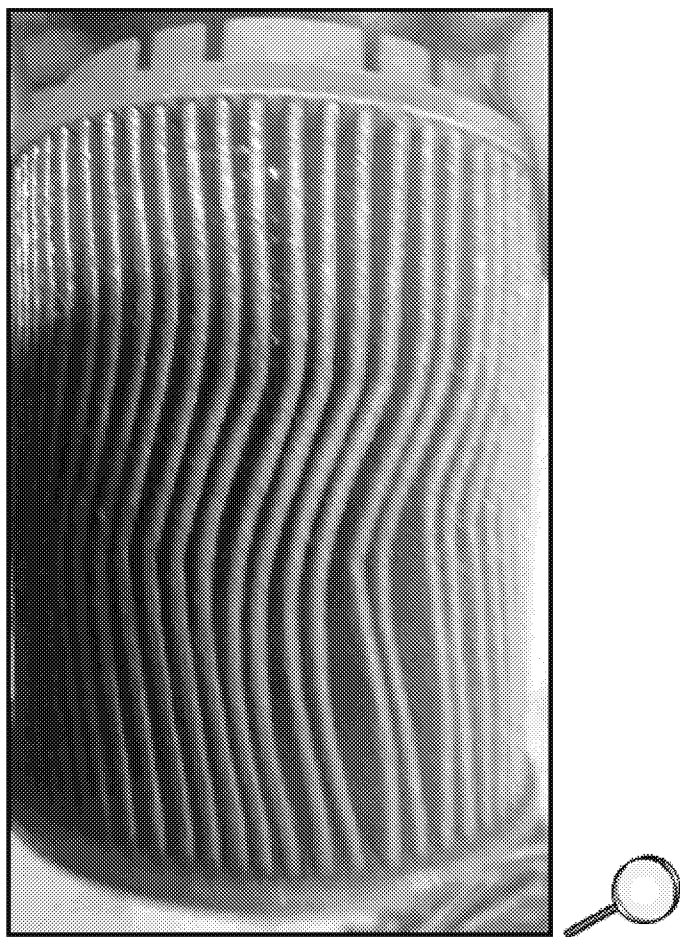
#### Oil Filter — Inspect for Excessive Debris

Shown are oil filter pleats with visible metal particles.

In this example, minimal amounts of metal particles are visible on oil filter pleats and should not pose a concern.

If excessive amounts of metal particles are observed, or if there is evidence of damaged oil filter pleats, then unfiltered oil with bearing debris may have been pumped into the oil lubrication galleries throughout the engine. This will require further inspection to confirm the degree of contamination and appropriate repair direction. Refer to Service Bulletin #19-NA-256 for HFV6 Gen 1 and Gen 2.
