#23-NA-115: Ticking, Tapping or Snapping Noise from Engine - 5.5L RPO LT6 Realign Camshaft Caps as Required - (Jun 28, 2023)

Subject: Ticking, Tapping or Snapping Noise from Engine - 5.5L RPO LT6 Realign Camshaft Caps as Required

Brand:	Model:	Model Year:		VIN:		Engine:	Transmission:
		from	to	from	to		
Chevrolet	Corvette	2023	2023	—	—	5.5L (RPO LT6)	—

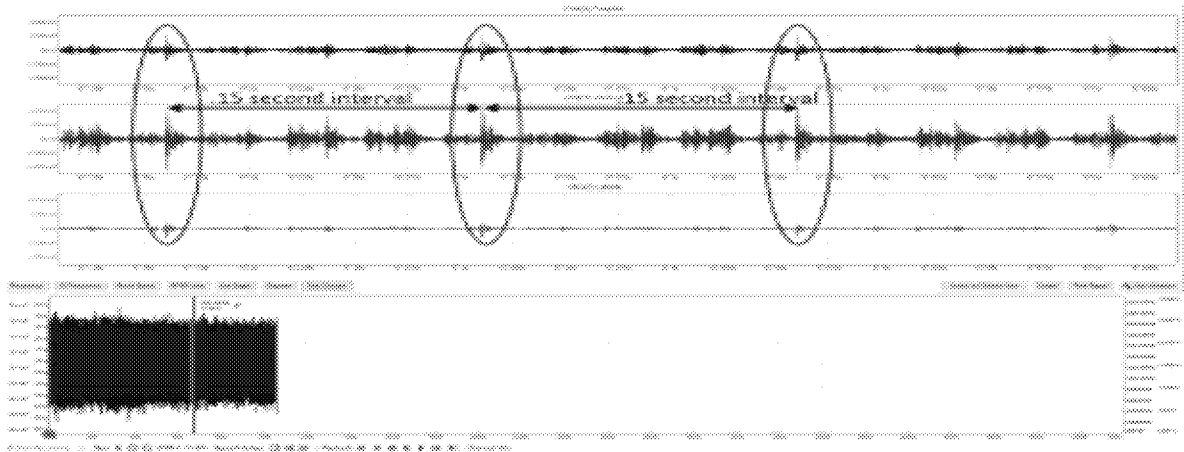
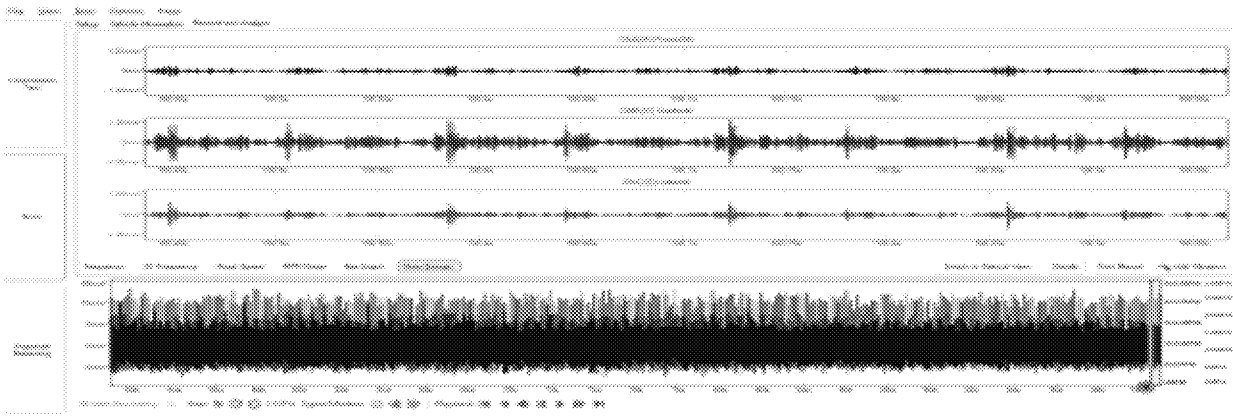
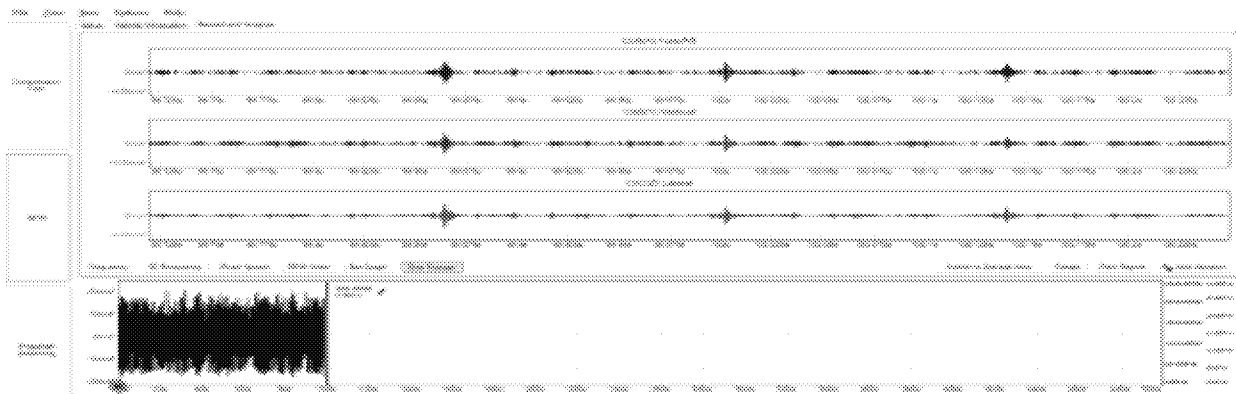
Examples of Tick:

1. Right click in the time domain display and change the display mode to single.
2. If scales on the left end for each channel are not ranging from -4 m/s² to 4 m/s², right click in the time domain display and select "reset scale."
3. Pull the yellow window cursors on the bottom in as close together as they will go.
4. Look at the channel lines in the time domain window for ticks with a .15s gap between them.
⇒ Compare to the examples below for an engine with a tick and an engine without a tick:

Once it is determined which bank the noise is coming from, it will be necessary to follow the service procedure below to adjust the camshaft cap torque.
