<b>GROUP</b> <b>Safety Recall Campaign</b>	<b>MODEL</b> <b>2011-2014MY Optima (QF/TF)</b> <b>2012-2014MY Sorento (XMa)</b> <b>2011-2013MY Sportage (SL)</b>
	<b>NUMBER</b> <b>SC147 (Rev 7, 03/29/2018)</b>	<b>DATE</b> <b>June 2017</b>
<b>SAFETY RECALL CAMPAIGN</b>		
<b>SUBJECT: THETA II ENGINE INSPECTION AND/OR REPLACEMENT</b>

This bulletin provides the procedure to inspect, and if necessary, replace the engine long block assembly on the following vehicles:

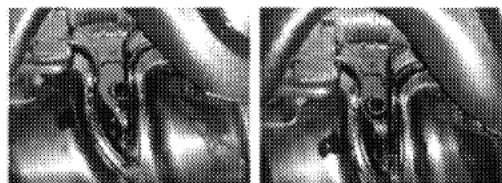
To avoid false readings, ensure the adapter (B) is properly inserted into the dipstick tube and that the tube is not in contact with the intake manifold.

If the dipstick tube is not centered and is close to or touching the manifold, carefully adjust (bend) and center the dipstick tube with a pry bar.

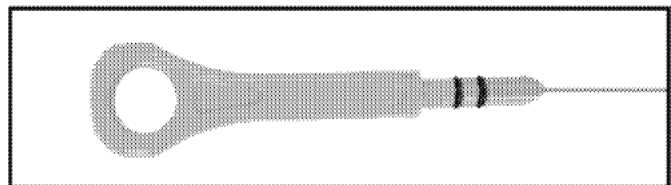
Yellow Dipstick (P/N: 26611 2G020)

21. Disconnect the engine noise tester from the KDS and carefully remove the adapter (B) from the dipstick tube by grasping the engine noise tester adapter.
22. For 2011-2013MY vehicles only: If the vehicle is equipped with a YELLOW dipstick, discard the dipstick and replace it with a new ORANGE one.

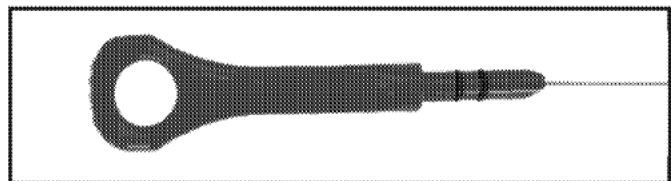
Red Dipstick (P/N: 26611 2G040)  
(NO REPLACEMENT REQUIRED)

If the vehicle is equipped with a RED dipstick, replacement is not necessary.
