GROUP Safety Recall Campaign	MODEL 2011-2014MY Optima (QF/TF) 2012-2014MY Sorento (XMa) 2011-2013MY Sportage (SL)
	NUMBER SC147 (Rev 6, 2/7/2018)	DATE June 2017
SAFETY RECALL CAMPAIGN		
SUBJECT: THETA II ENGINE INSPECTION AND/OR REPLACEMENT

This bulletin provides the procedure to inspect, and if necessary, replace the engine long block assembly on the following vehicles:

Metal debris may have been generated from factory machining operations of the engine crankshaft and may not have been completely removed from the crankshaft's oil passages during the cleaning process. It was also determined that the additional machining processes of the crankpins may have caused uneven surface roughness. These combined conditions can restrict oil flow to the bearings increasing the potential for premature bearing wear.

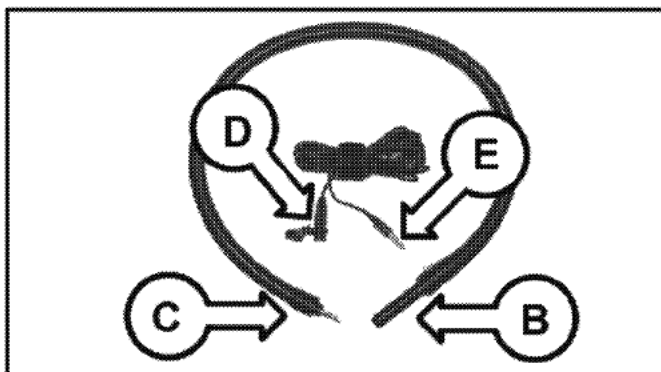
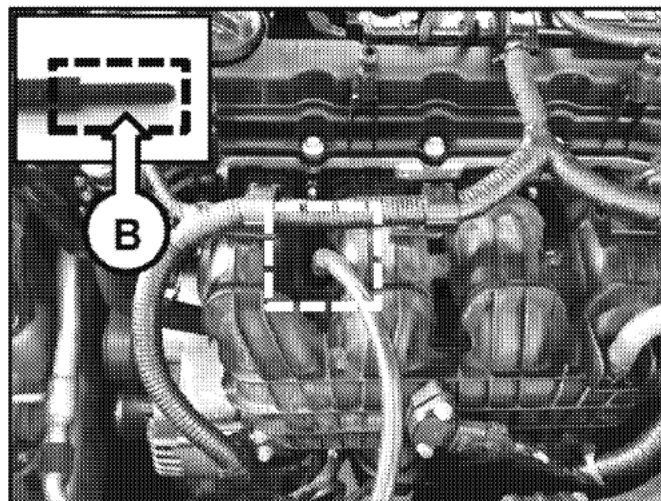
To avoid false readings, ensure the adapter (B) is properly inserted into the dipstick tube and that the tube is not in contact with the intake manifold.

If the dipstick tube is not centered and is close to or touching the manifold, carefully adjust (bend) and center the dipstick tube with a pry bar.
