CQIS DETAIL REPORT

VEHICLE: 2016 FOCUS,SE,4 DOOR ,SEDAN VIN: [REDACTED]  
 Engine : 1.0L 12V DI TC I3 GS 120PS FOX Odometer: 17,420 MILES  
 Operating Environ: WCC :  
 Vehicle Use : Rsp. Act:

SYMPTOM: 5 51 9 02 DRIVING PERFORMANCE IDLE QUALITY  
 ROUGH ALWAYS  
 Additional Symptom: VIBRATION COMPLAINT  
 Other Veh. With Concern: Severity Rating - Customer: Engineering:

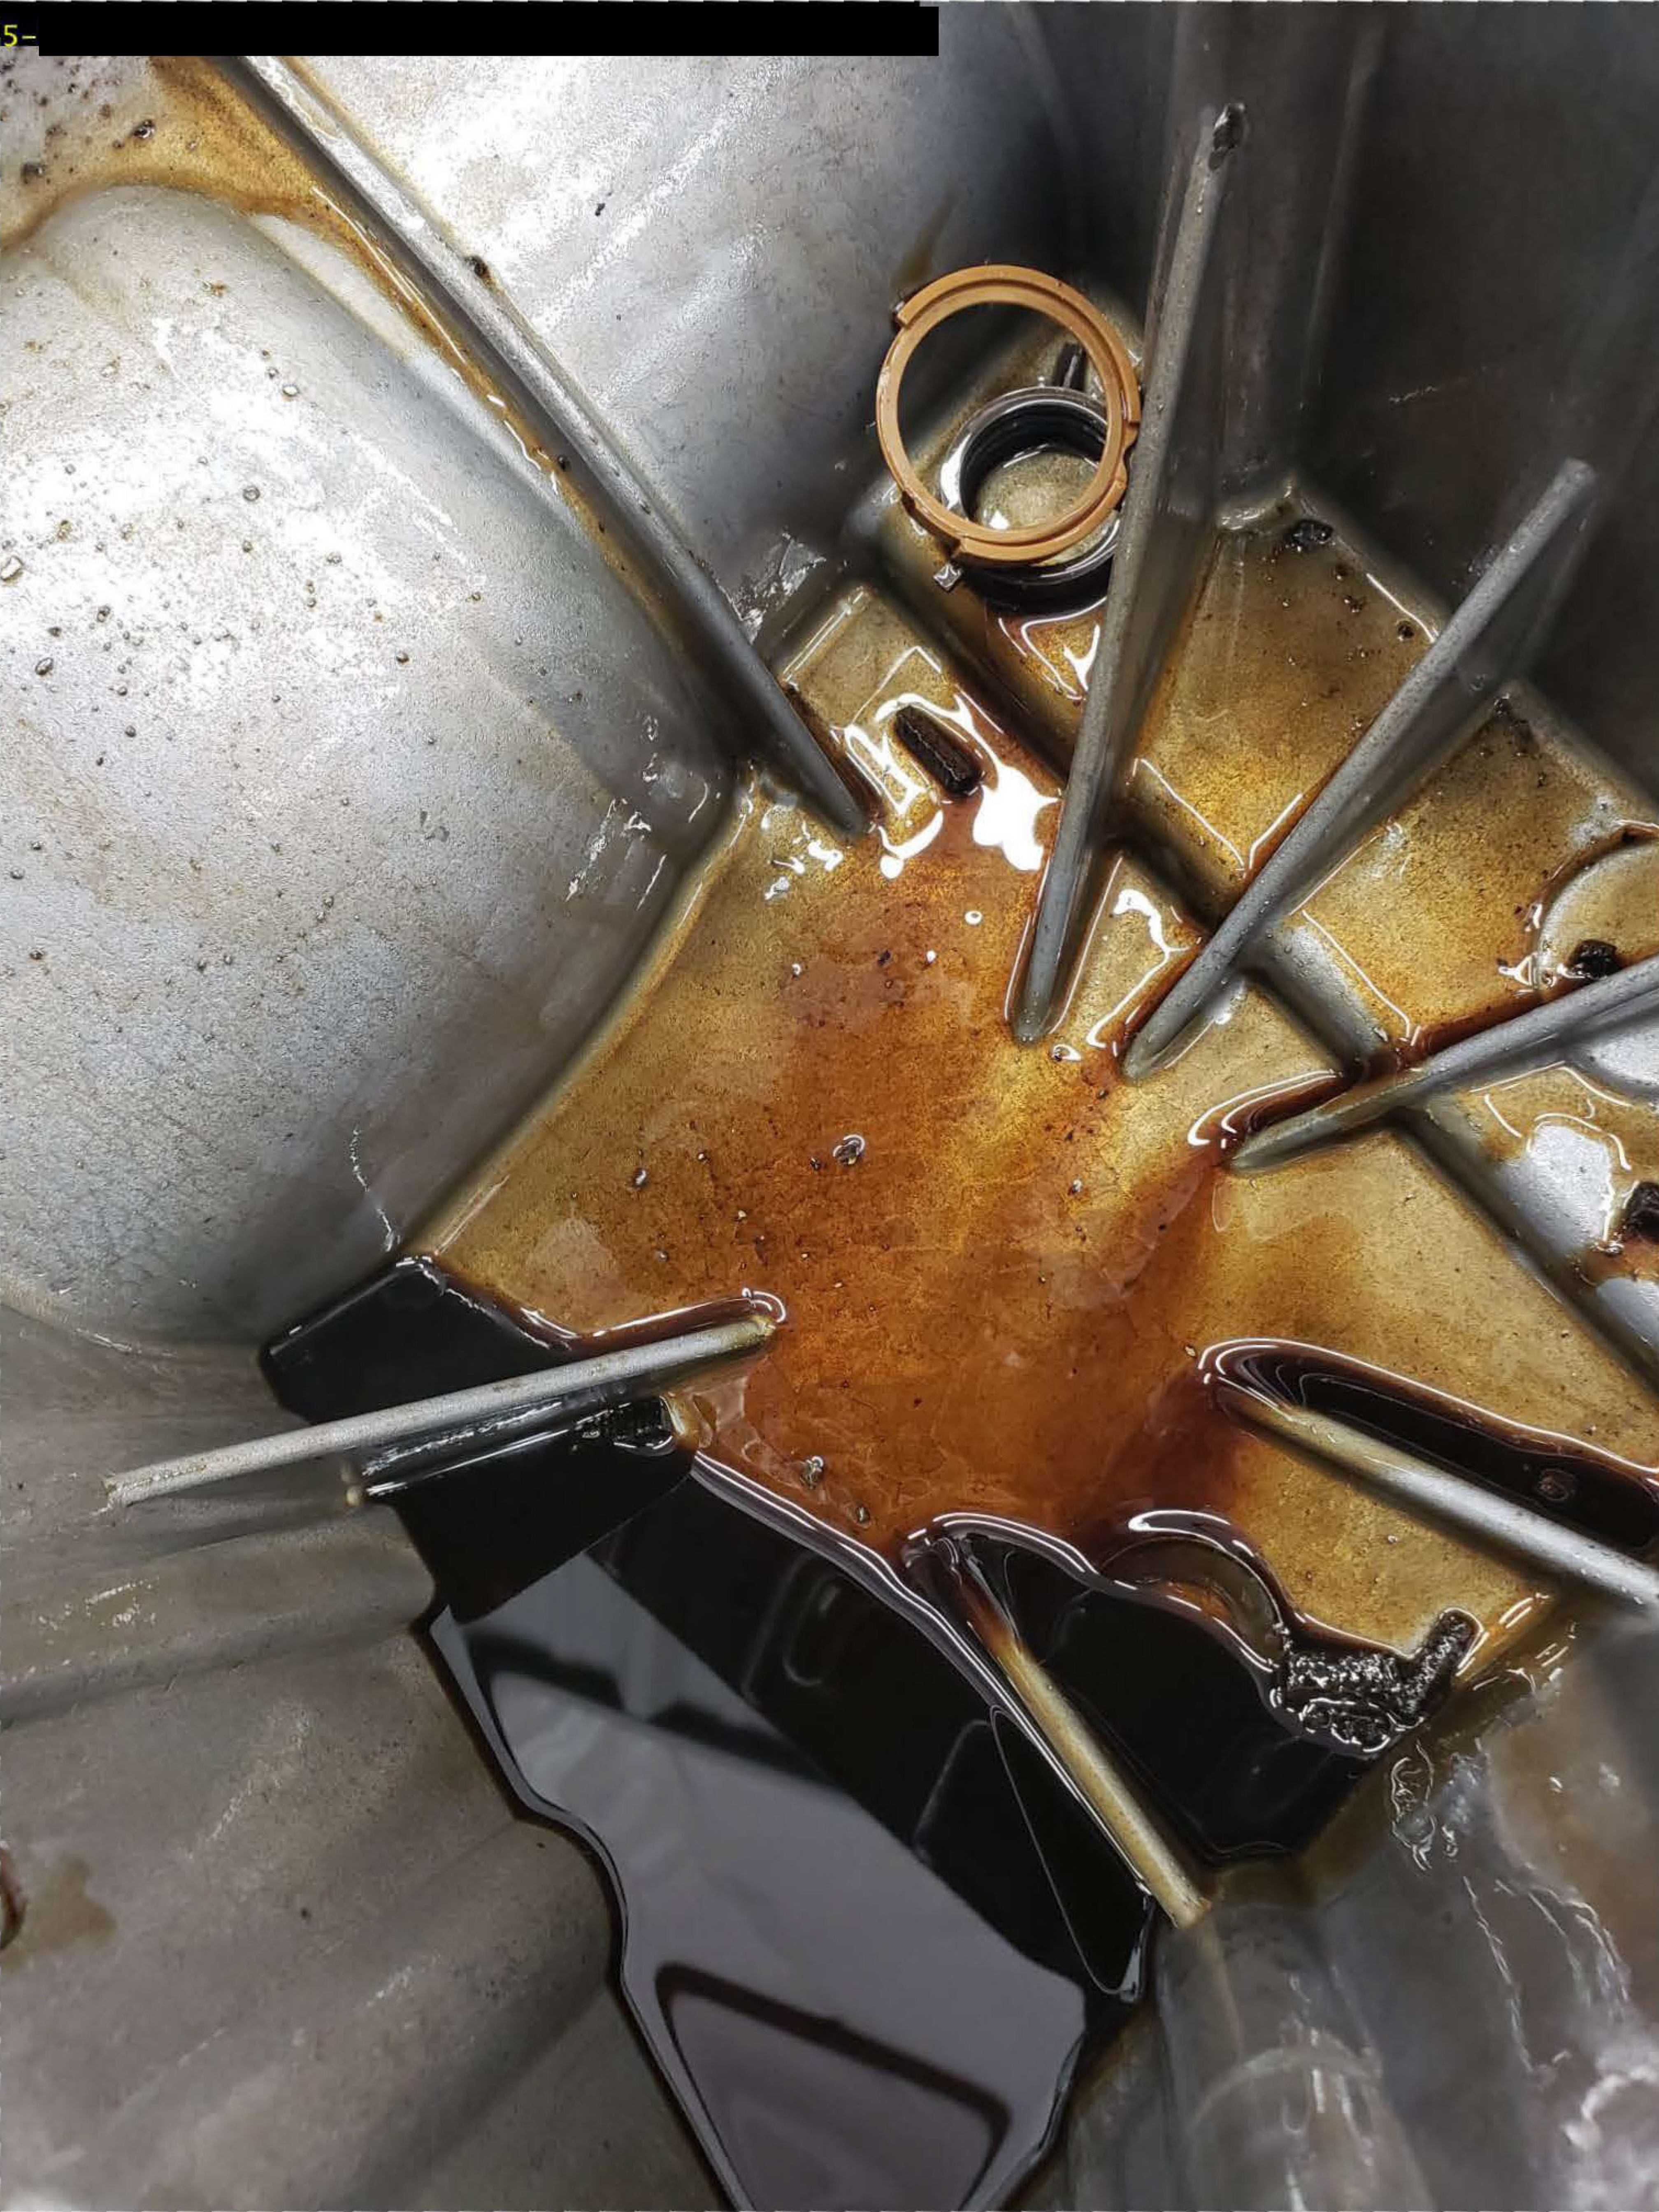
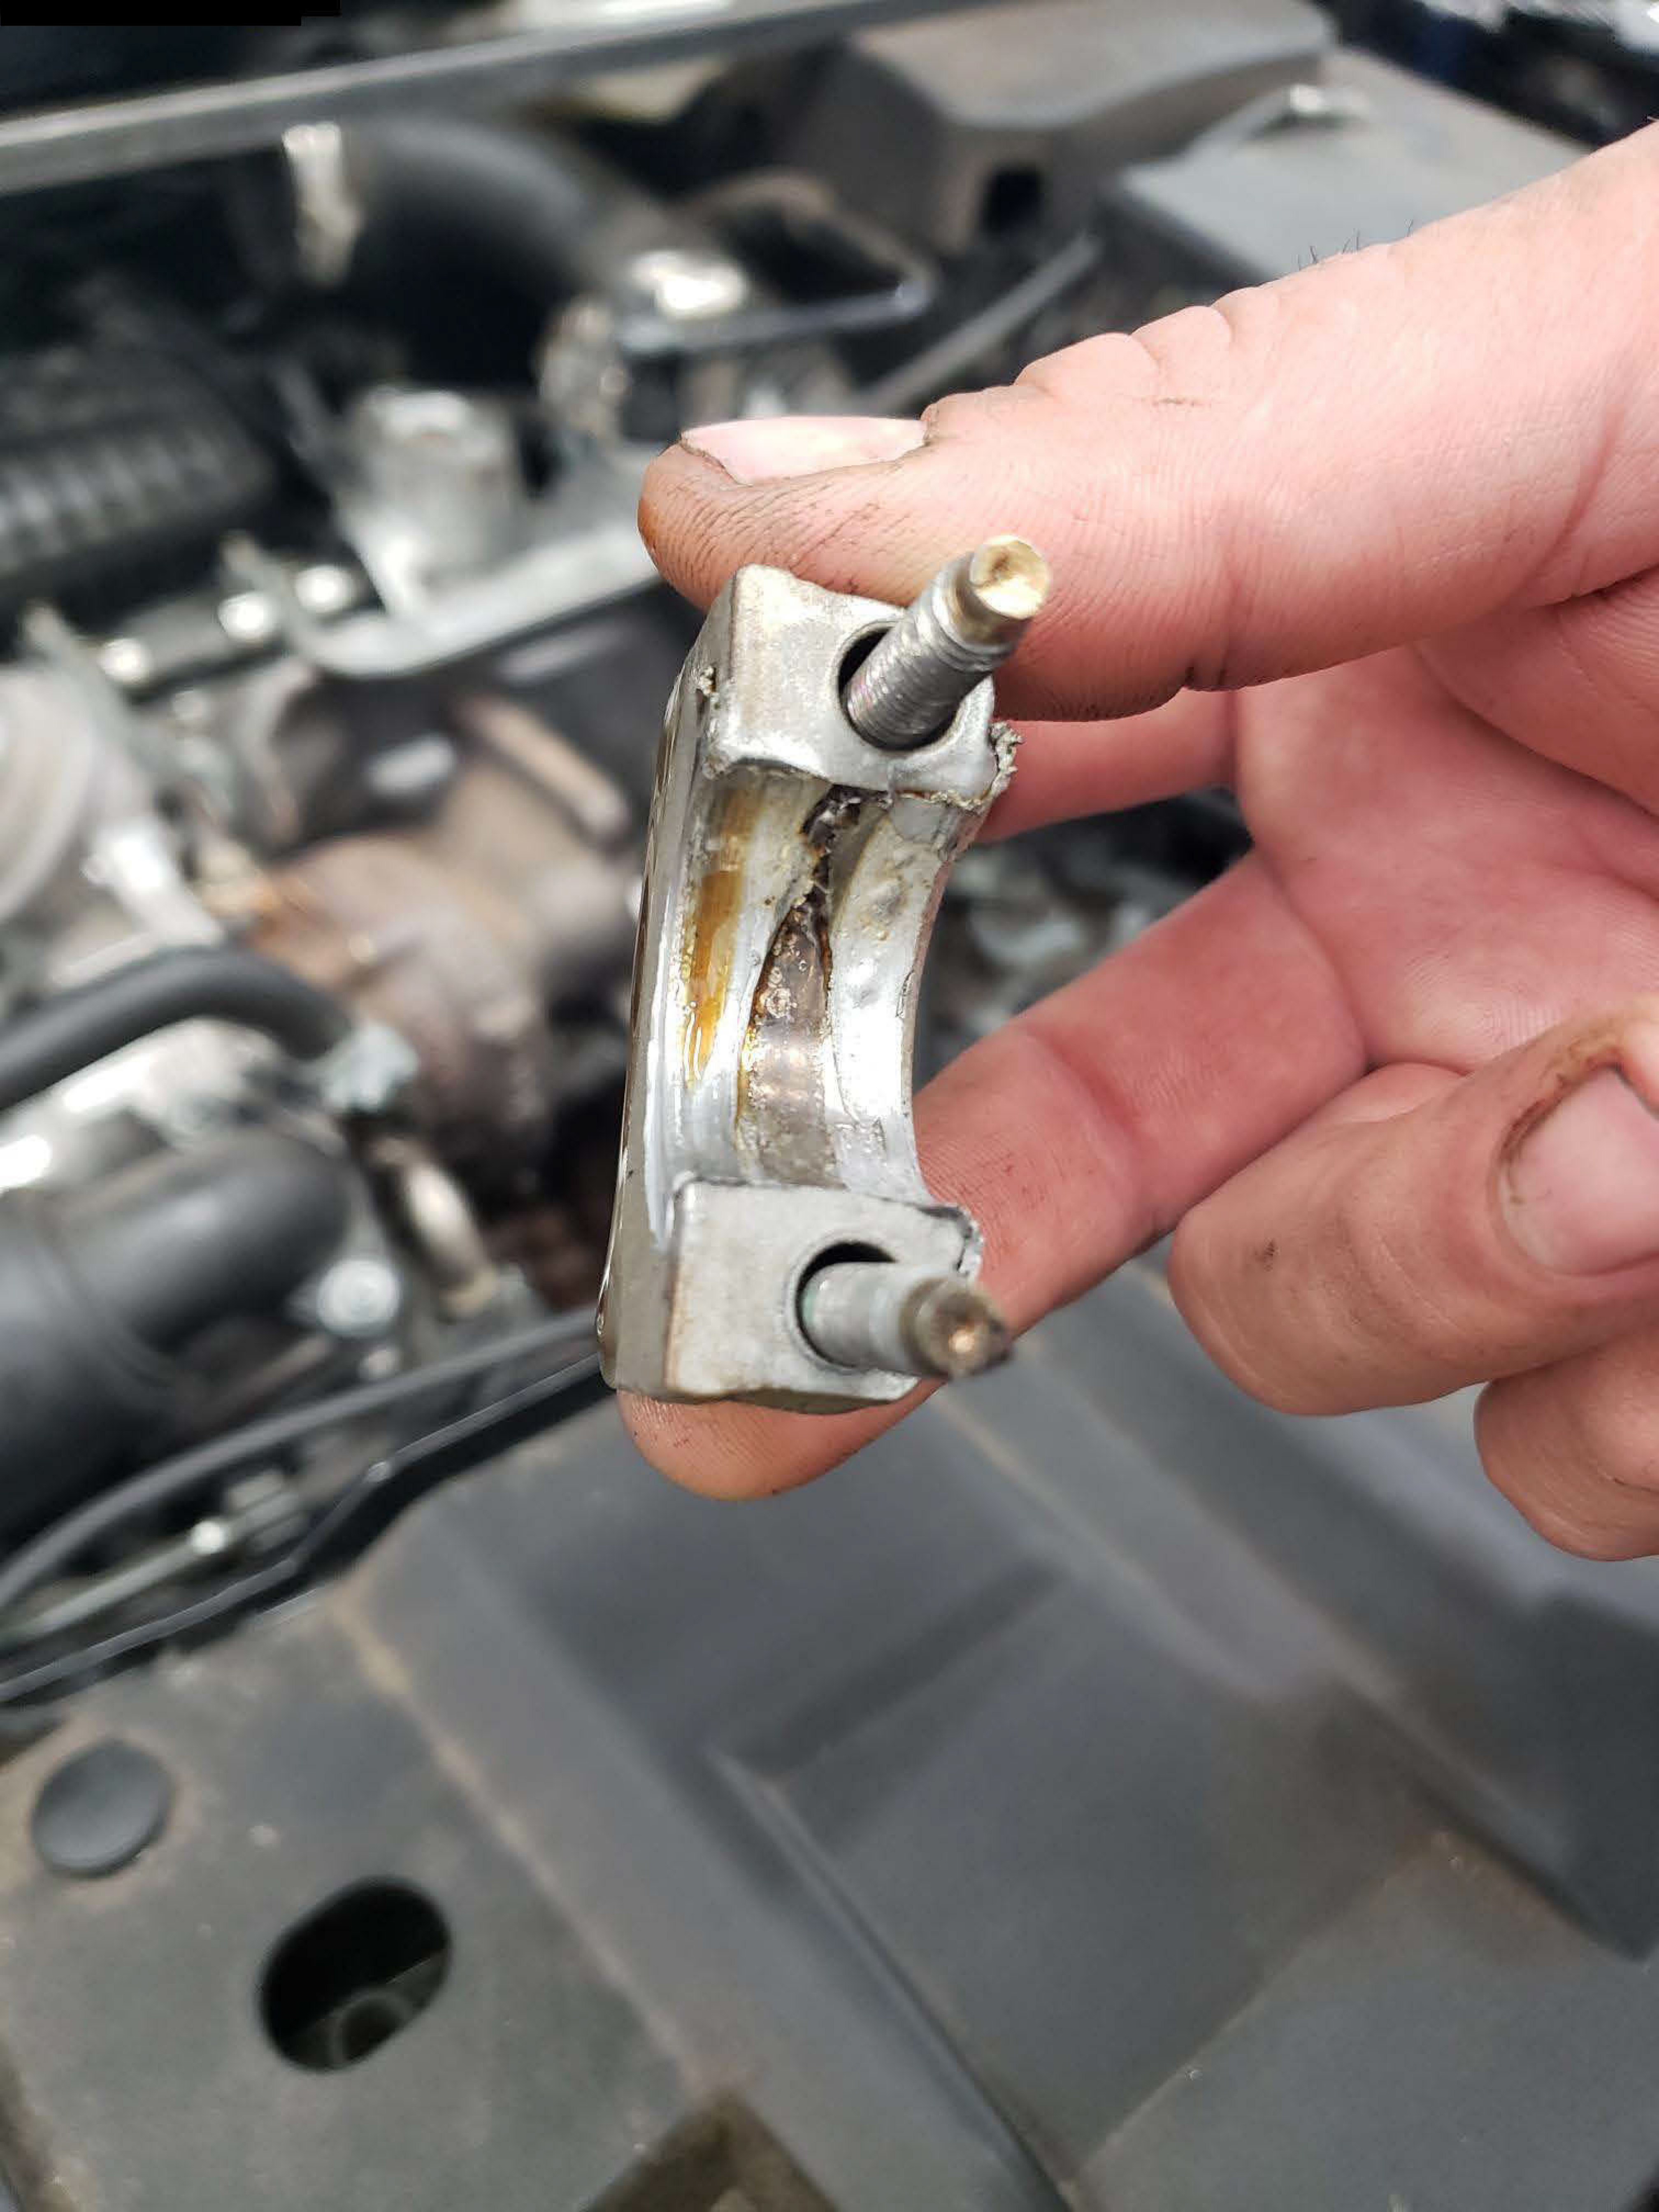
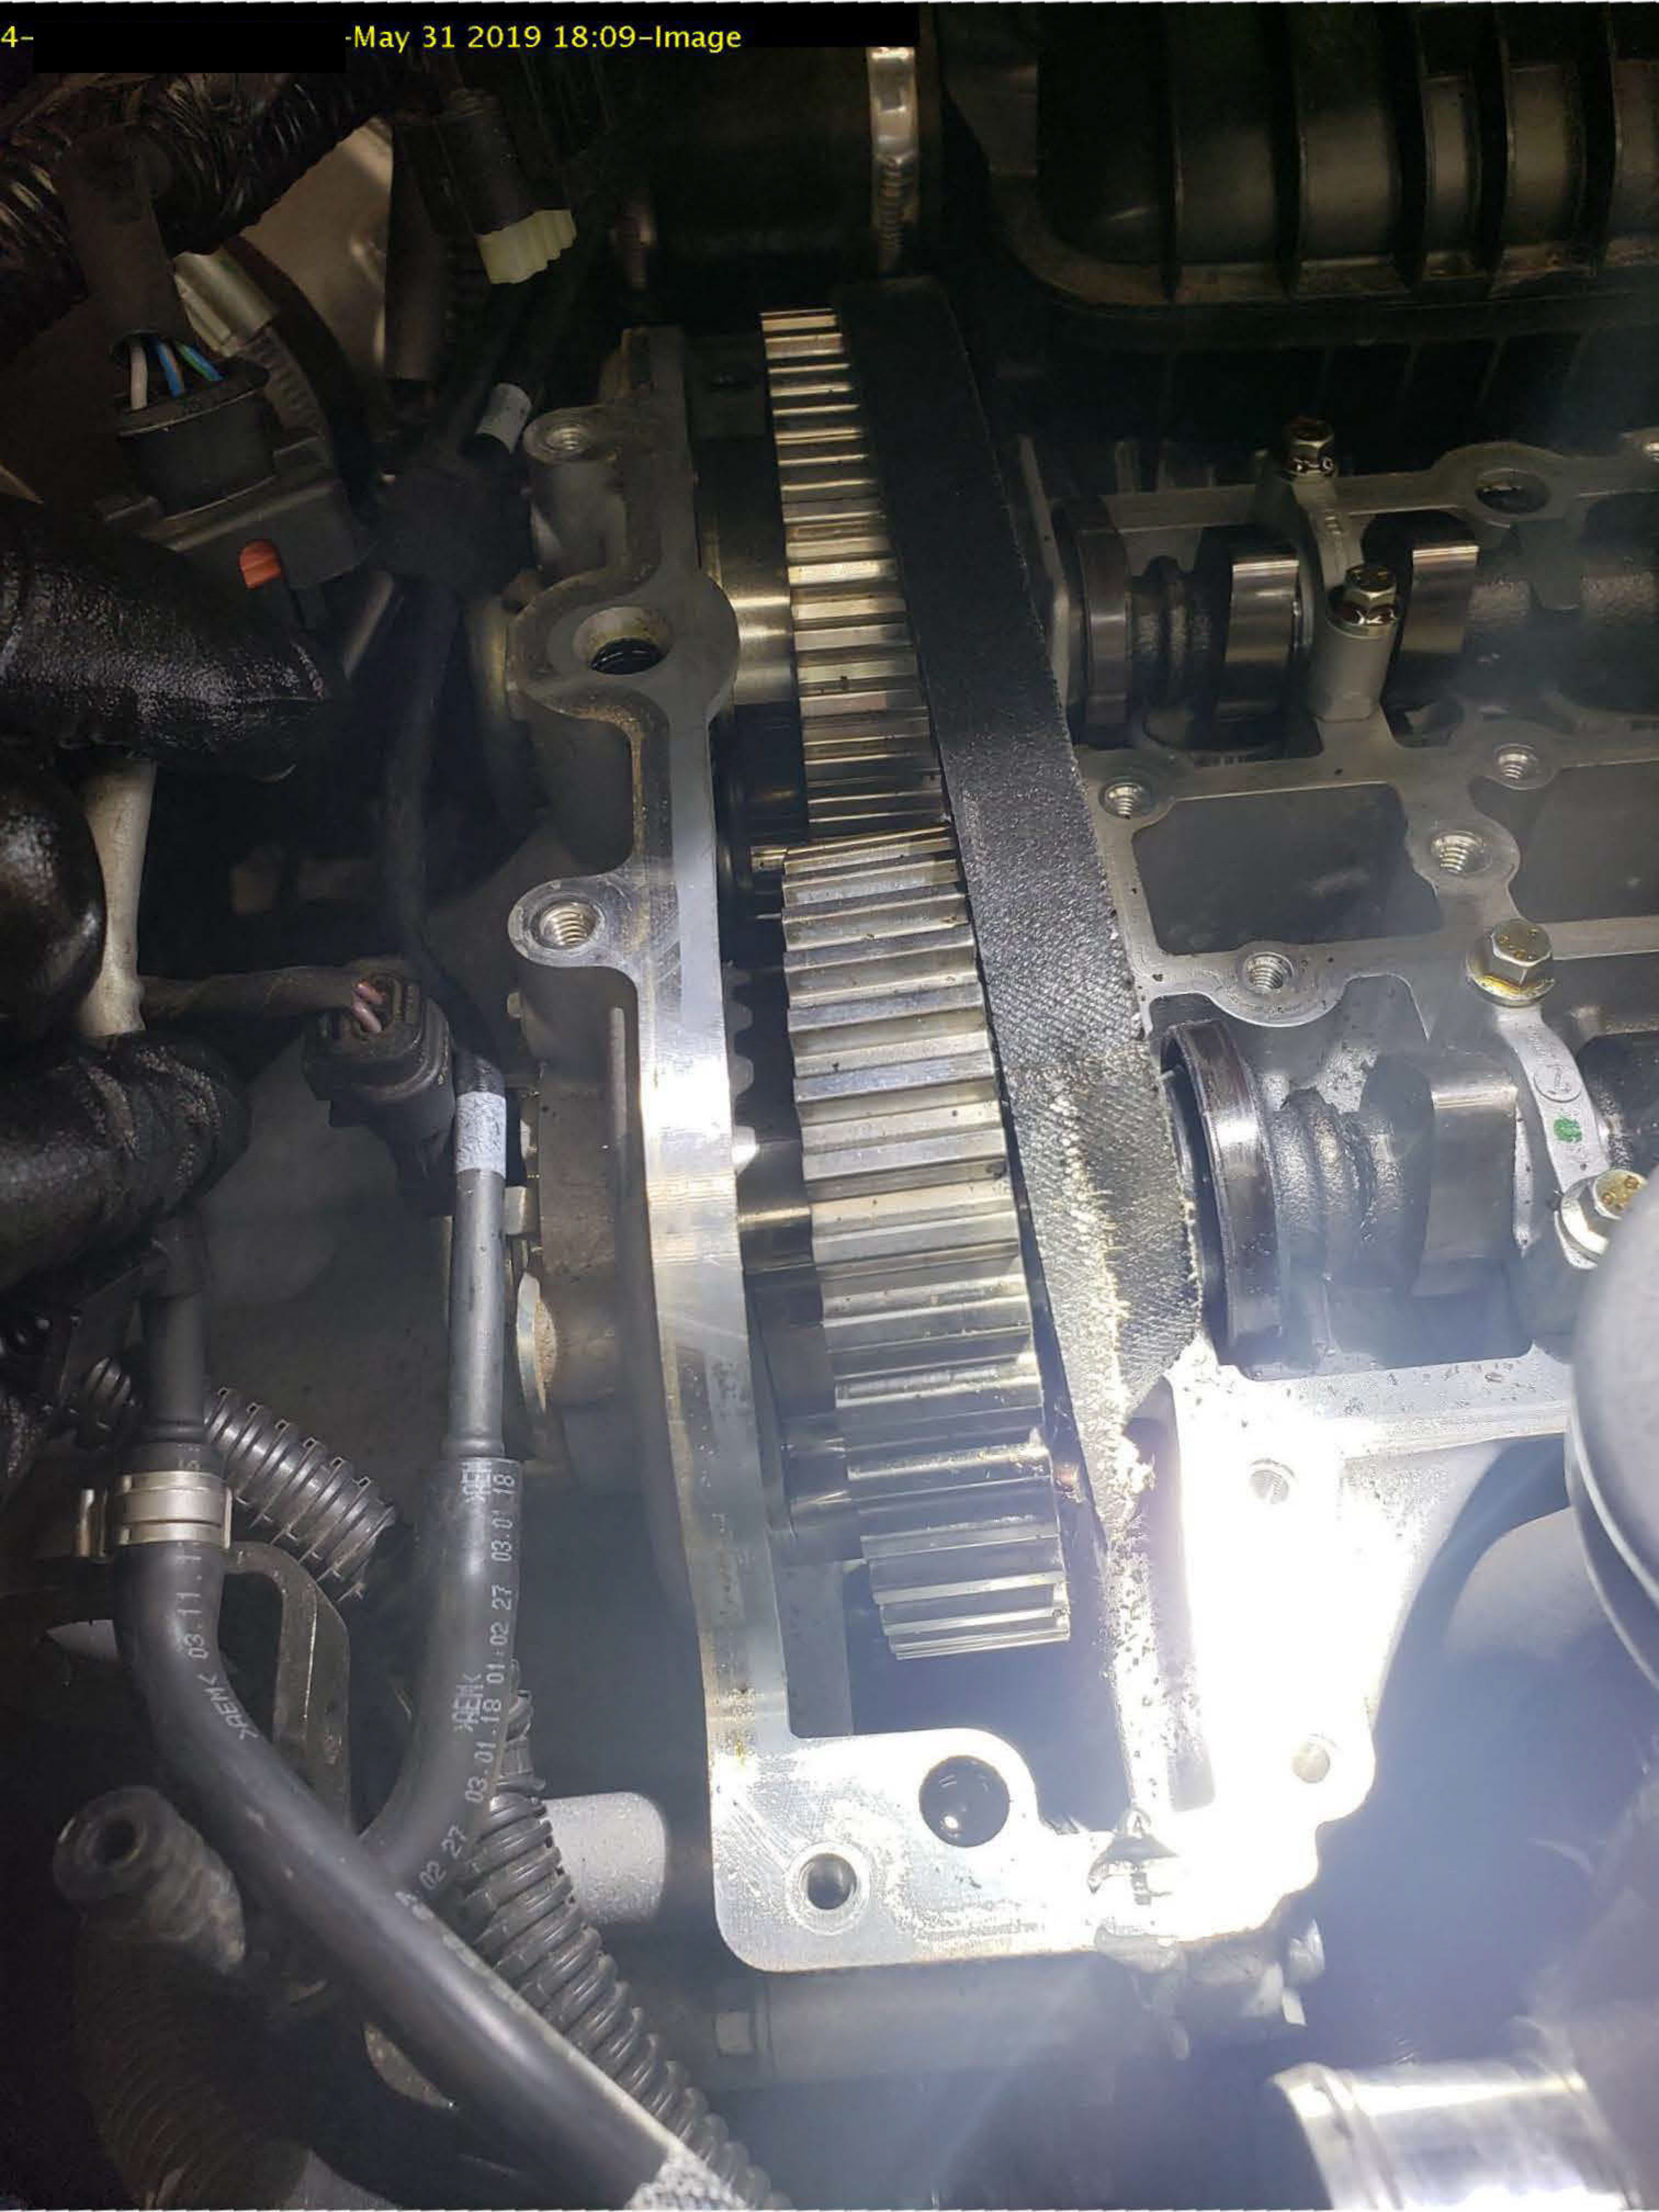
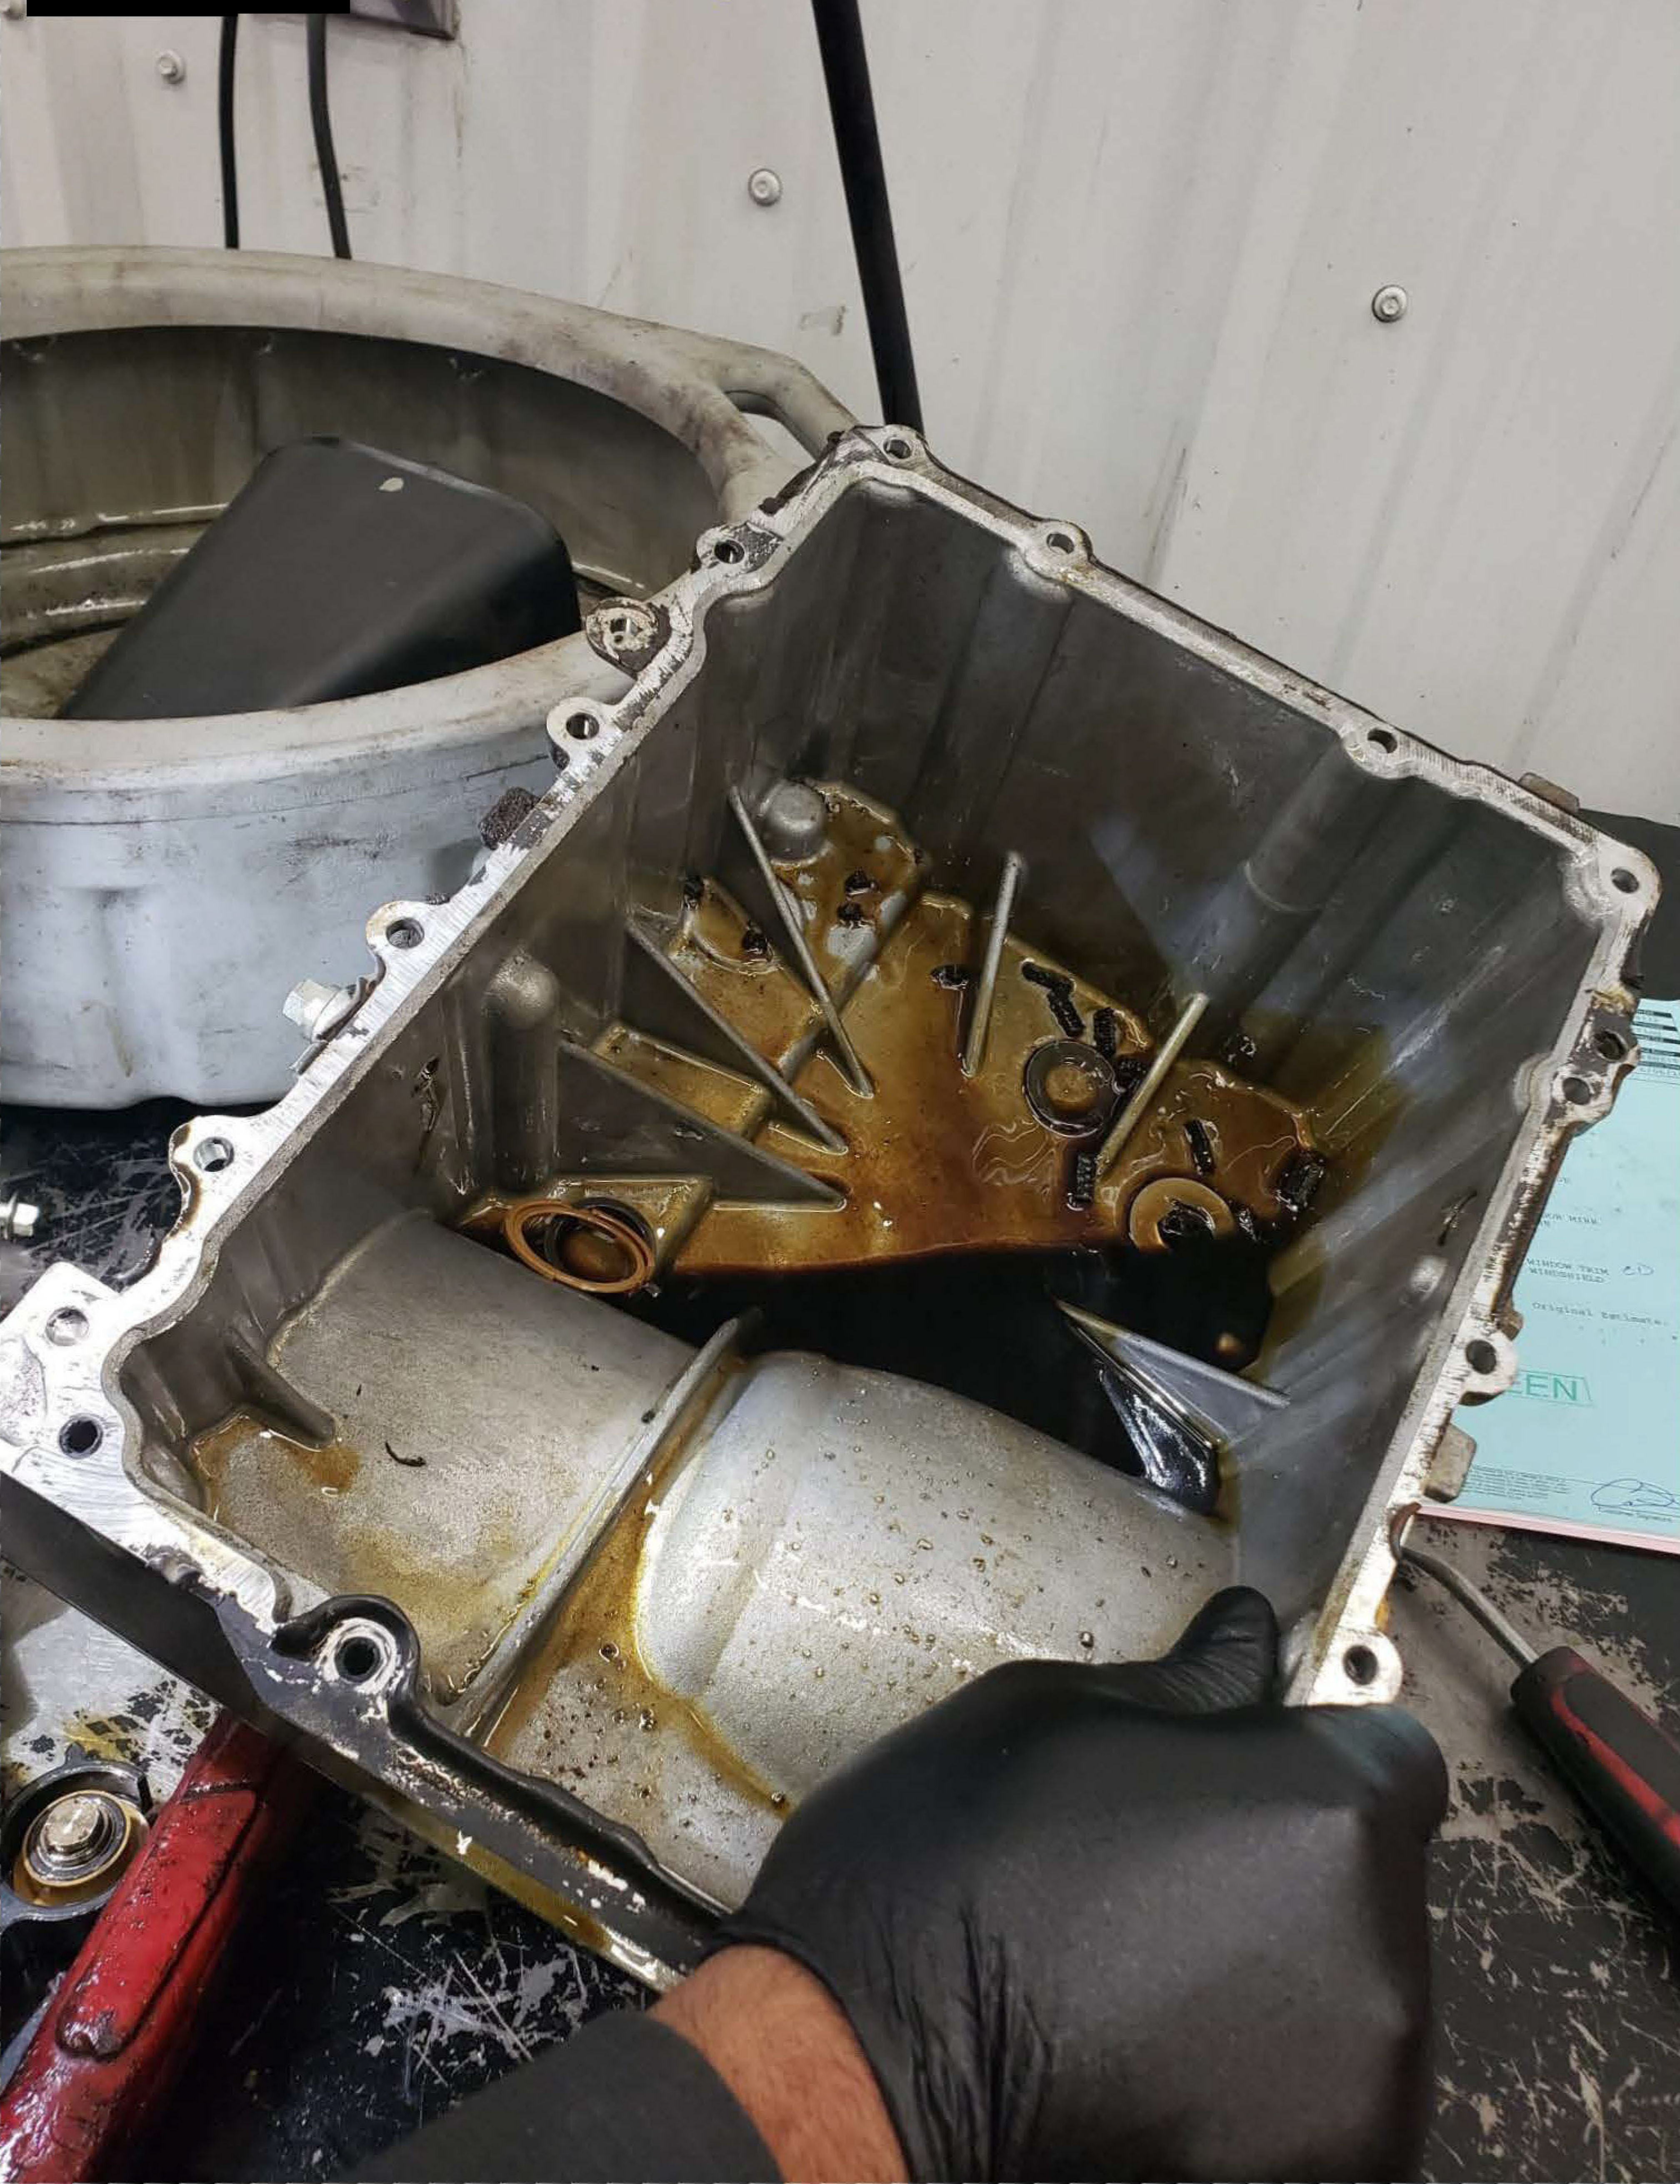
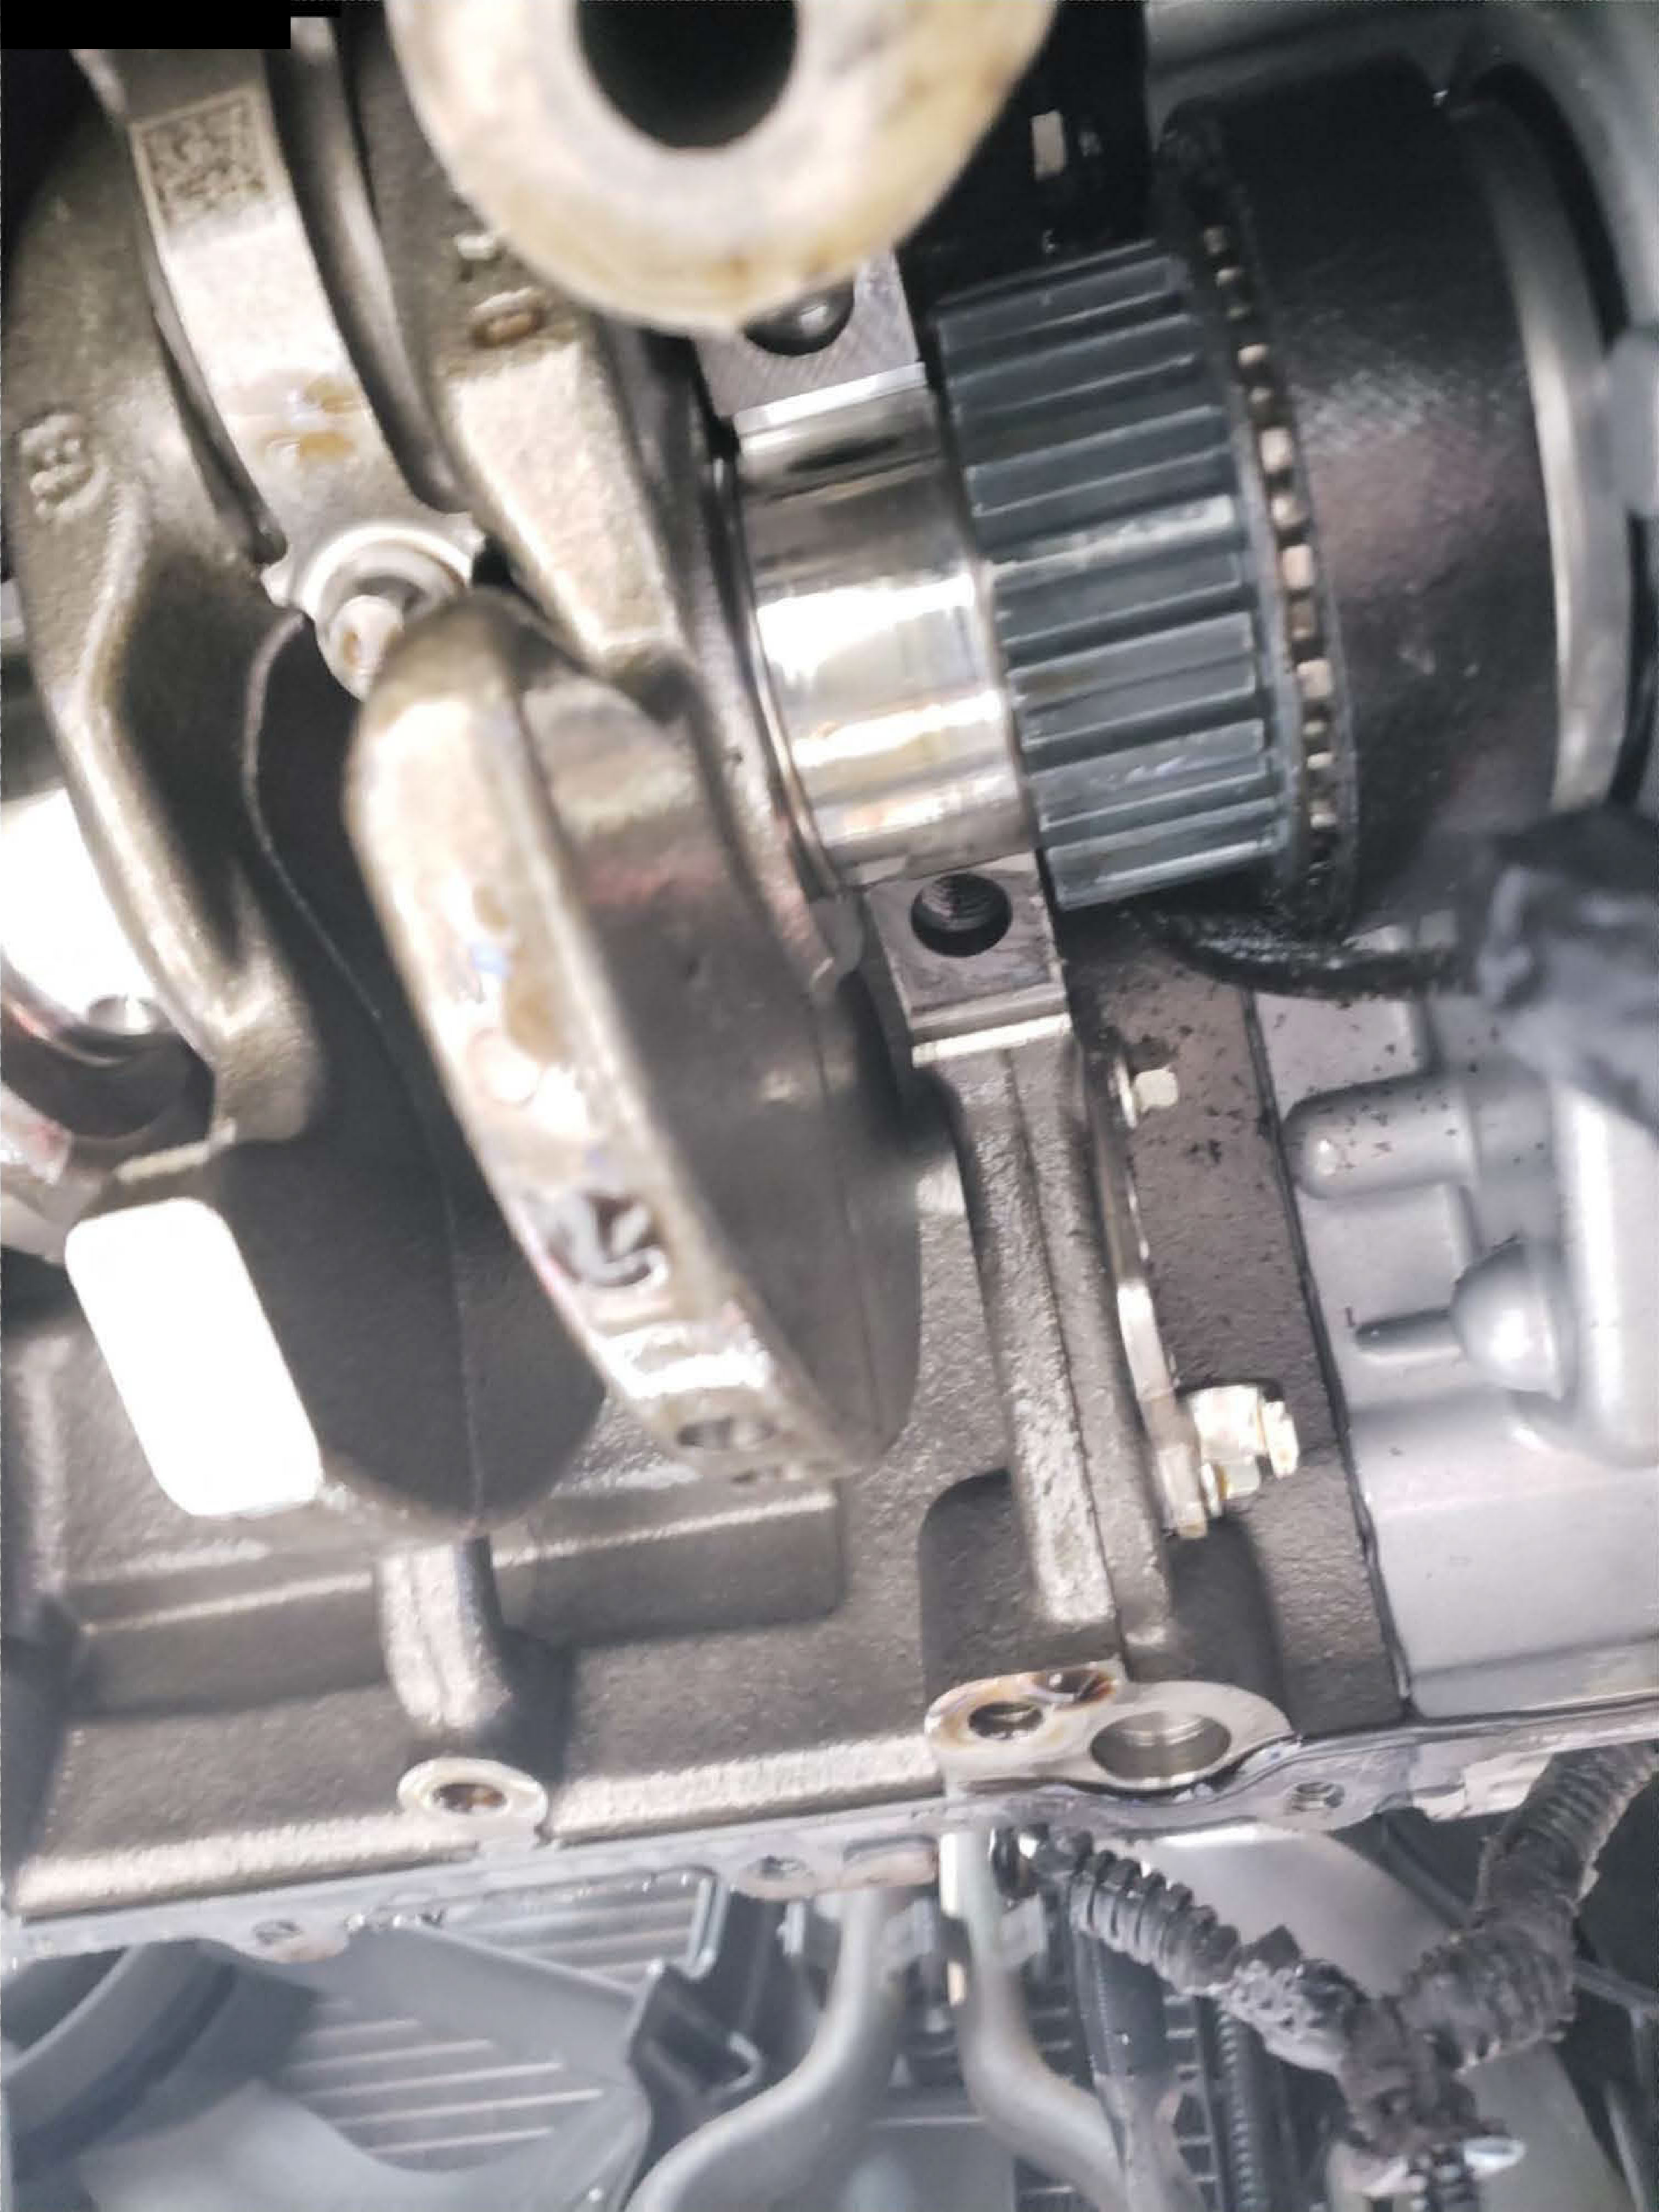
CONCER 05/31/2019 06:16PM SPILLWAY  
RO: [REDACTED] RO Date: 2019/05/15 Warranty Type: FWR SPW Install  
Mileage: SPW Install Date: Please describe customers concern. Include  
as many details as possible. customer states vehicle no crank no start  
If applicable, please list any prior repair attempts (driveability or  
transmission related) which may have contributed to the customer  
symptom. none Please provide the diagnostic steps that were performed  
to determine that the assembly needed to be replaced. Please list the  
pinpoint tests completed and include test results (pressure readings,  
electrical measurements, etc.). pulled vehicle into shop checked for  
dtc performed relative compression test cylinder one 0 pse cylinder 2  
no compression cylinder 3 was 35 psi(on manual compression test)  
remove valve cover found timing belt broken found cam broken. removed  
cylinder one cam cap was completely destroyed. removed oil pan found

debris in oil pan removed oil baffle removed main bearings caps found  
crank on cylinder one scored. drained oil and saved oil metal debris  
in oil. tensioner debirs laying in oil pan List major components (by  
name, not part) needed for repair: long block Please list part (by  
name, not part) that was root cause of failure: timing tensioner Are  
there indications of Vehicle or Component Abuse, Modifications, or  
Lack of Maintenance?<br> If so please continue to the Warranty  
Cancellation/Reinstatement Request Form. To get to this form proceed  
to <a href="http://www.fmcdealer.com">www.fmcdealer.com</a> and follow  
these steps: <ol> <li>Select Parts and Service tab</li> <li>Select  
Warranty Administration & Warranty Parts Return from the left  
navigation menu</li> <li>Select Warranty Cancellation/Reinstatement  
Request Form (right side of the screen, near the bottom)</li>  
<li>Complete the form, including photo uploads and details about
