CQIS Report Number: M8QCQ006 Program Type: H Orig Rpt #:
Report Source: MSS - FCSD - TECH ASSIT CENTER Report Date: 08/17/2021

VEHICLE: 2017 FOCUS,SE,4 DOOR ,SEDAN VIN:1FADP3FEXHL238150
Engine : 1.0L 12V DI TC I3 GS 120PS FOX Odometer: 39,360 MILES
Operating Environ: WCC :
Vehicle Use : Rsp. Act:

SYMPTOM: 5 50 A 02 DRIVING PERFORMANCE RUNS ROUGH
ALL RUNNING MODES ALWAYS

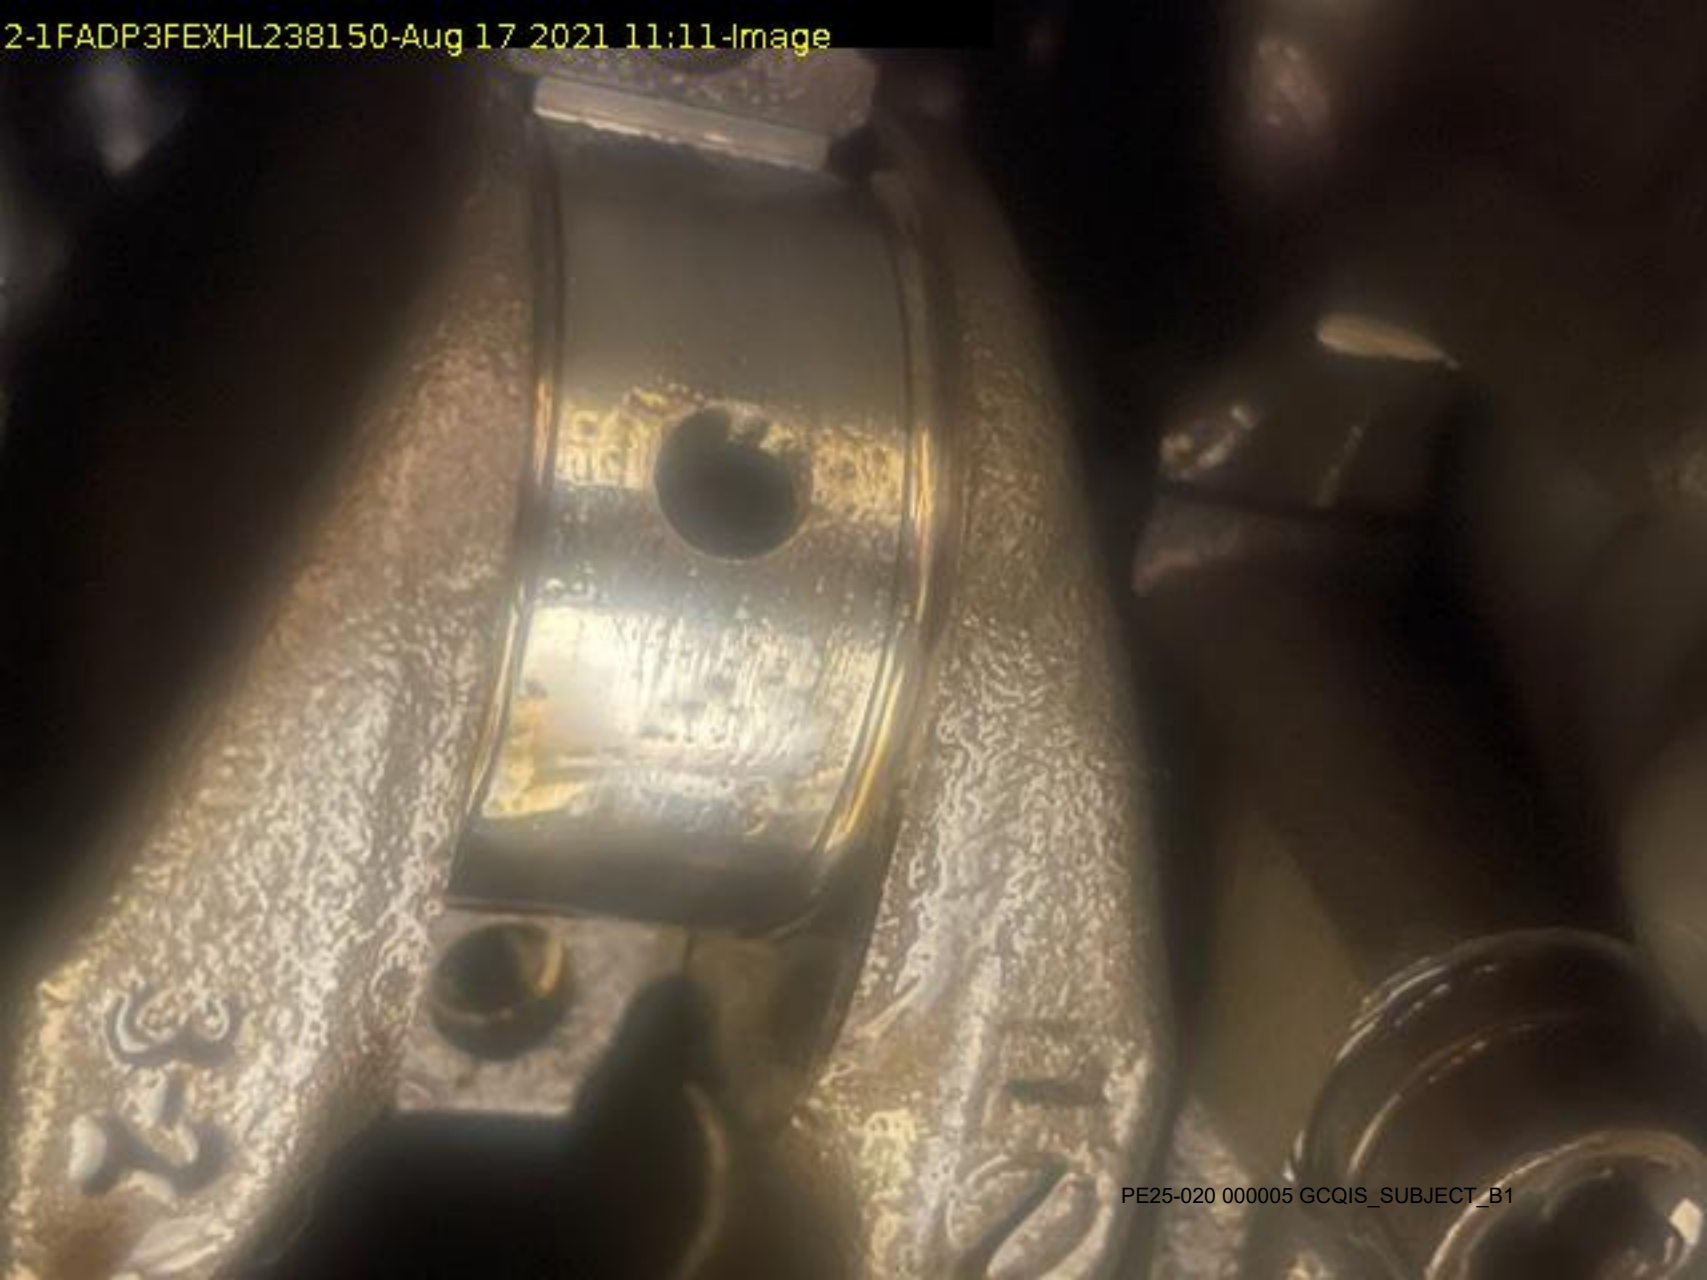
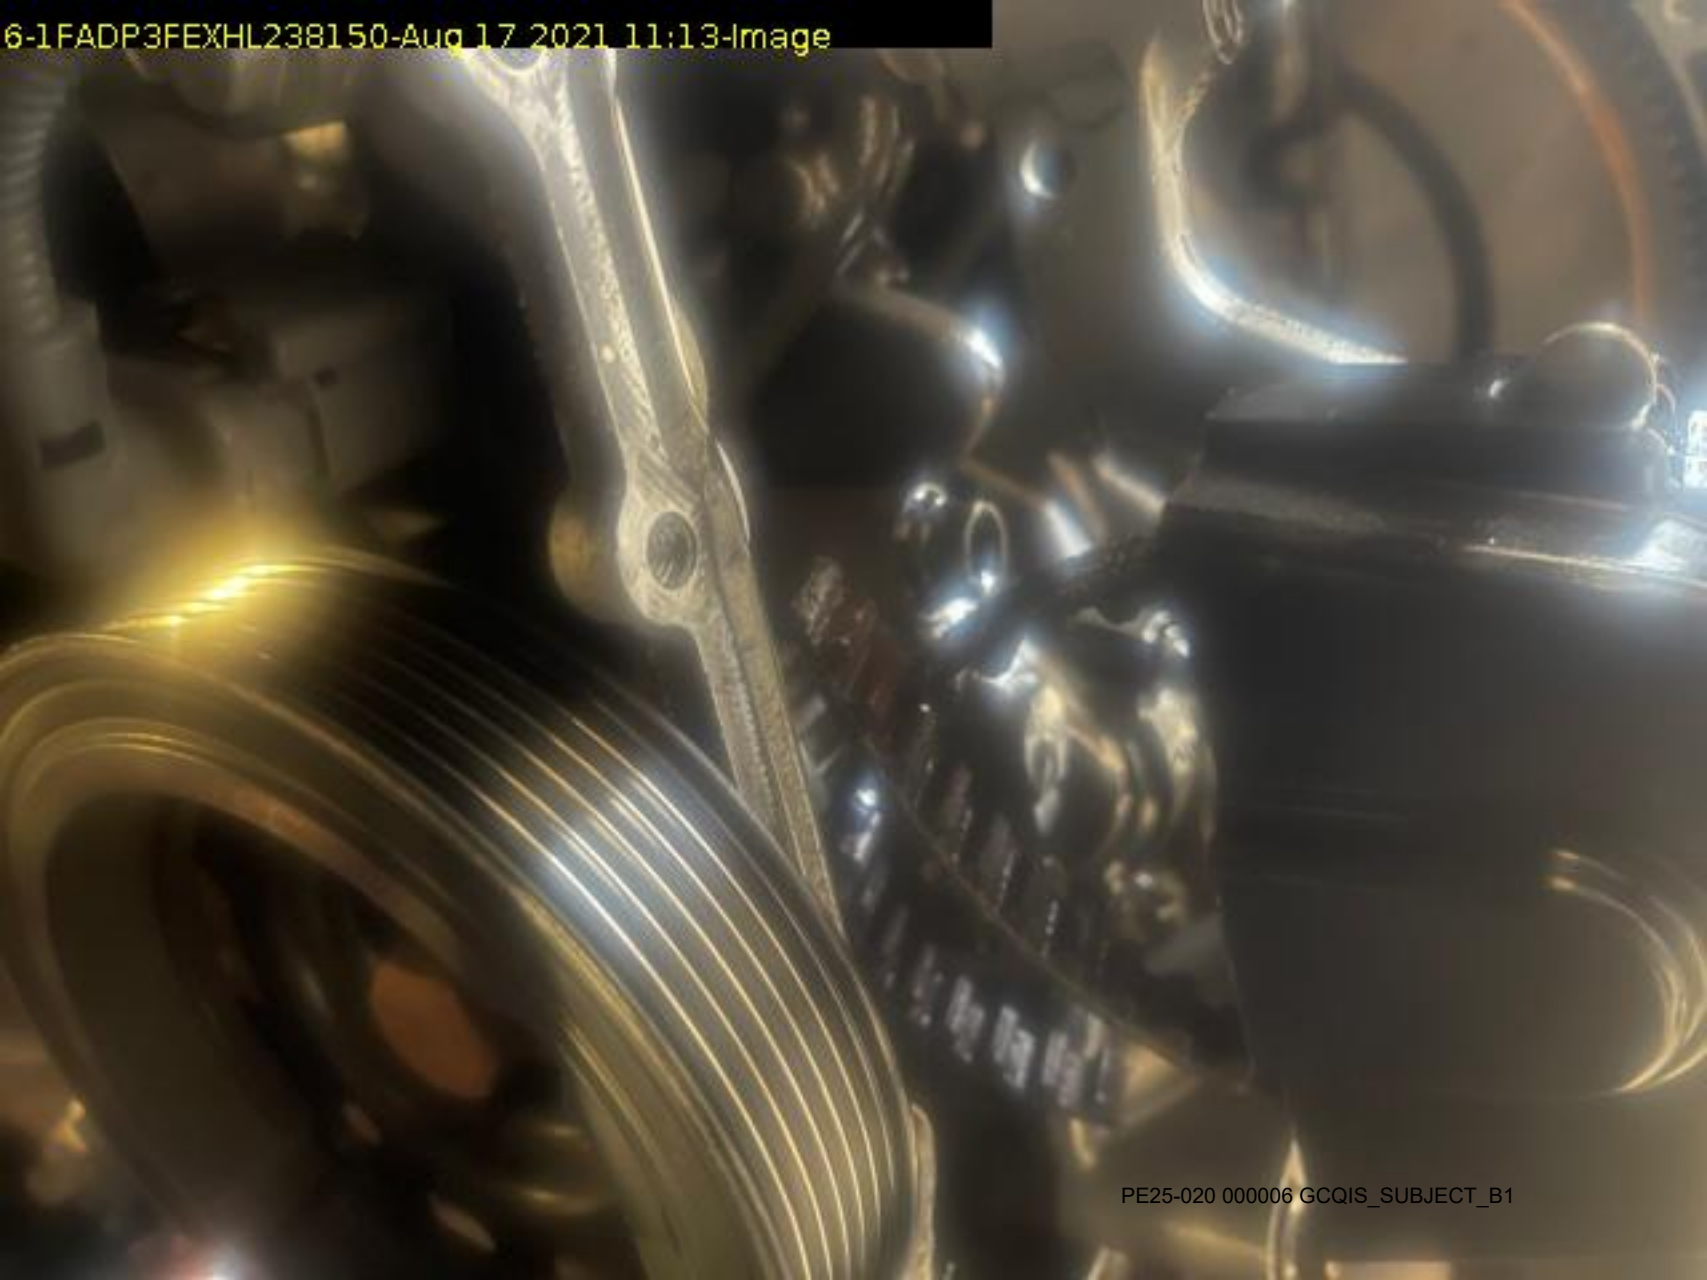
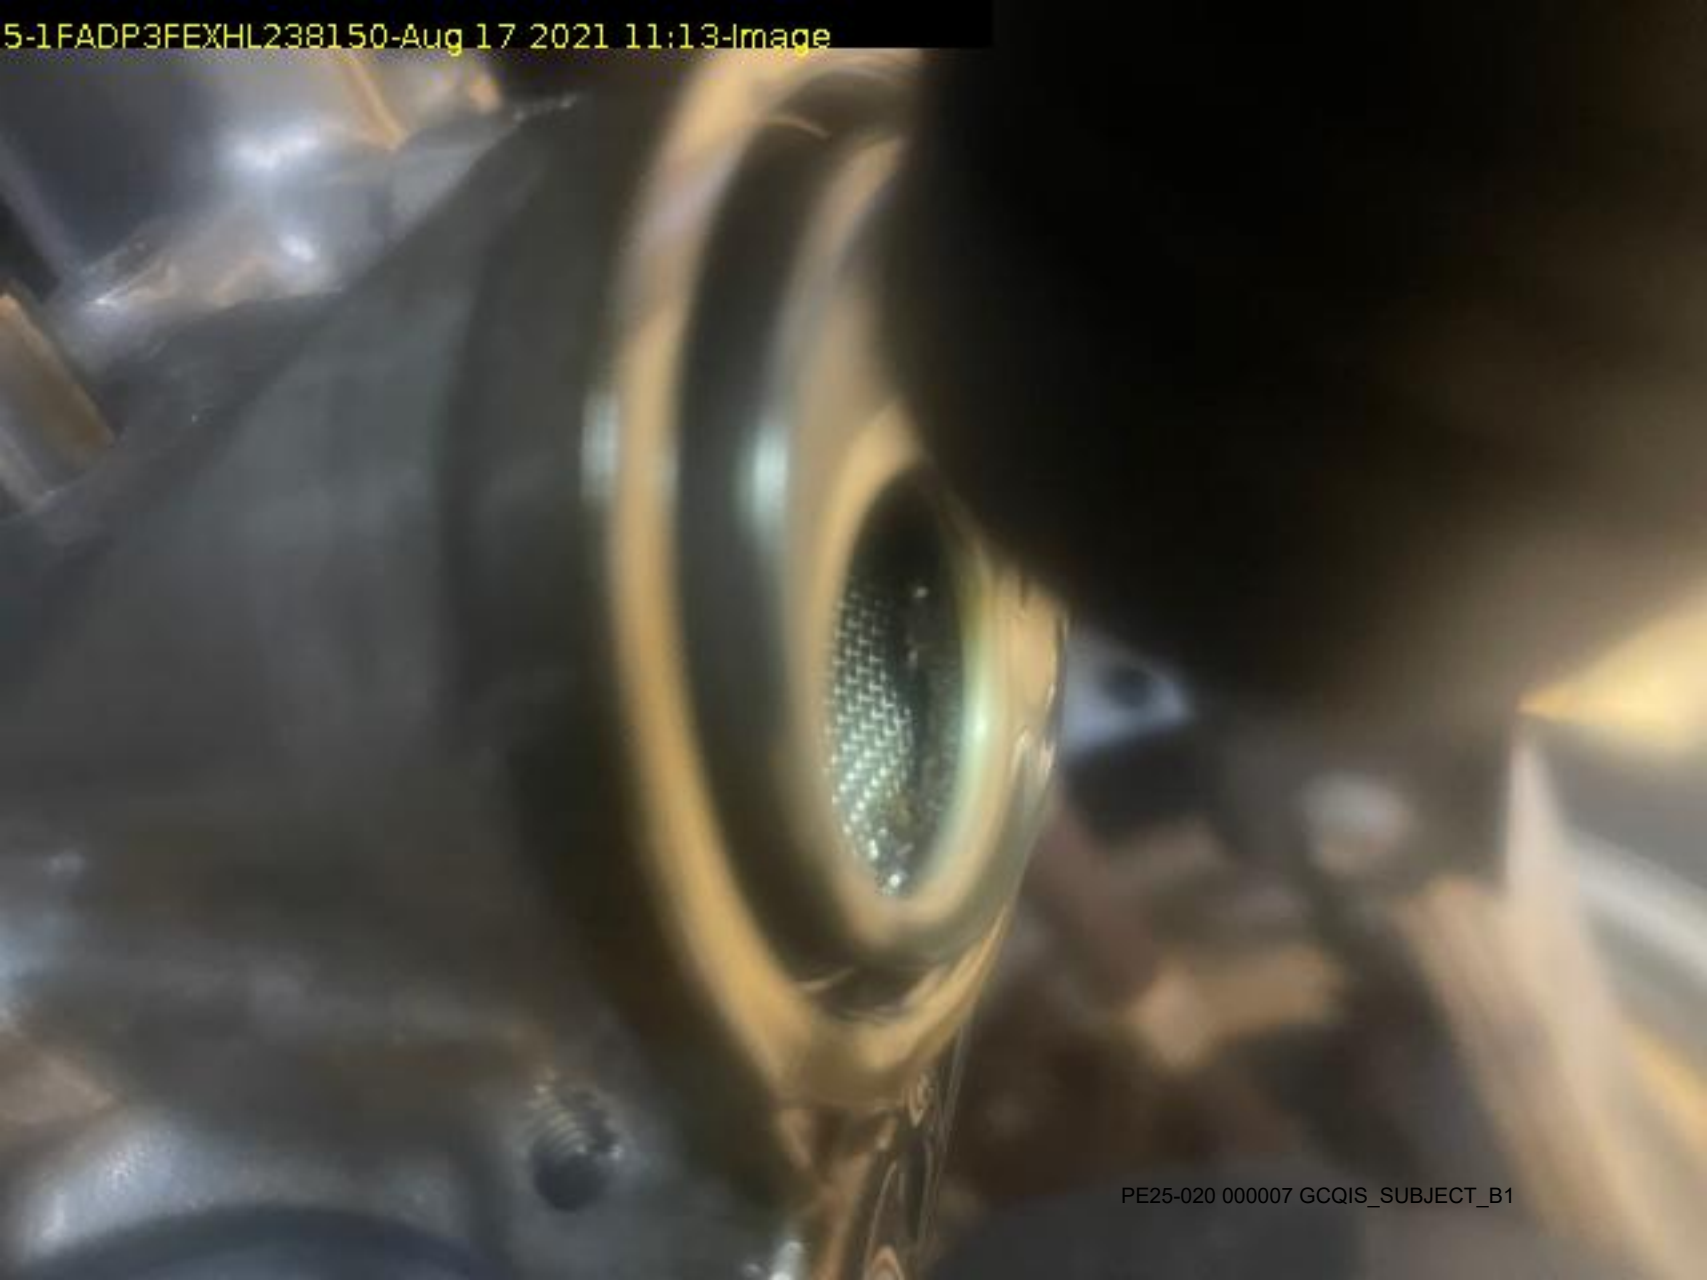
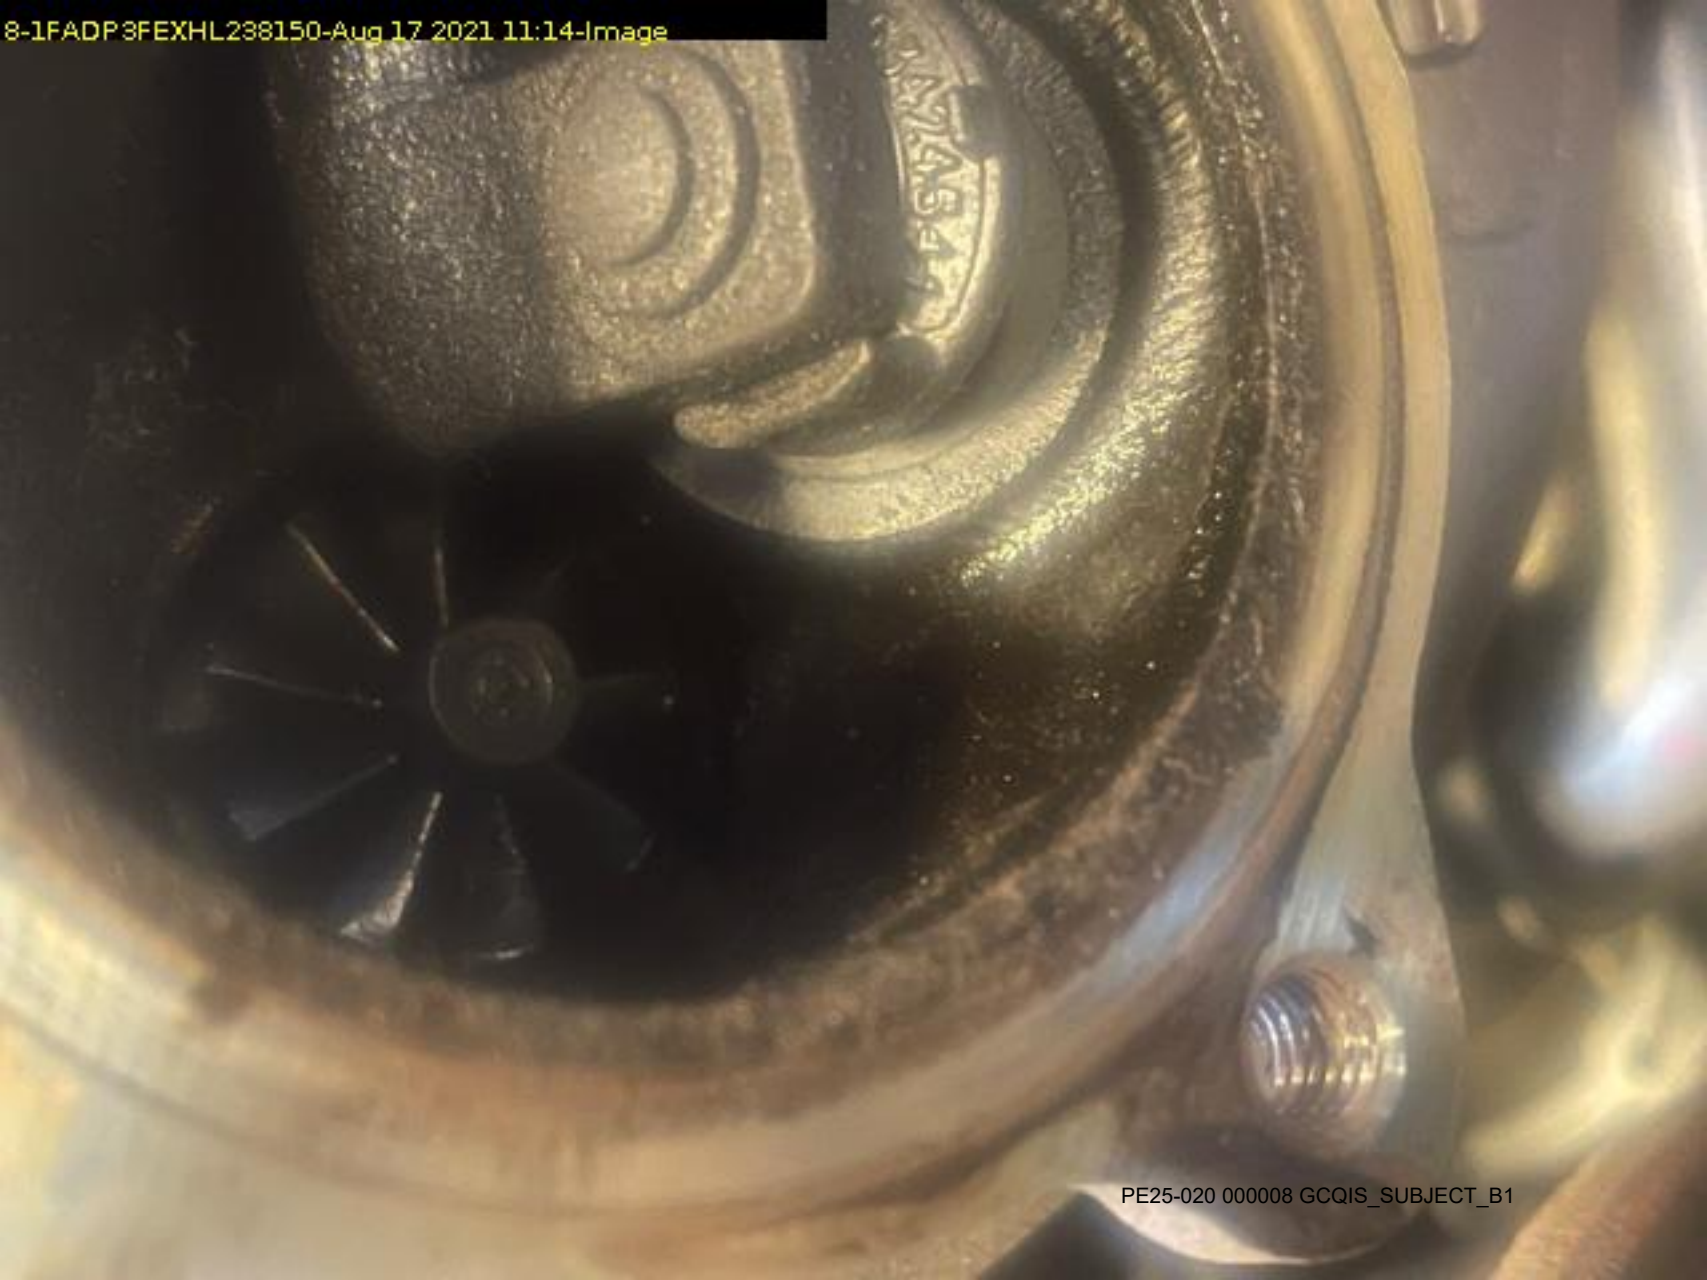
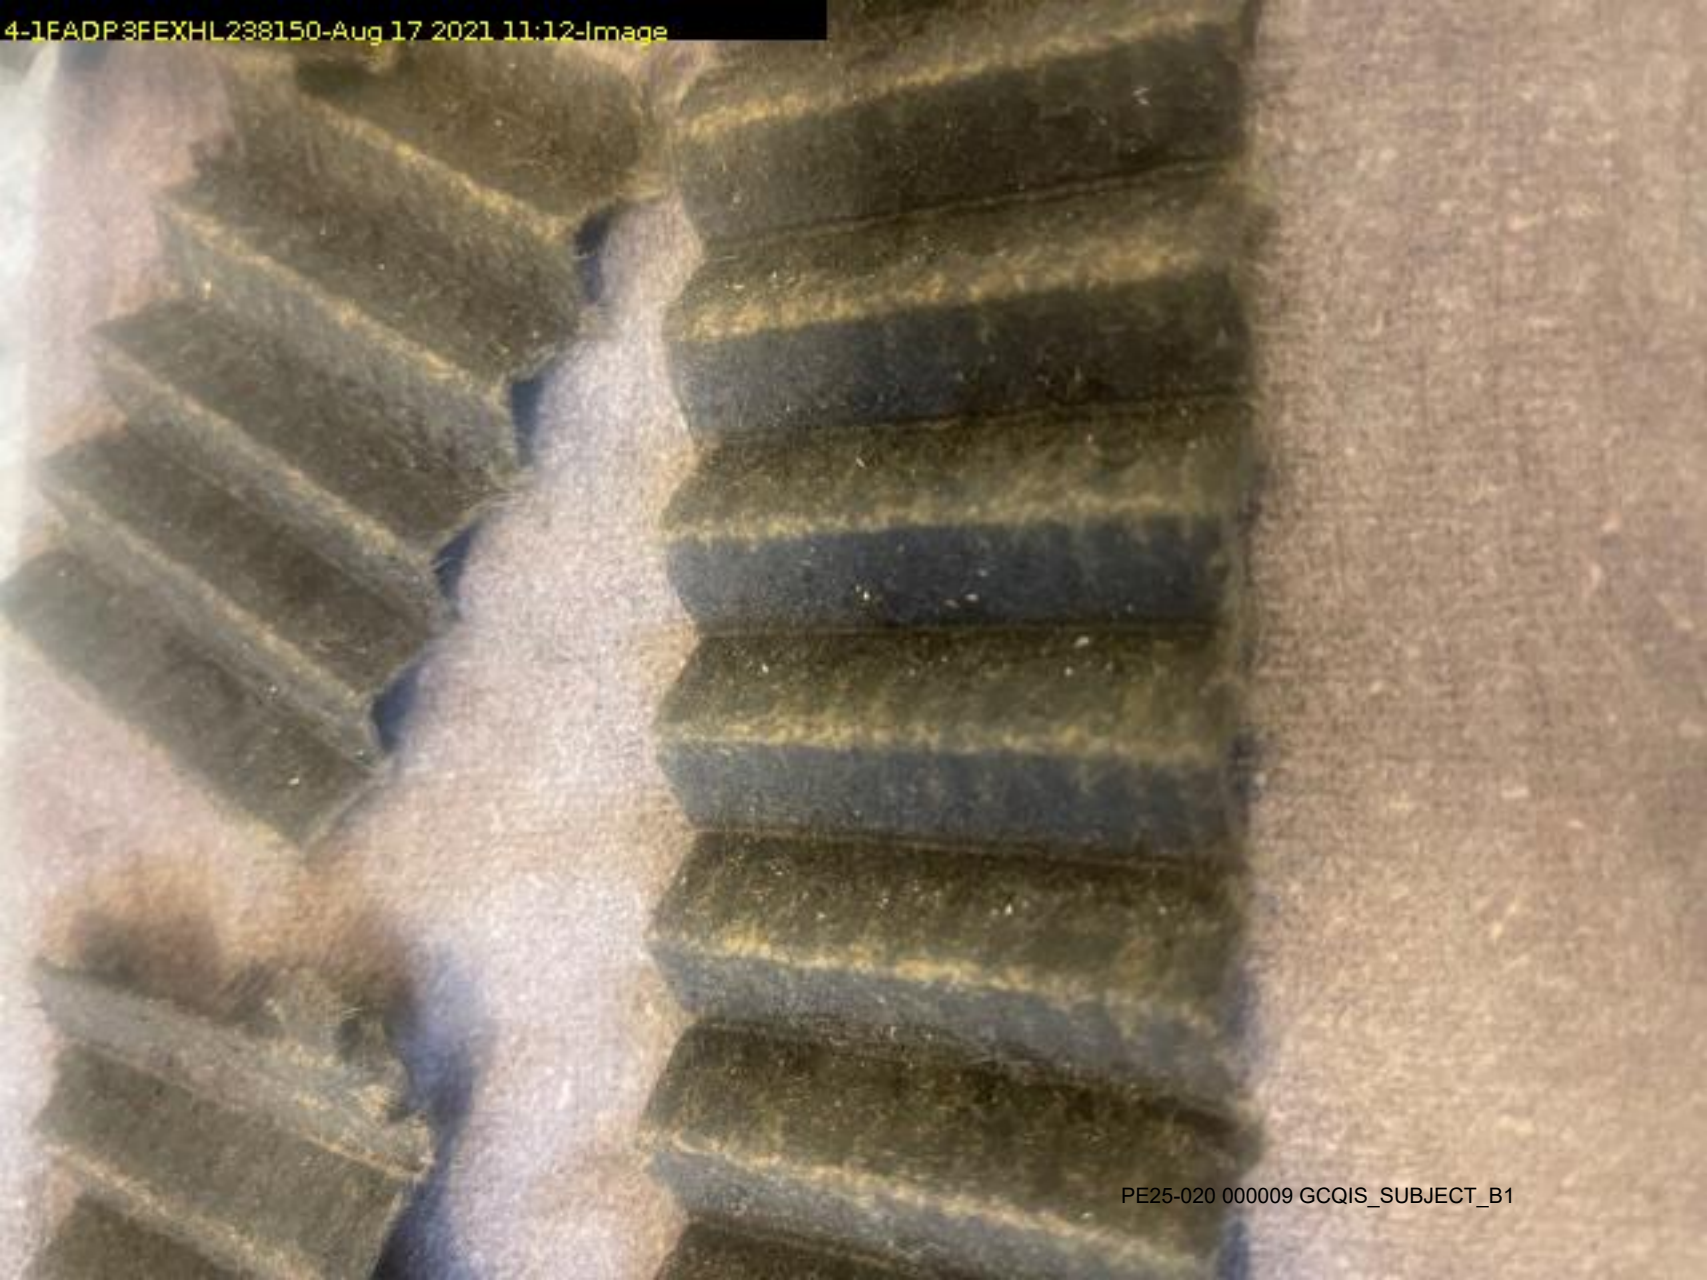
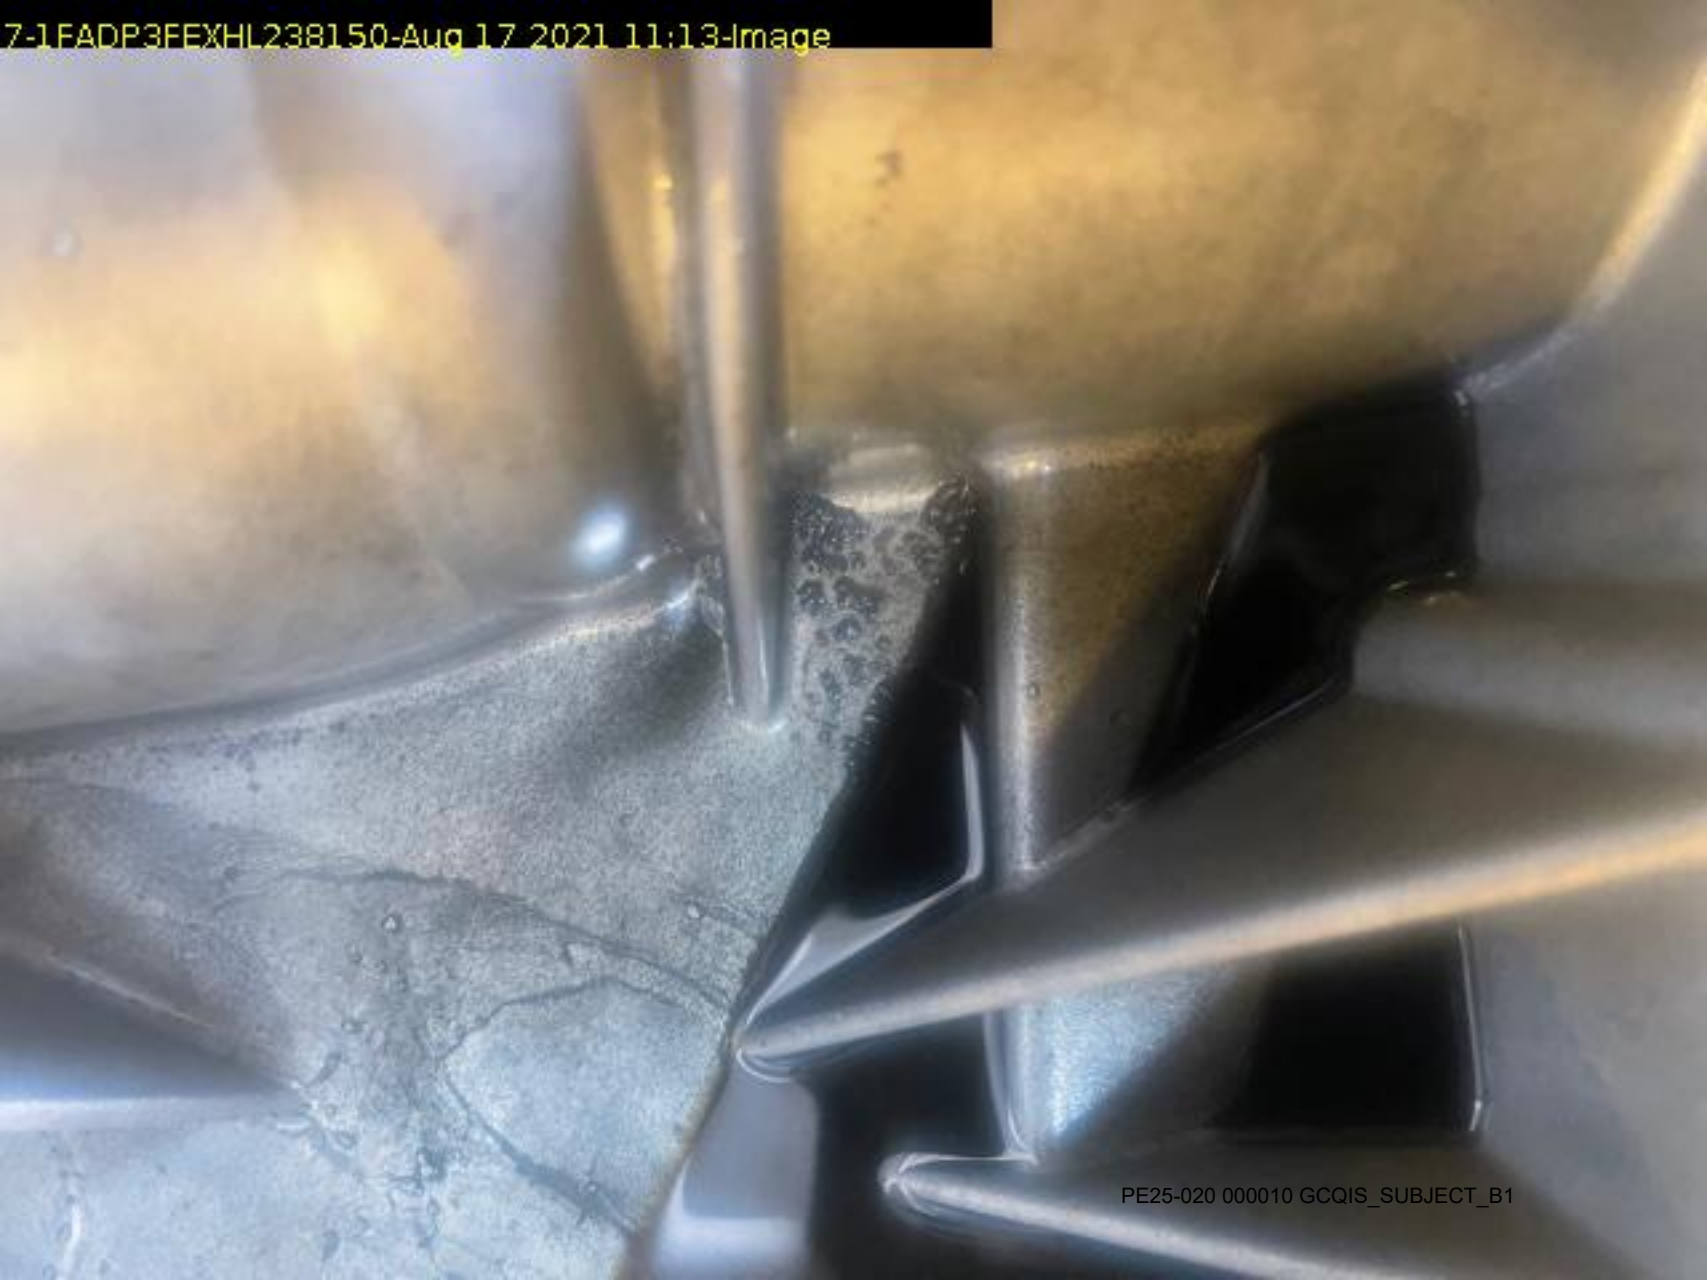
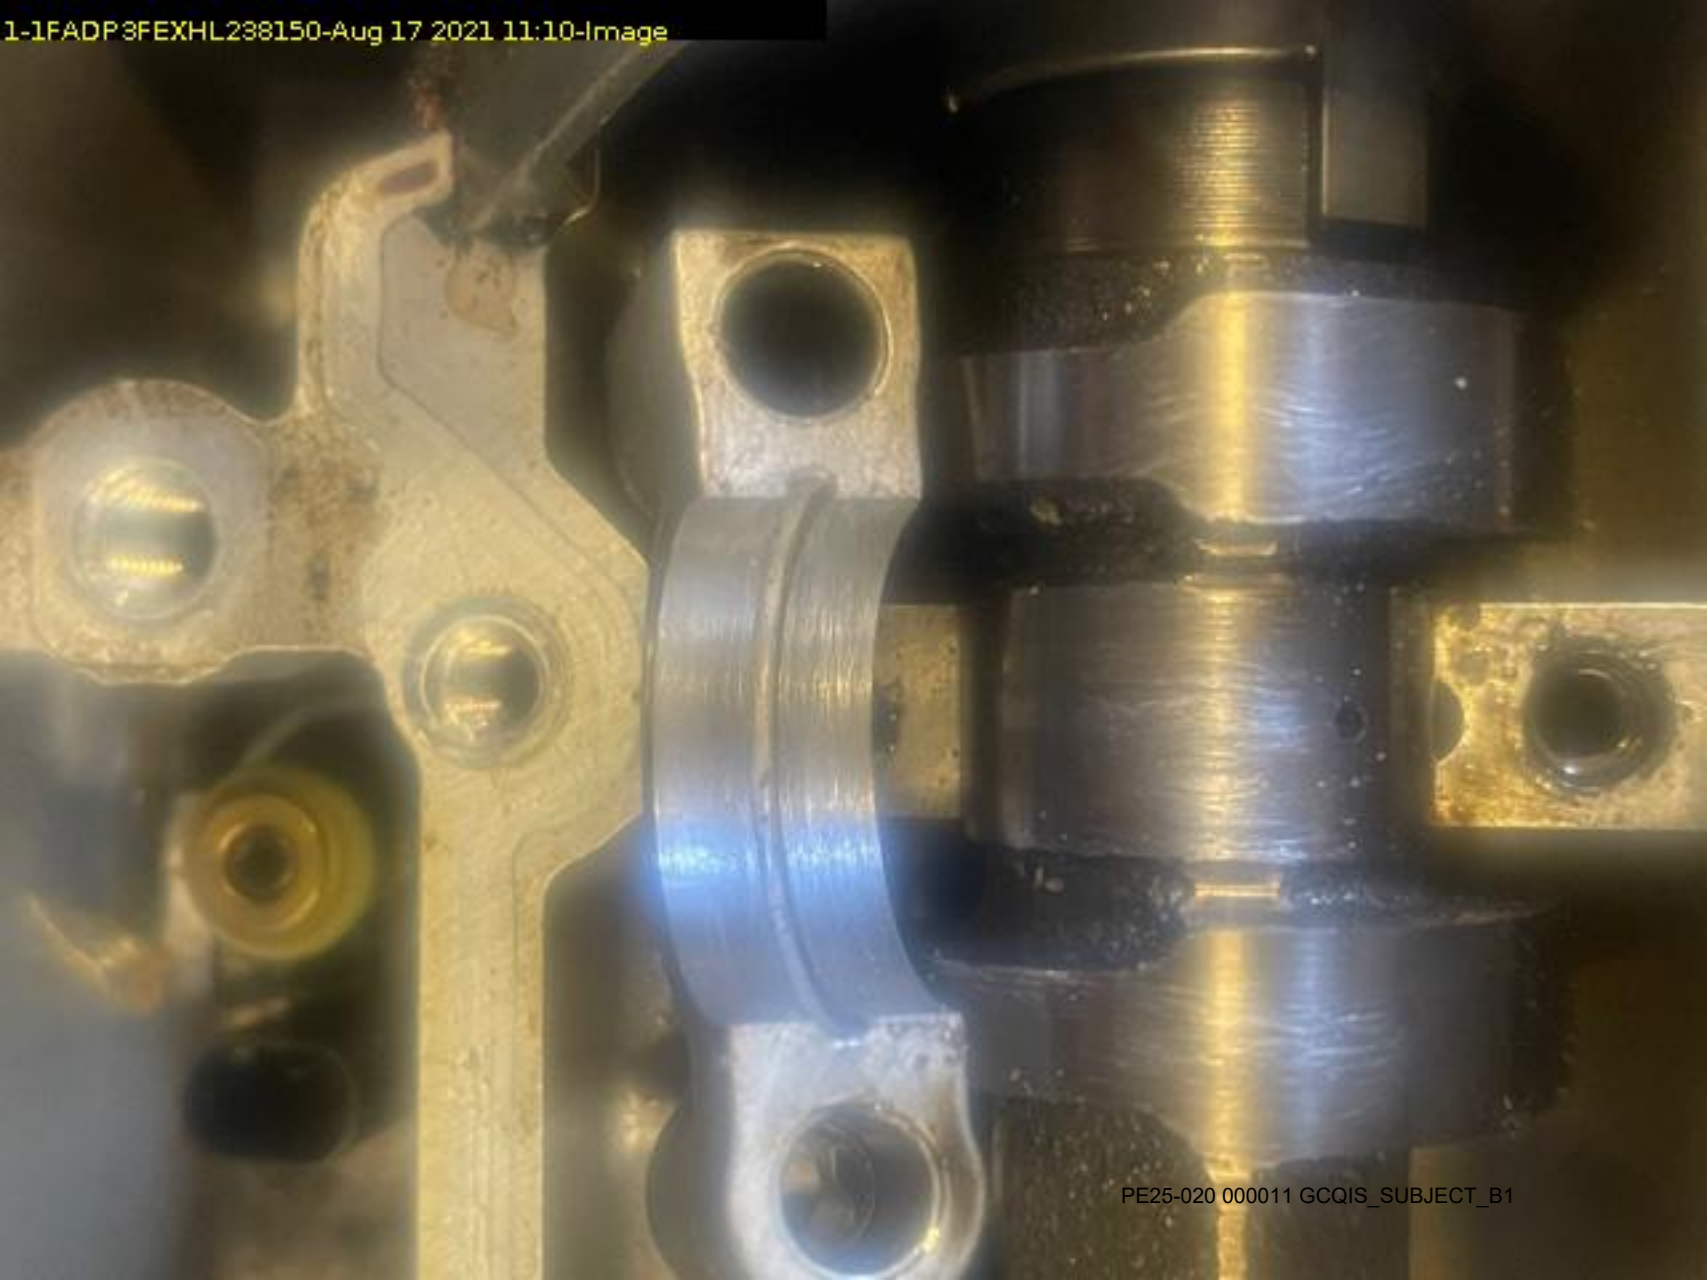
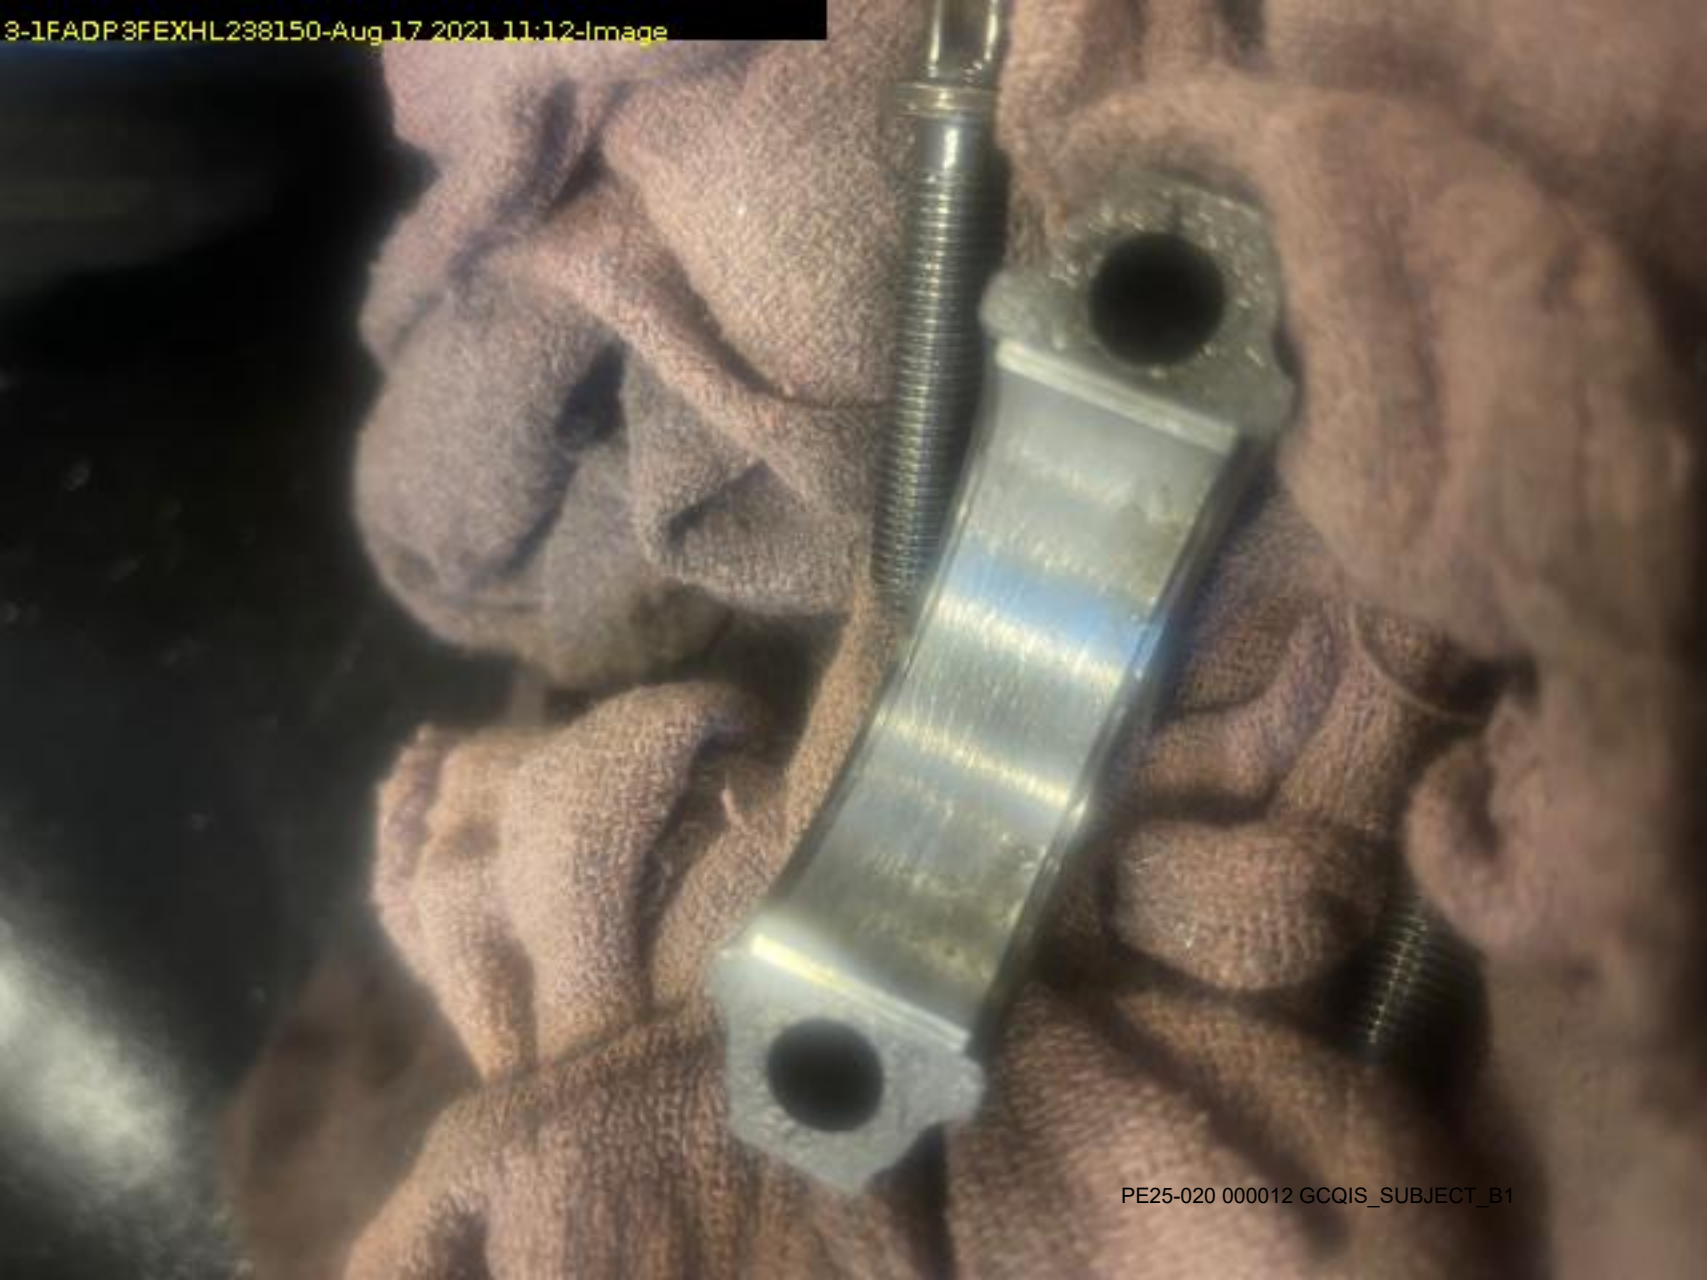
CONCER 08/17/2021 11:41AM ASPEZIA2
RO: 675719 RO Date: 2021/07/20 Warranty Type: FWR SPW Install Mileage:
SPW Install Date: Please describe customers concern. Include as many
details as possible. While driving down the road the car lost all
power and oil pressure light came on. If applicable, please list any
prior repair attempts (driveability or transmission related) which may
have contributed to the customer symptom. None Please provide the
diagnostic steps that were performed to determine that the assembly
needed to be replaced. Please list the pinpoint tests completed and
include test results (pressure readings, electrical measurements,
etc.). Upon visual inspection found metal debris on oil dipstick and
vehicle oil level is 3 quarts low. Vehicle barely runs and has loud
knocking and ticking noises, also lots of white smoke coming from tail
pipe. Drained engine oil and found lots of metal debris in oil.

Removed valve cover, found scoring present on camshaft journals and
tappets. Removed oil pan and found oil pump belt broken into and metal
debris in oil pan, also scoring present on rod journals and caps.
Removed Catalytic converter from turbocharger and found severe
turbocharger damage (Turbine wheel is broken into with lots of play
and severe amount of engine oil has leaked into Catalytic Converter
and onto oxygen sensors.) List major components (by name, not part)
needed for repair: Engine Longblock Turbocharger Assembly Catalytic
Converter Assembly Both Oxygen Sensors Please list part (by name, not
part) that was root cause of failure: Oil pump belt and turbocharger
Are there indications of Vehicle or Component Abuse, Modifications, or
Lack of Maintenance?
 If so please continue to the Warranty
Cancellation/Reinstatement Request Form. To get to this form proceed
to www.fmcdealer.com and follow
these steps: Select Parts and Service tab Select

CONCER 10/20/2021 04:19PM GTCGQSP
cost cap has been redone removing unneeded items the scoring in the head is evident in the last pics from running after oil pump belt broke. we feel the cams have wear on them and are discolored from heat build up and should be replaced as well. we are asking for approval for short block and head to get this cust back on the road as soon as possible and be repaired sooner. thanks

RECOMM 10/20/2021 04:33PM JONATHAN RICE MSS - FCSD - SBDS DIAG SVC PL
Patrick, Thank you for the additional information. As the cost cap has returned a REPLACE decision, replacement of the long block assembly (6006) is approved. Please note, however, that a separate prior approval request will need to be submitted for the catalytic converter
