CQIS DETAIL REPORT

VEHICLE: 2015 FOCUS,SE,4 DOOR ,SEDAN VIN: [REDACTED]  
 Engine : 1.0L 12V DI TC I3 GS 120PS FOX Odometer: 40,679 MILES  
 Operating Environ: WCC :  
 Vehicle Use : Rsp. Act:

SYMPTOM: 5 52 2 02 DRIVING PERFORMANCE STALLS/QUITS  
 ACCELERATION ALWAYS  
 Additional Symptom: Stalls on acceleration  
 Other Veh. With Concern: Severity Rating - Customer: Engineering:

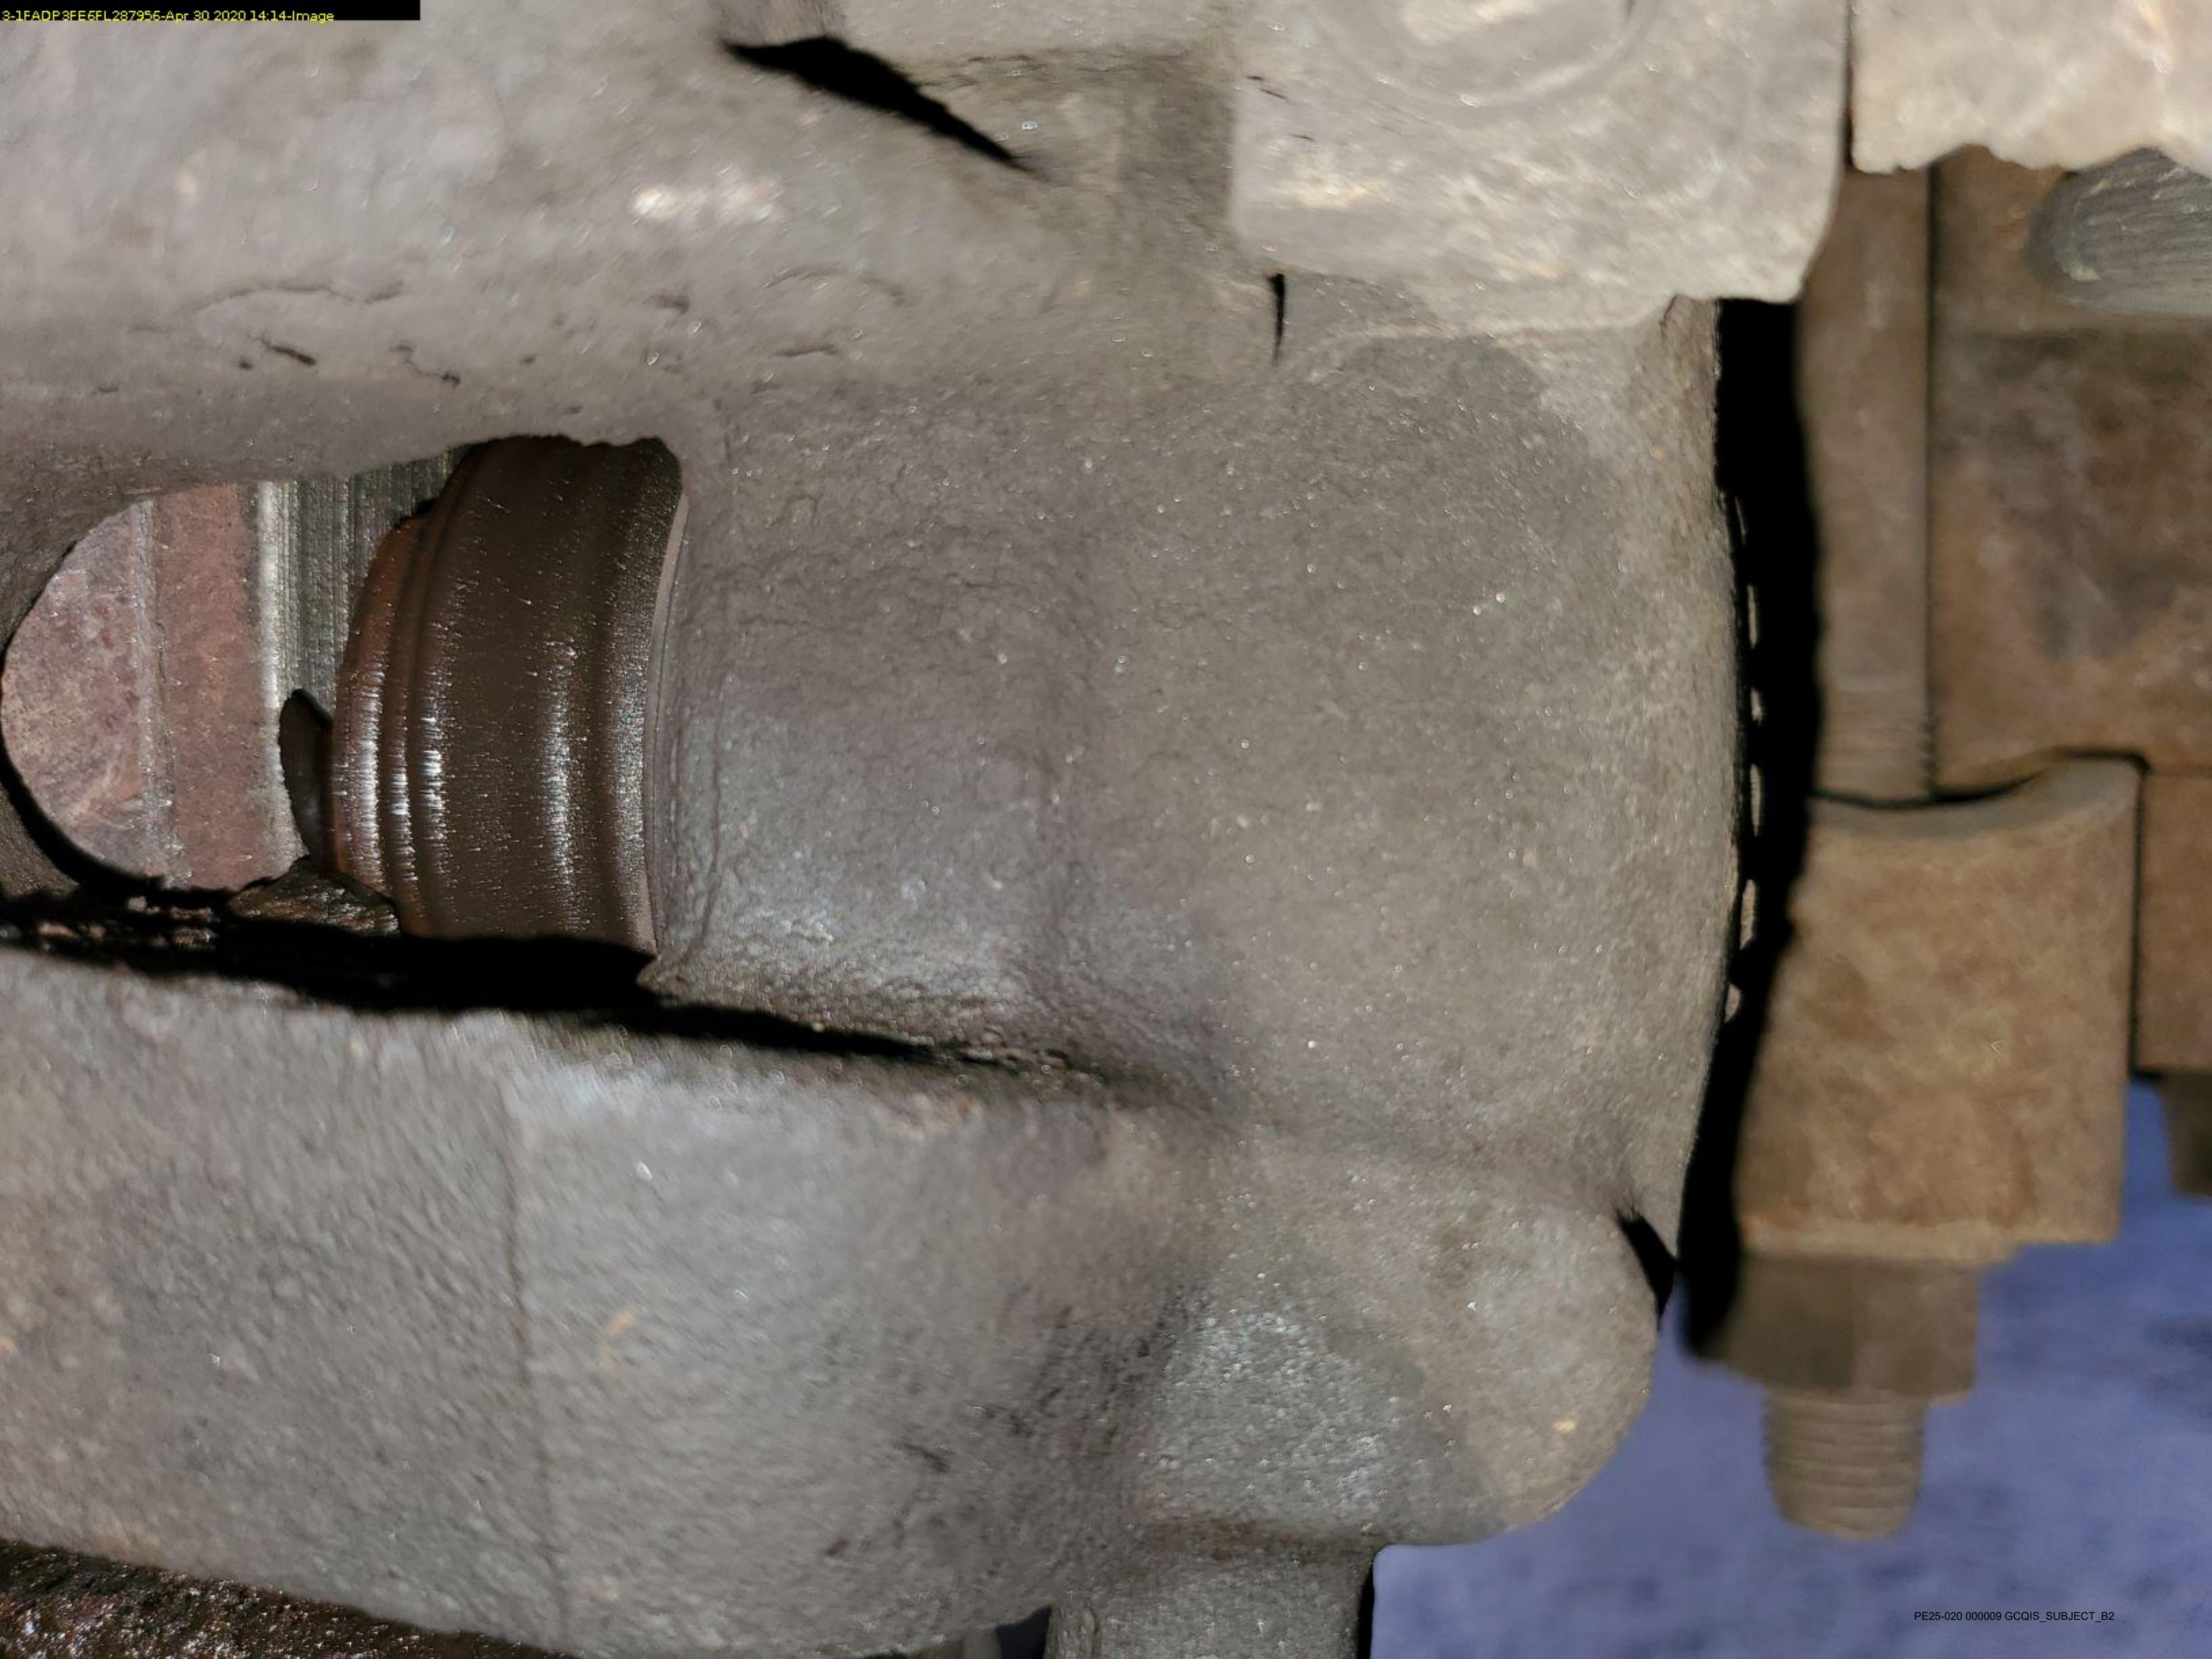
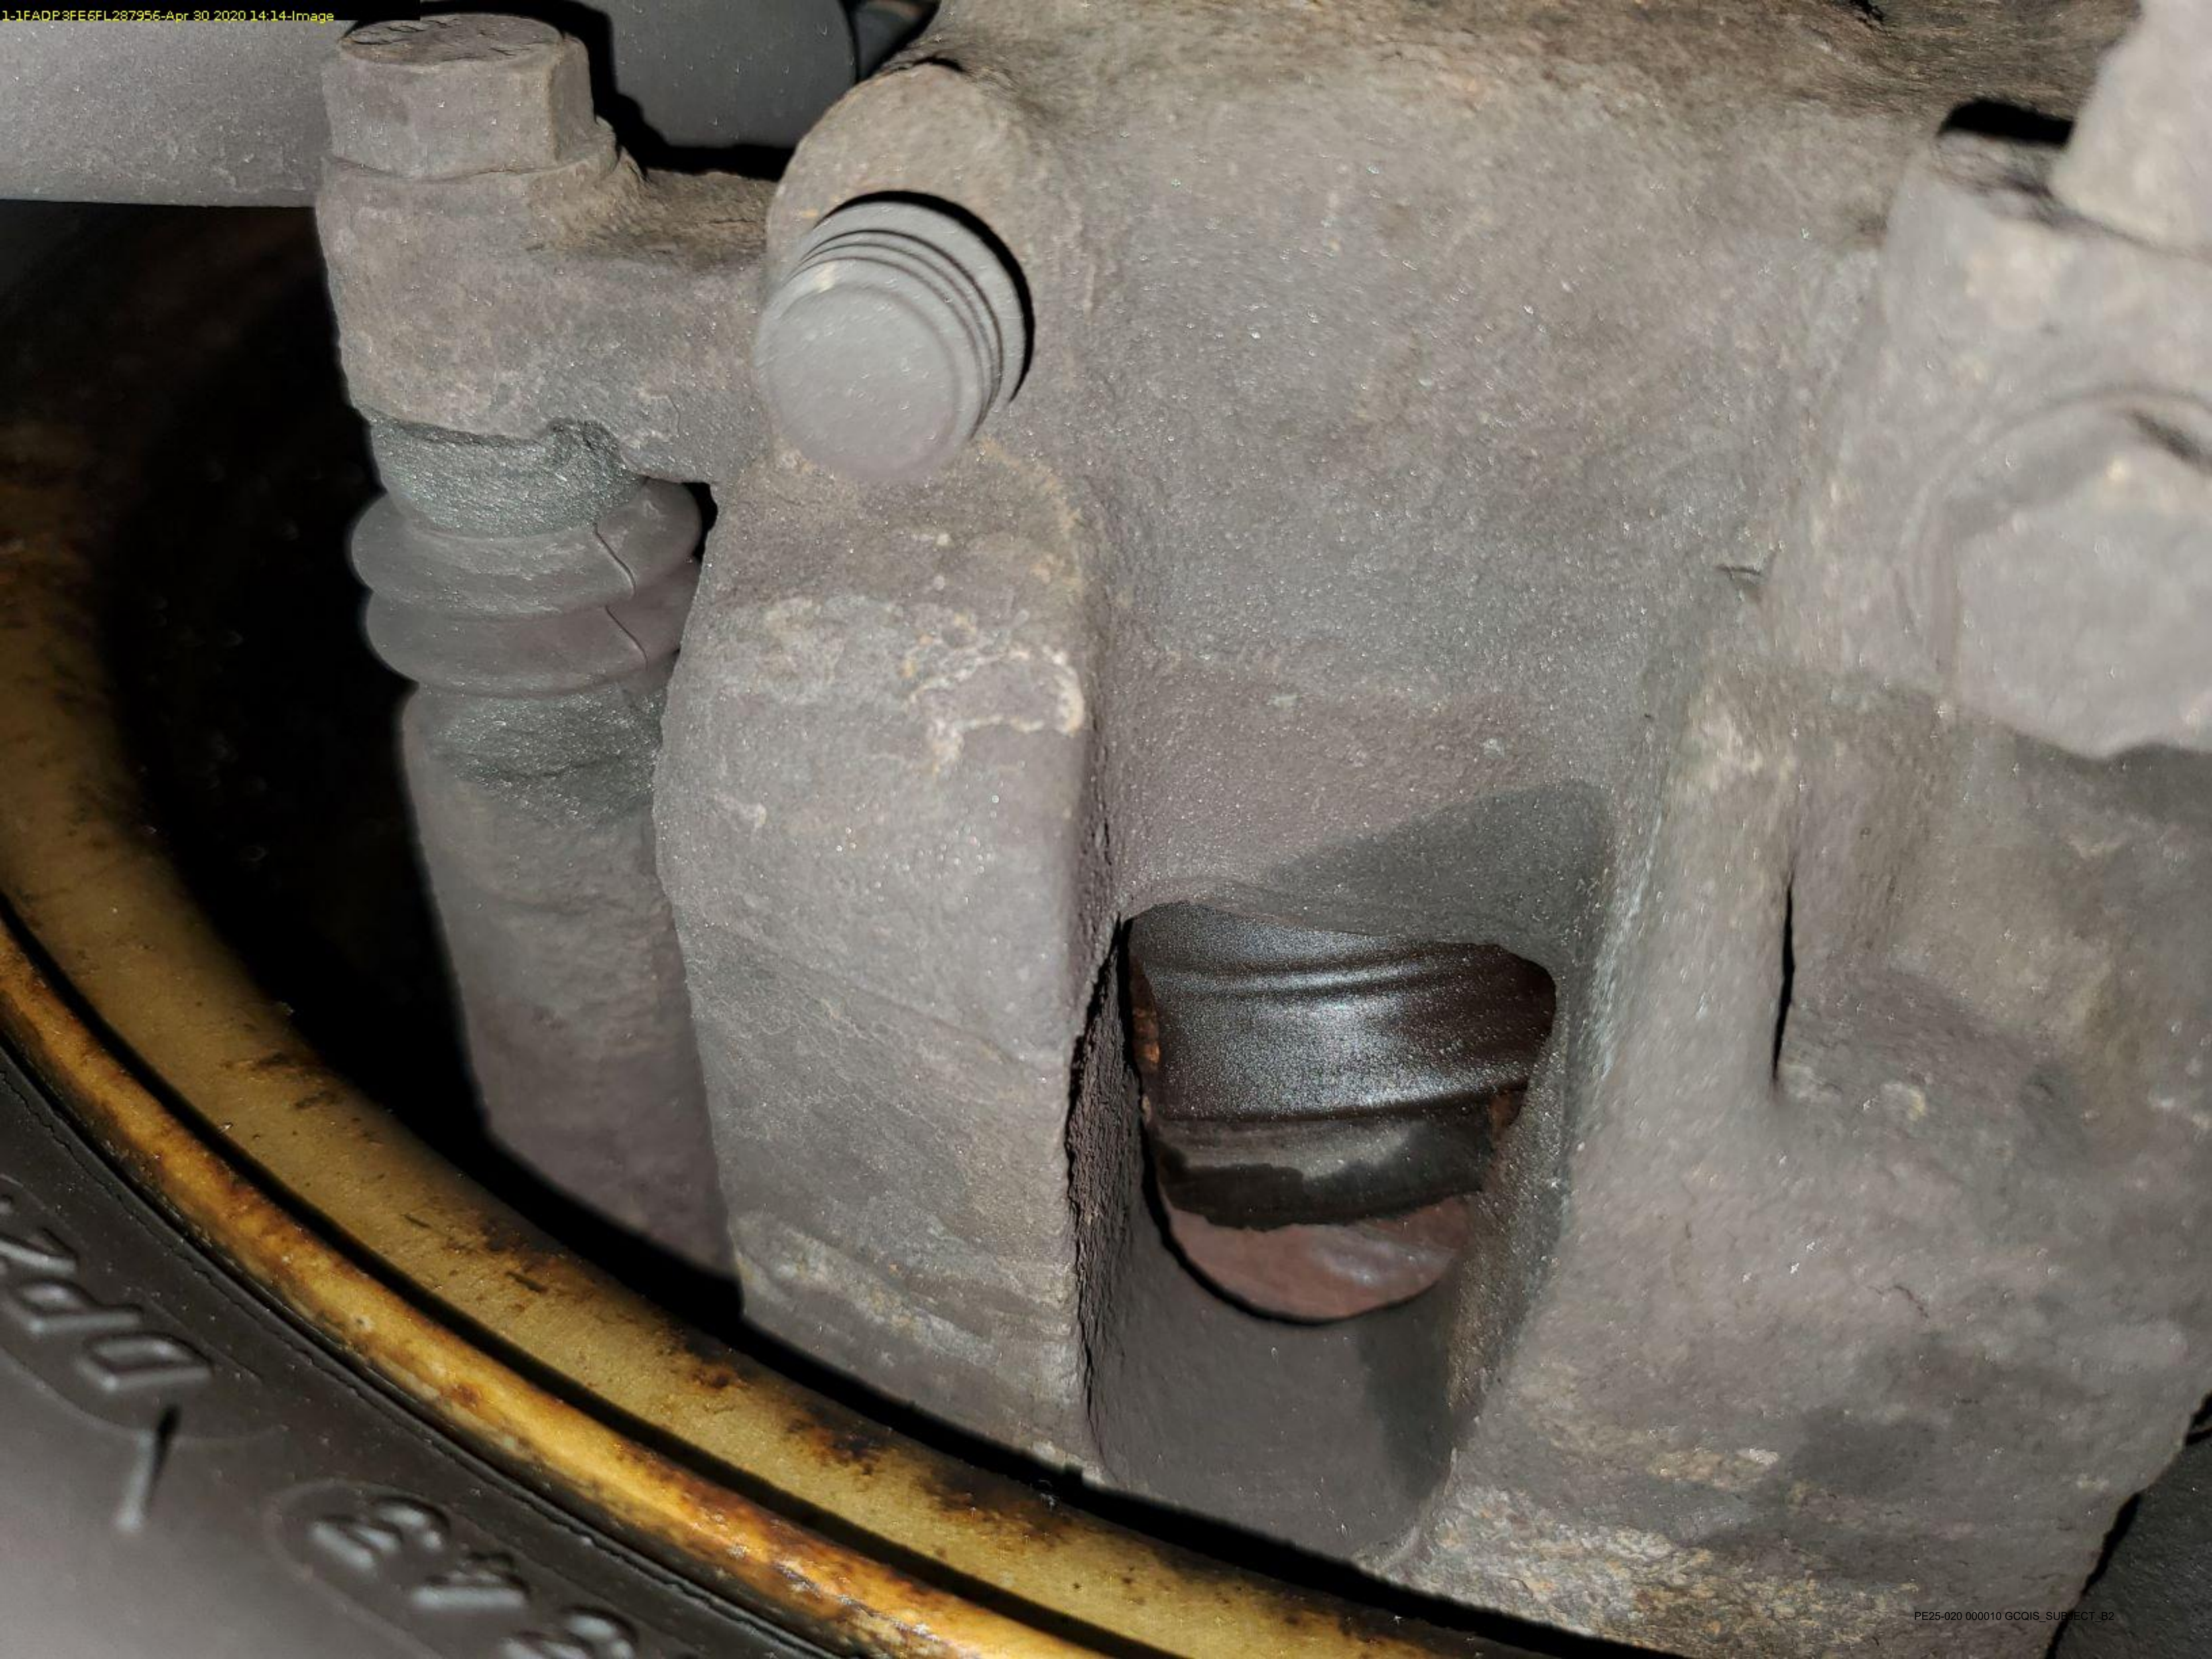
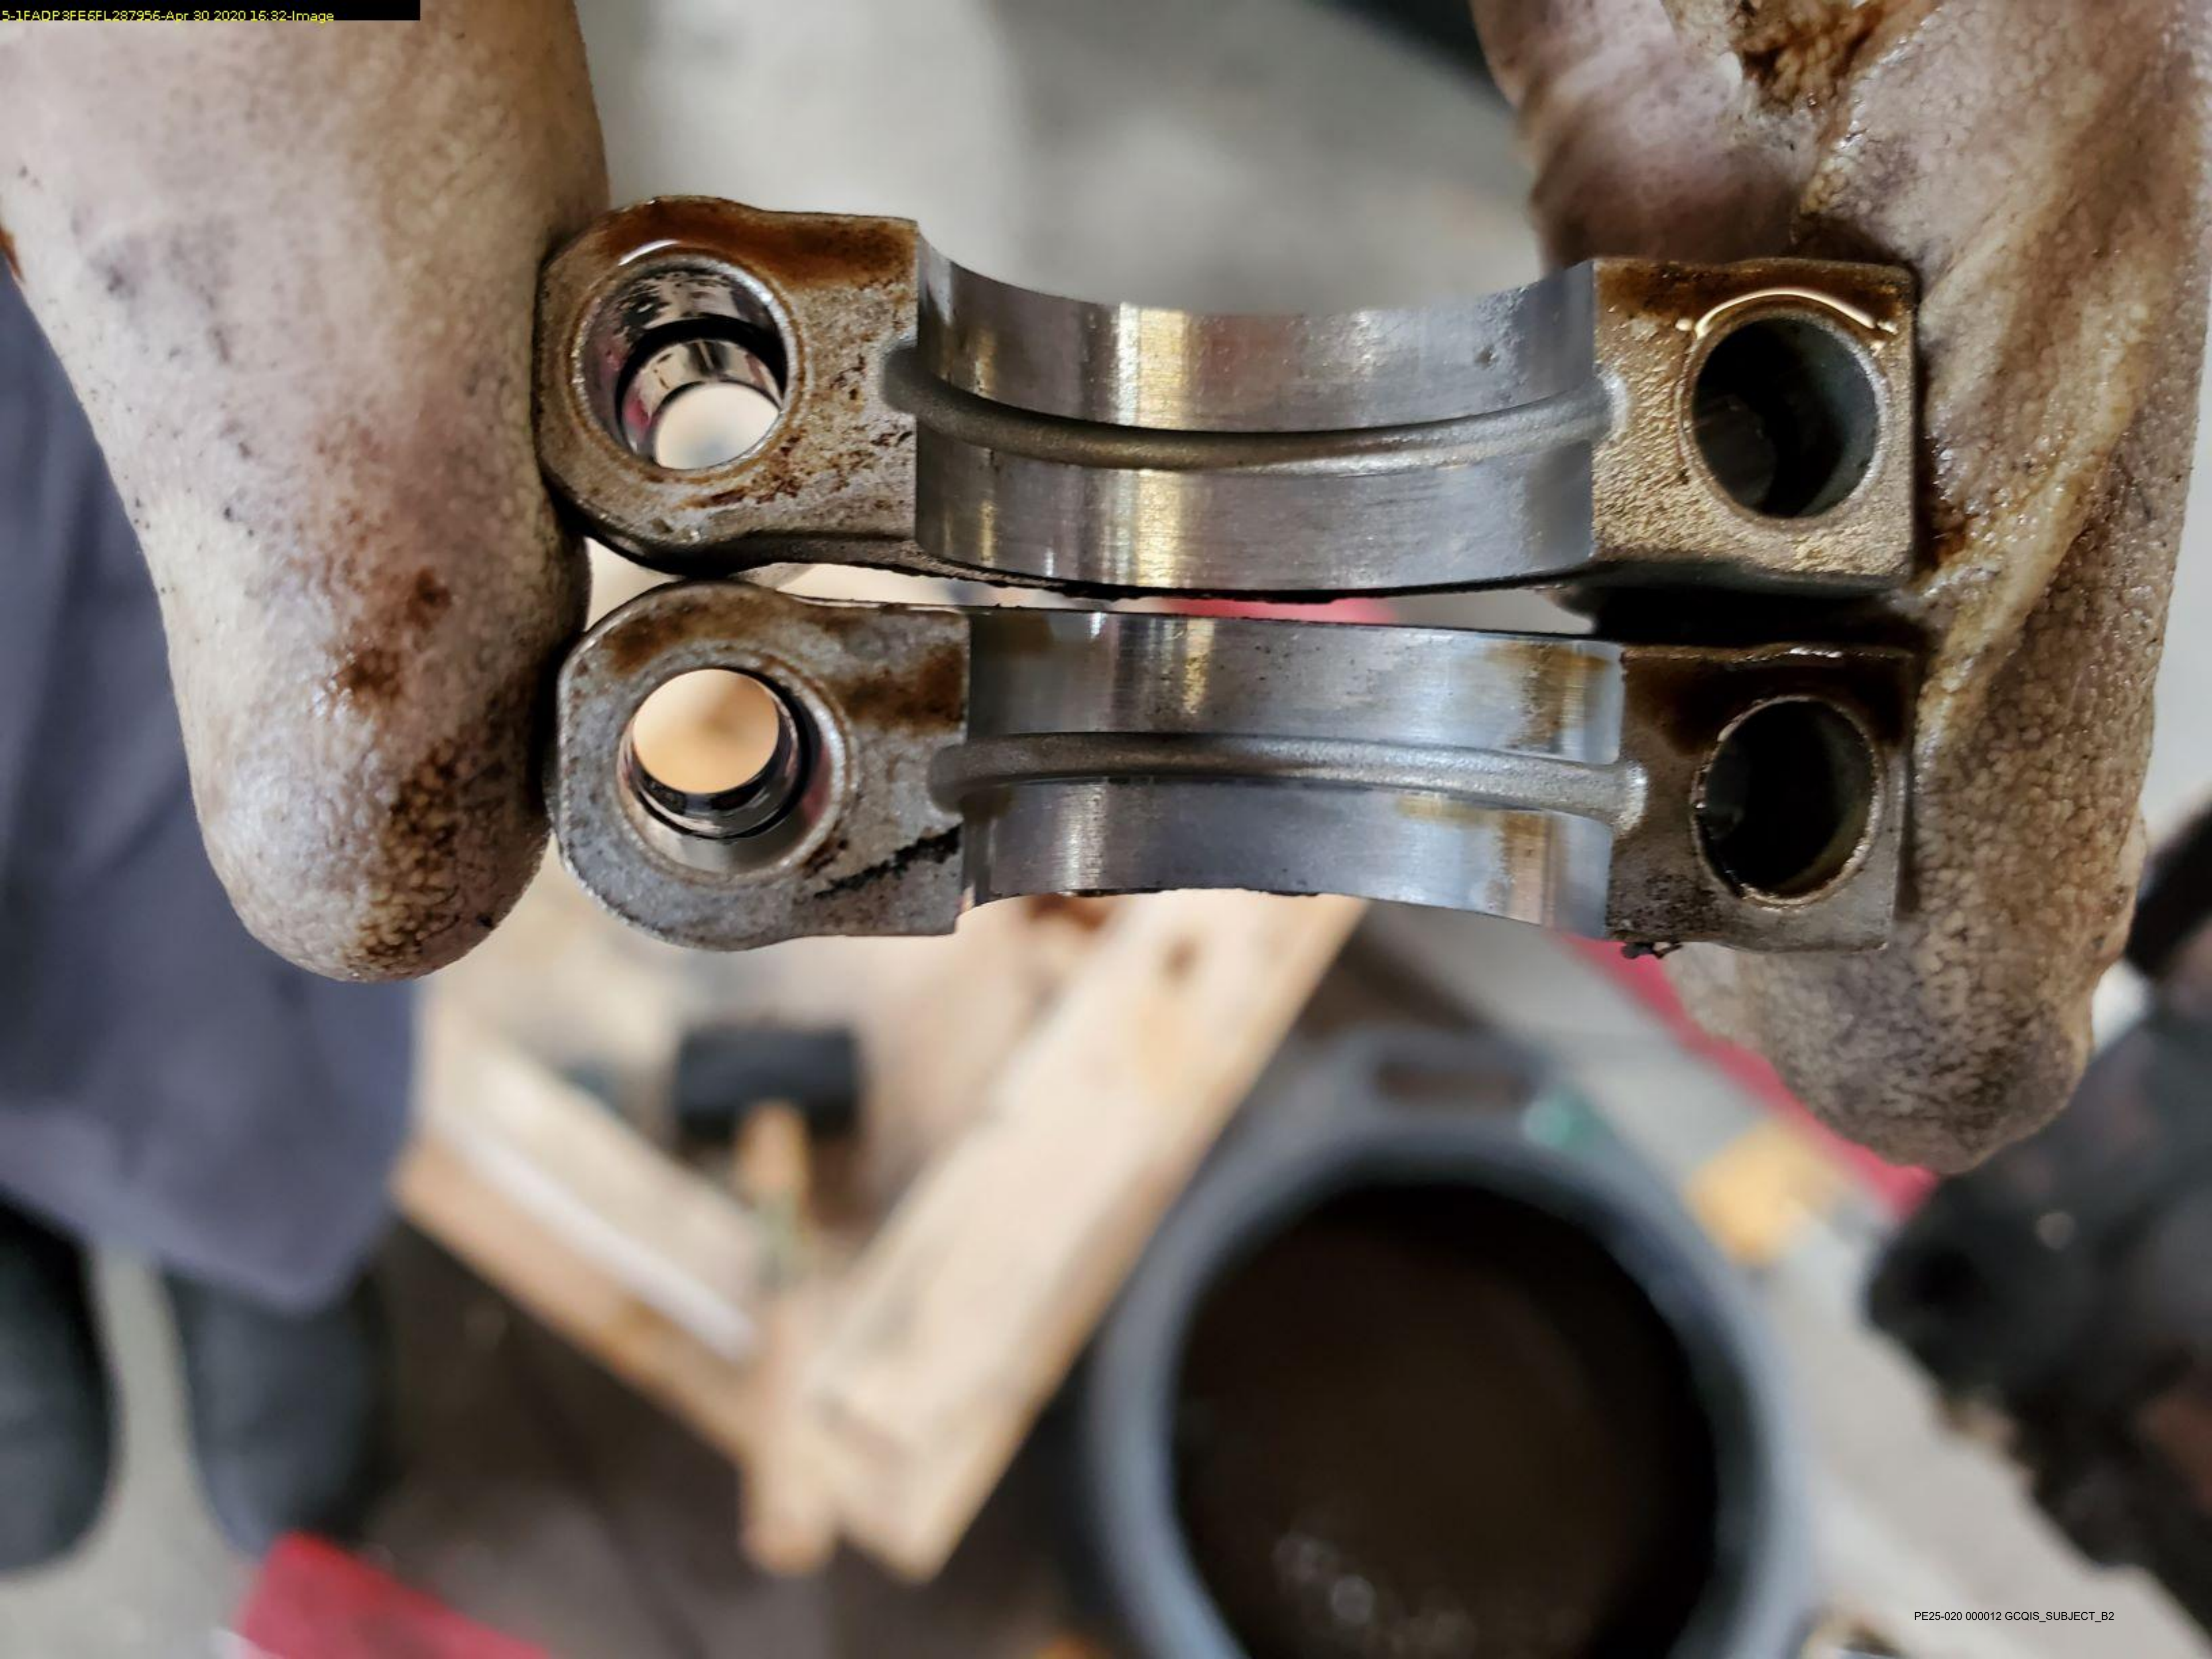
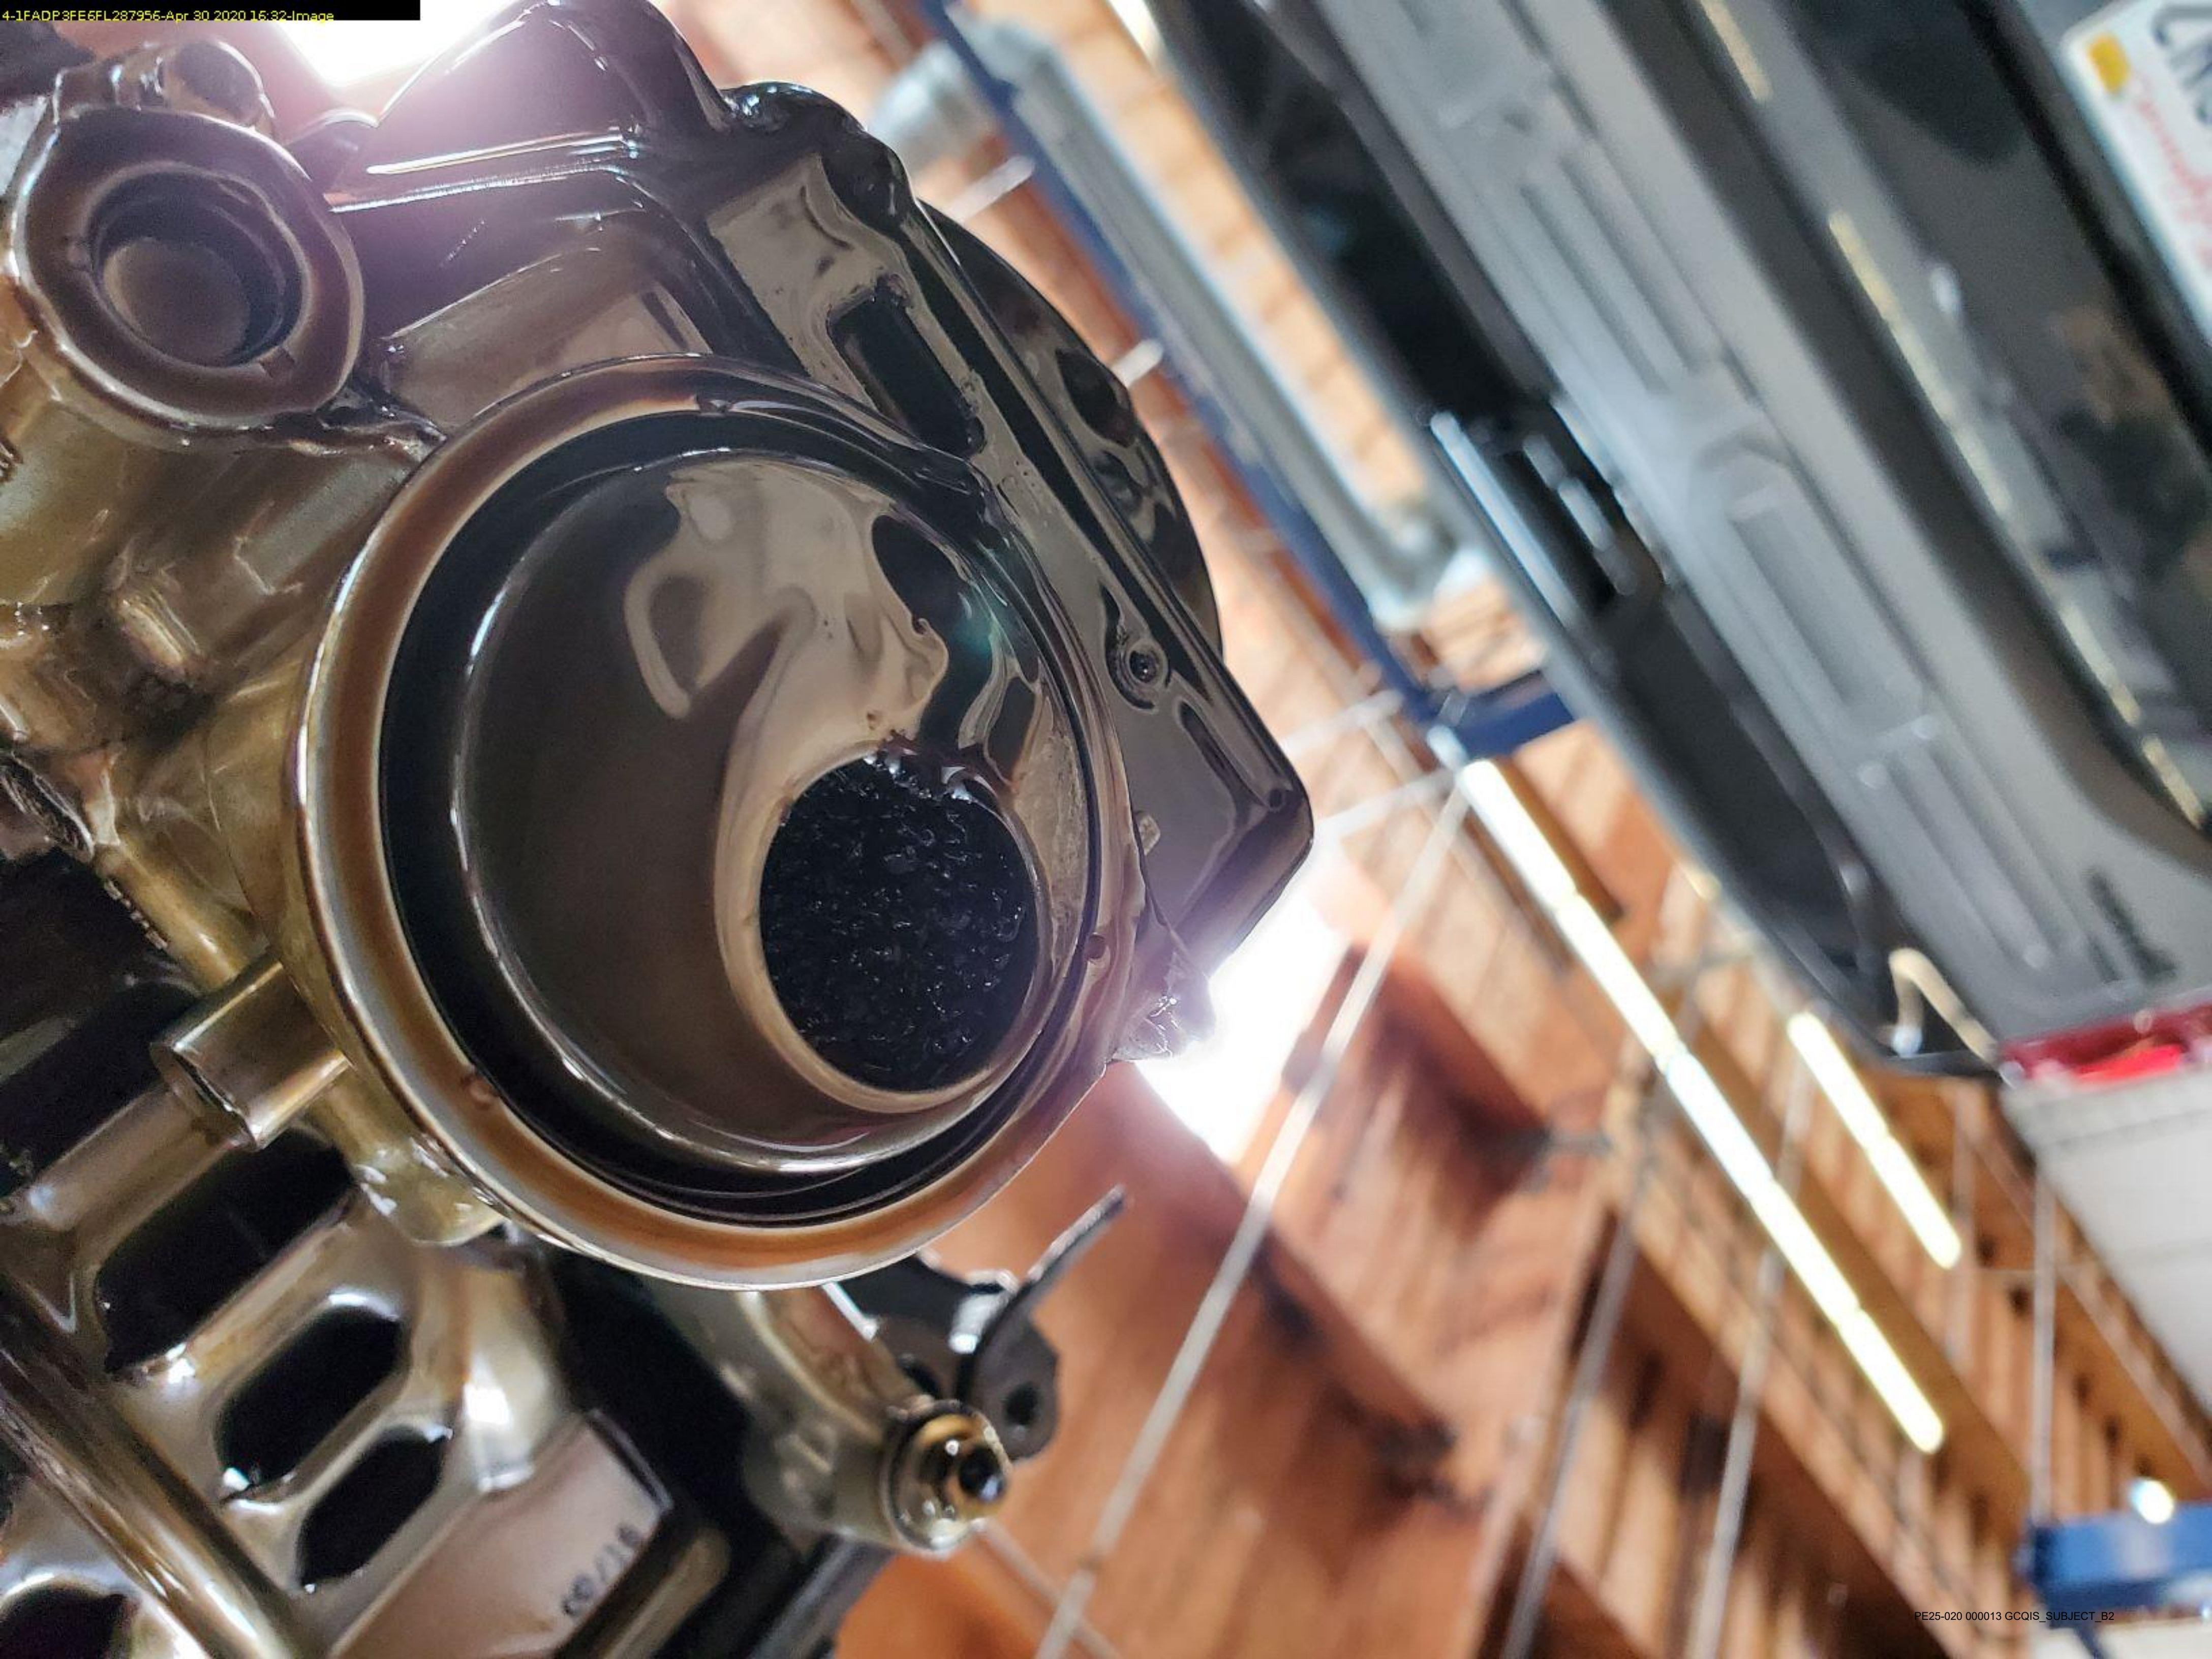
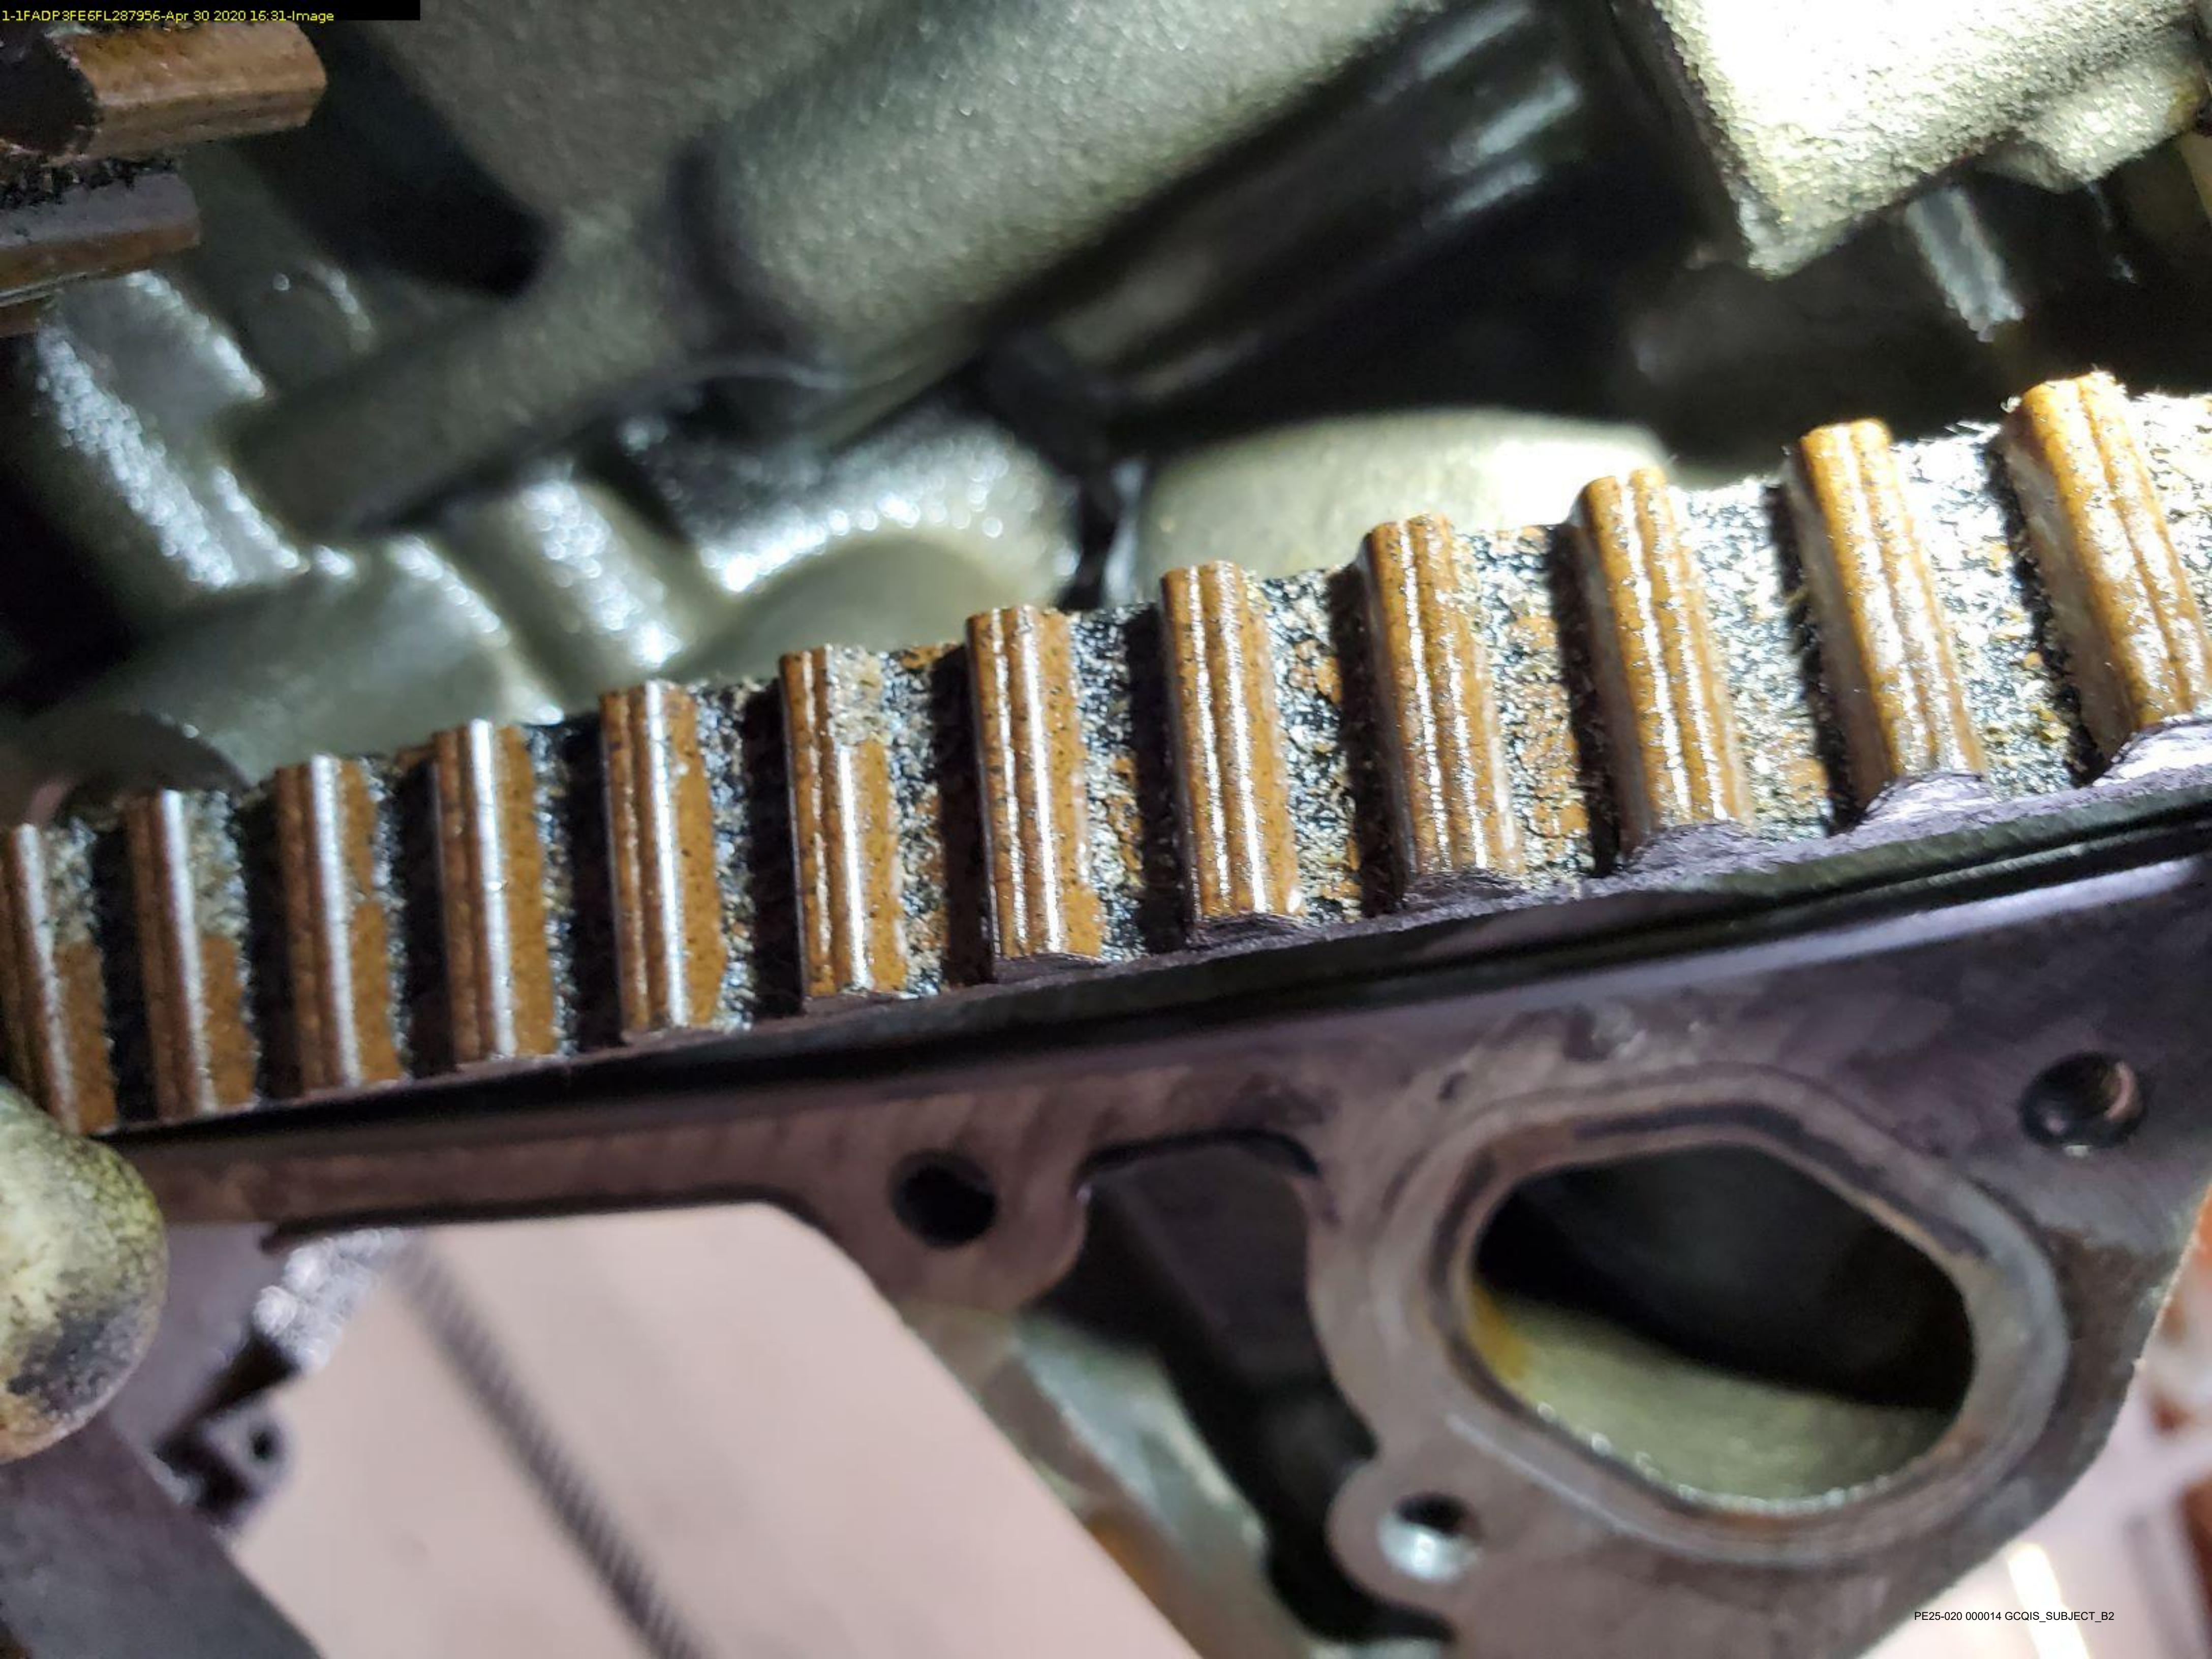
You know i am pretty sure we do not need prior approval. The warranty
administrator said we do as of february. the cost cap was done in
april. I was just looking for an approval code.
RECOMM 04/30/2020 03:27PM DPETE202
Hello [REDACTED] If prior approval is required for this engine, then the
description of the damages and the images that are requested for this
concern will be needed on this form to continue with the Prior
Approval process. Else if your warranty administrator had determined
that prior approval is not needed for this RO and your dealership,
then proceed with the necessary repairs as directed by the cost cap.
This form will remain as status Additional Information Required in
case that prior approval is required for this request. If so, then
please update with the required information. GASPA Additional
Information Required
CONCER 04/30/2020 04:34PM [REDACTED]
from the pictures you can see metal in the pan. the journals are

scored because they are oil starved. material from the belt got sucked
up into the pick up tube, staving the engine and turbo for oil.
RECOMM 04/30/2020 04:55PM [REDACTED] MSS - FCSD - TECH ASSIT CENTER
[REDACTED] The scoring damage can be seen on the camshaft caps. There
does not appear to be any damage to the short block components at this
point (ie. connecting rod or main bearings, cylinder walls). If you
suspect damage to these lower end components, they should be
inspected. If damage is present, upload photos to the form for further
review. Note: Metal debris in the oil pan and filter does not
automatically condemn the short block components without inspection
results supporting physical damage. Upon further review, it appears
the engine has already been replaced. The claim has already been
submitted in OWS for payment. Since the repair has been completed,
this would be considered a post approval request. To obtain an

CONCER 04/30/2020 06:32PM [REDACTED]  
 PRIMARILY THE DAMAGE TO THIS TURBO CHARGER WAS DONE BY THE OIL  
 STARVATION FROM THE BELT MATERIAL IN THE OIL PICK UP SCREEN. PICTURES  
 WHERE PROVIDED TO SHOW THE CAM JOURNALS AND CAM SHAFT HAVE SCORING ON  
 THEM

CONCER 04/30/2020 06:55PM [REDACTED]  
 A PRIOR APPROVAL WAS PERFORMED FOR THE TURBO CHARGER. THE ROOT CAUSE  
 OF THIS FAILURE IS THE BELT. IT IS BELIEVED THE TENSIONER CAUSED THAT  
 DAMAGE TO THE BELT. THE TENSIONER IS INTACT AND A PICTURE OF IT WOULD  
 NOT INDICATE ANY FAILURE WITH IT. THE DEBRI FROM THE BELT GOT SUCKED  
 UP INTO THE OIL PICK UP AND OIL STARVED THE MOTOR. THE MOTOR HAD  
 SIGNIFICANT DAMAGE AND PUT METAL SHAVINGS IN THE OIL PAN. THE CAM  
 JOURNALS AND CAM SHAFT SHOW SCORING.

CONCER 04/30/2020 07:01PM [REDACTED]  
 METAL DEBRIS WHERE FOUND IN THE OIL SUPPLY LINES. TECHNICIAN SAID THE  
 TURBINE HAS SOME PLAY AND SIGNS OF THE TURBINES RUBBING THE HOUSING.  
 THE TURBINES DO SPIN BUT IT IS NOT FREE. WE BELIEVE THAT SOME OF THE  
 METAL SHAVINGS IN THE PAN MADE IT TO THE TURBO.

CONCER 04/30/2020 07:42PM [REDACTED]  
OBC to [REDACTED] to discuss the turbocharger approval, and offered to help get this one finished up. He spoke with technician Nicholas. He stated engine had rod bearing damage from lack of lubrication. Rod knock and excessive metal debris.

RECOMM 04/30/2020 07:42PM [REDACTED]  
[REDACTED] Thank you for taking the time to describe the damage found with the short block assembly. Since the oil pump belt failed causing loss of oil pressure and damage to the short block and cylinder head, proceed with long block replacement per the Cost Cap. Order a Remanufactured Long Block (base part 6006) through your parts department. If a remanufactured assembly is not available, order a new assembly. <P>Before installation, please review the service manual and literature provided with the replacement engine regarding intake manifold cleaning/replacement, priming the oil system, filling the cooling system, etc. <B>Note:</B> If the intake manifold is not attached/supplied with the assembly, it must be thoroughly inspected to ensure that it is free of any and all metal debris. If
