This bulletin supersedes G0 [REDACTED] 4. Reason for update: Update the vehicle model years [REDACTED]

This article supersedes GSB G0000184 to update the vehicle model years affected.

This bulletin is a guide to engine failure analysis and preventing repeat engine failure.

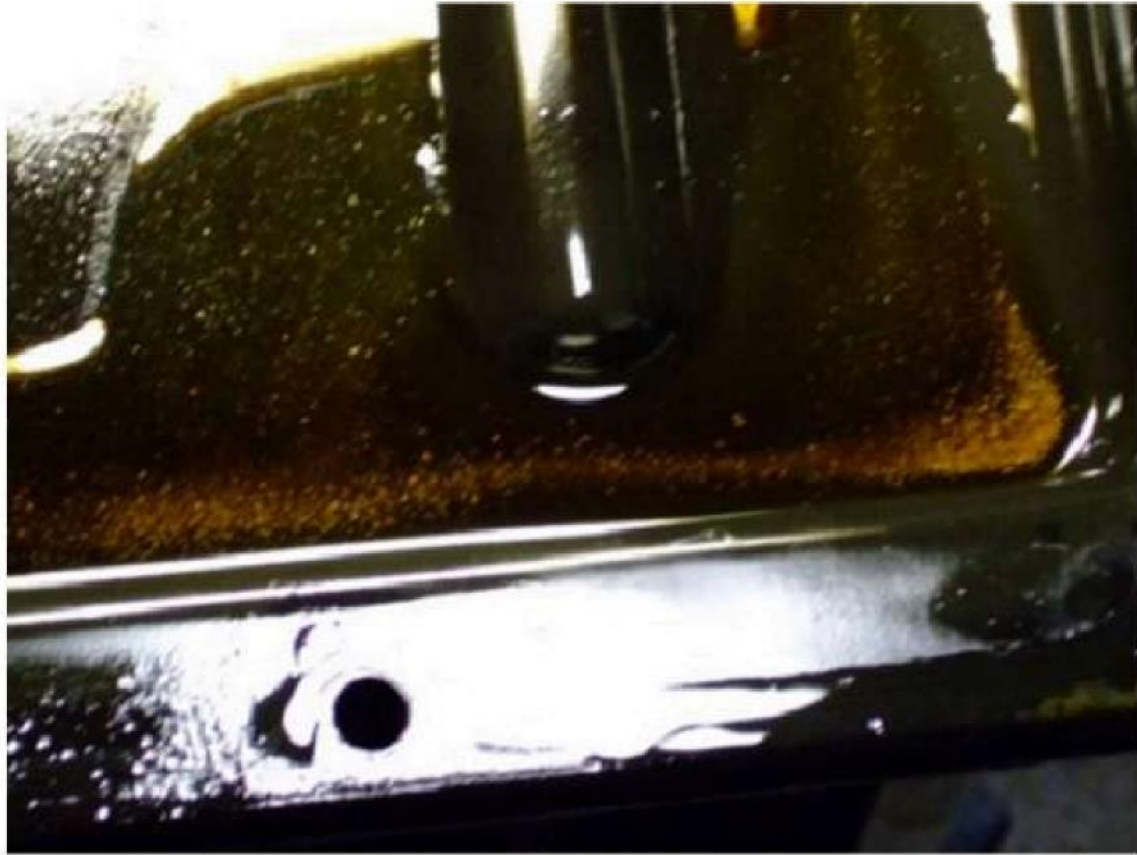
Figure 1

Some metal in the oil pan and filter is expected and considered normal (Figures 1-2).

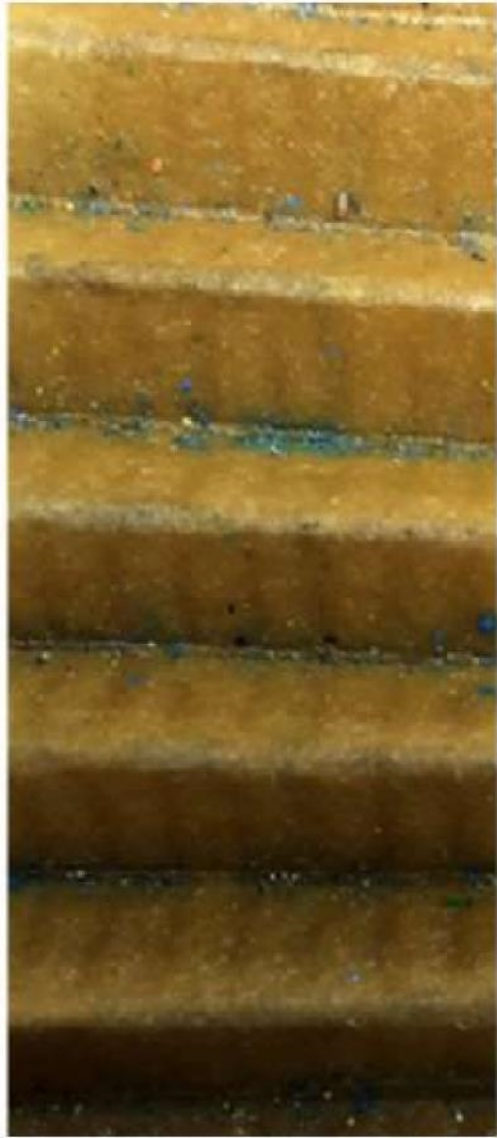
[REDACTED]
[REDACTED] Small specs of metal in the filter media is normal (Figure 4).
[REDACTED]

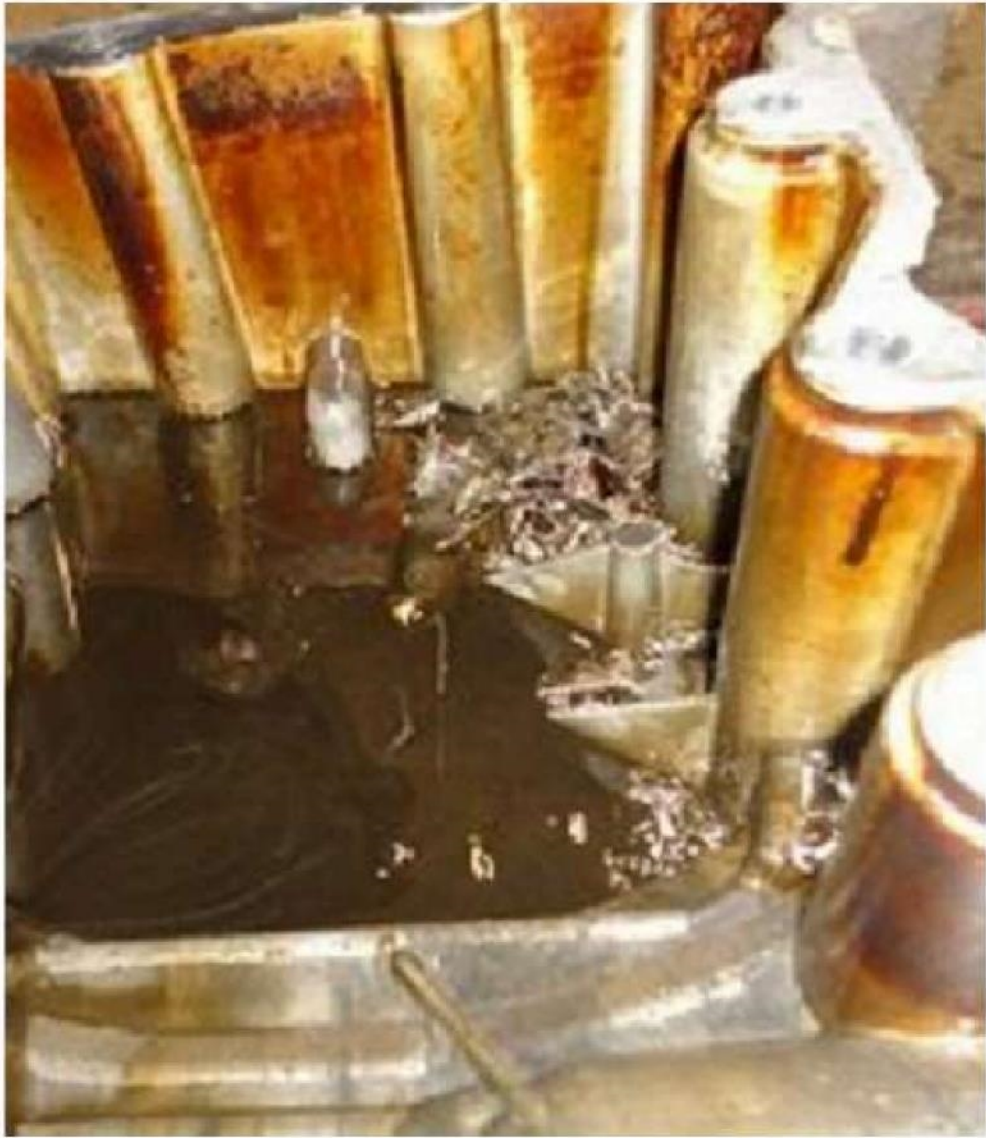
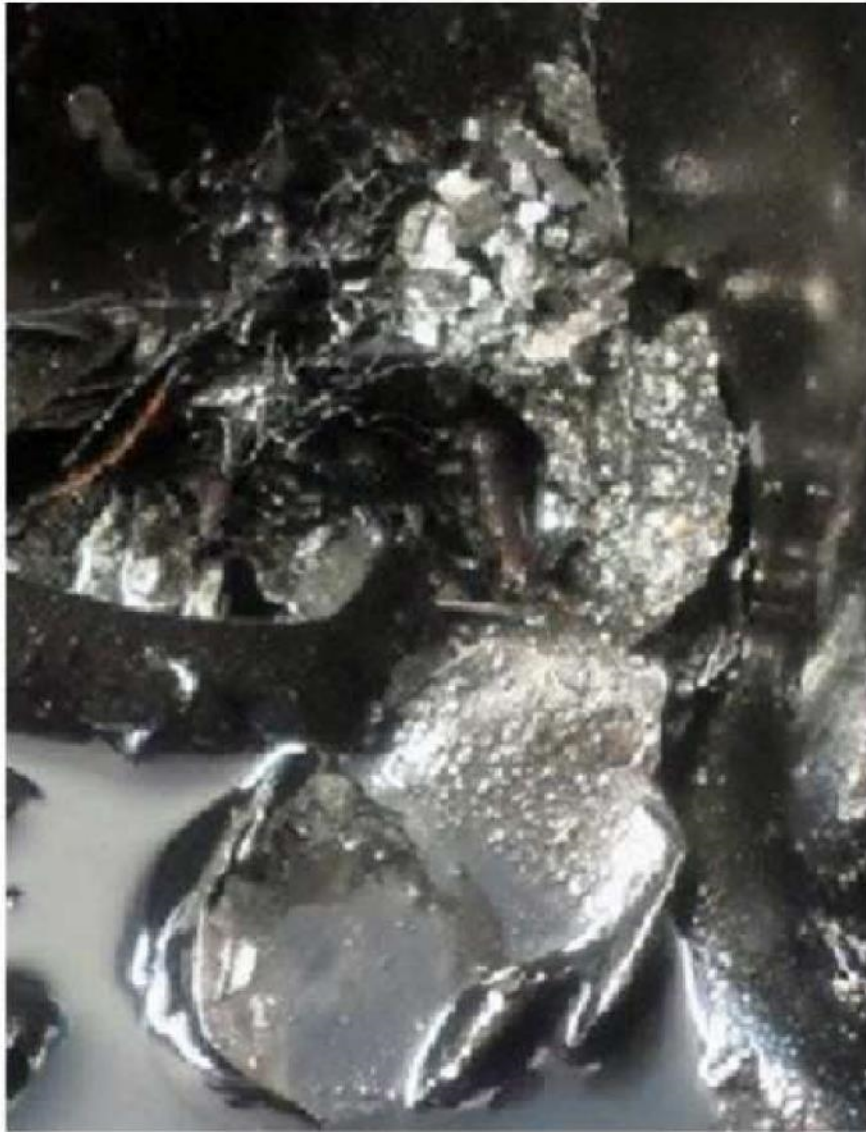
[REDACTED] chunks of metal in the pan and/or filter merit further root cause investigation (Figures 5-6).

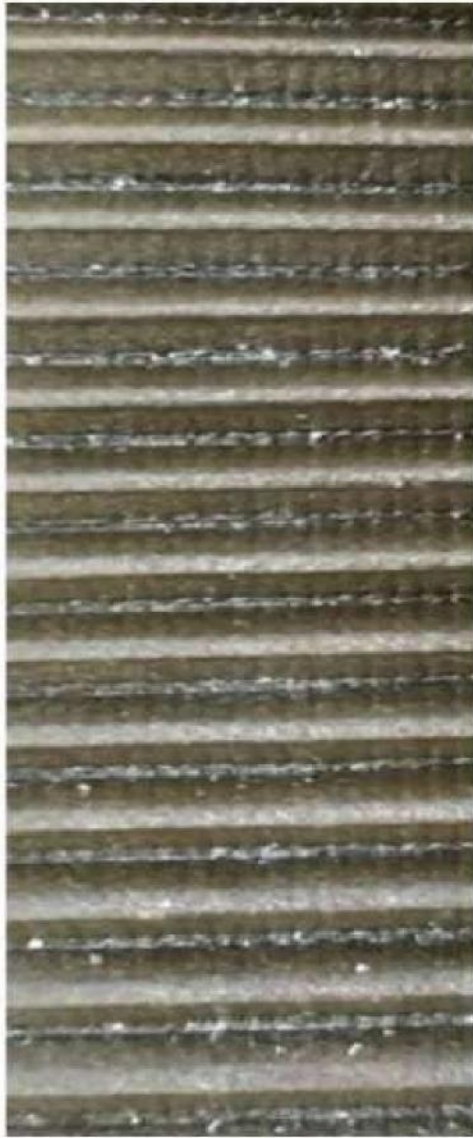
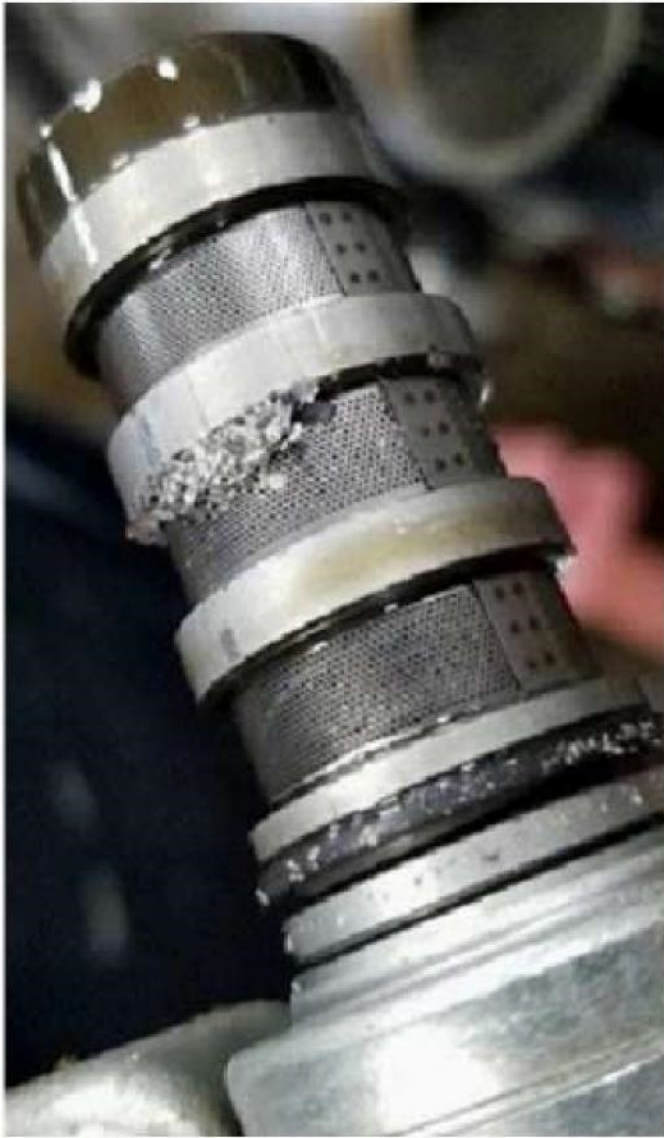
Excessive amounts of metal in the oil filter and/or screens require further root cause investigation (Figures 7-8).

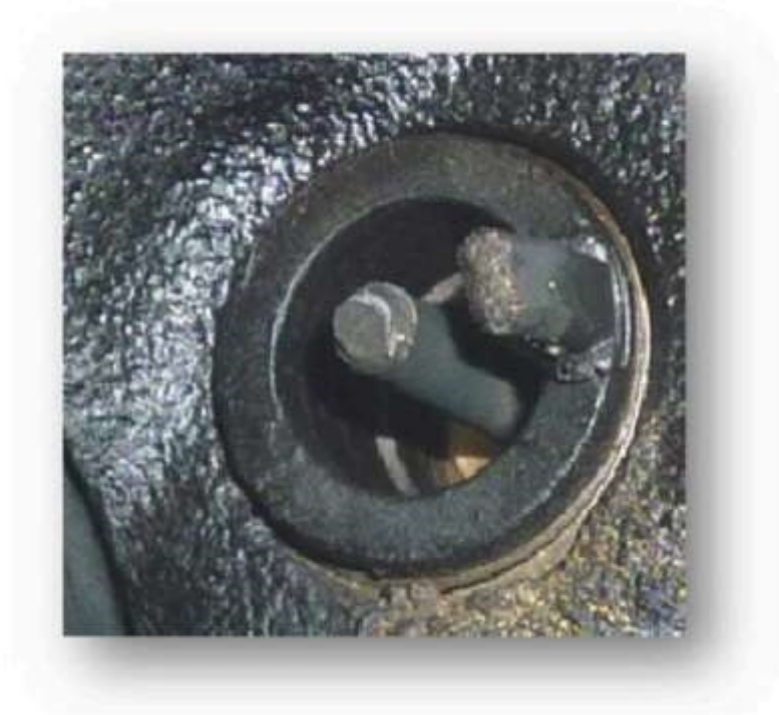
Figure 50

Spark plug damage (porcelain fracture or melted electrode) is an indication of excess detonation (Figure 50)

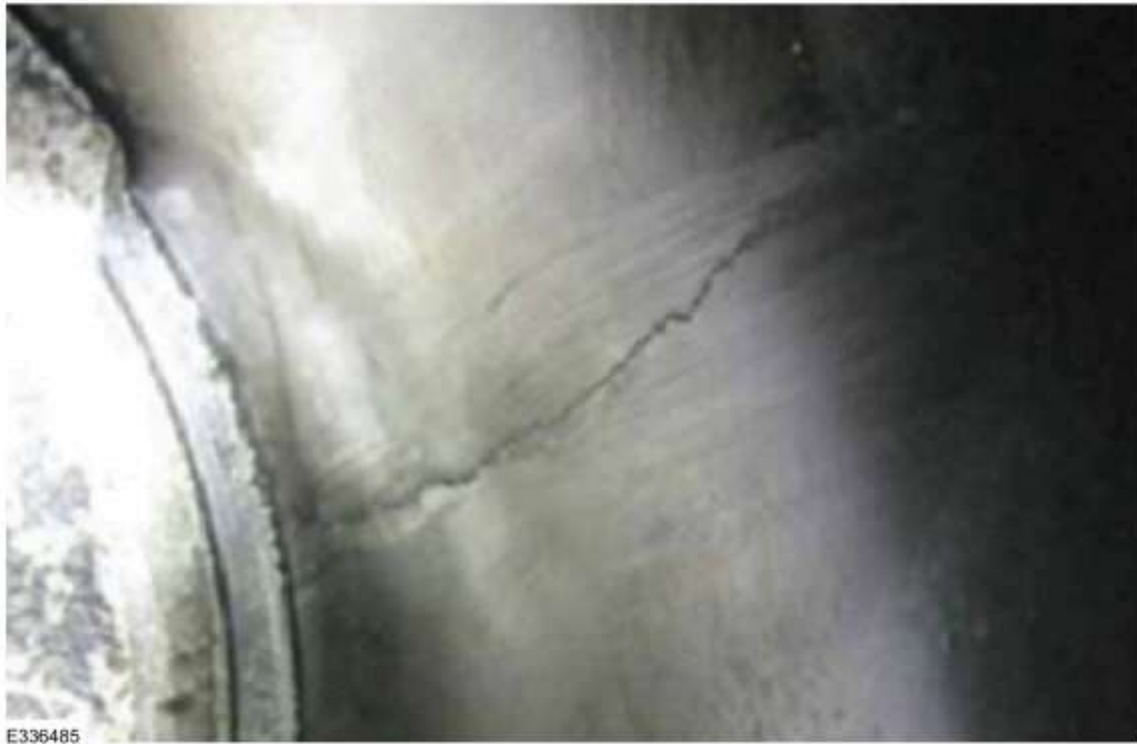
Figure 51

Heat generated from friction can cause cylinder walls to crack. (upper ring land damage) (Figure 51)

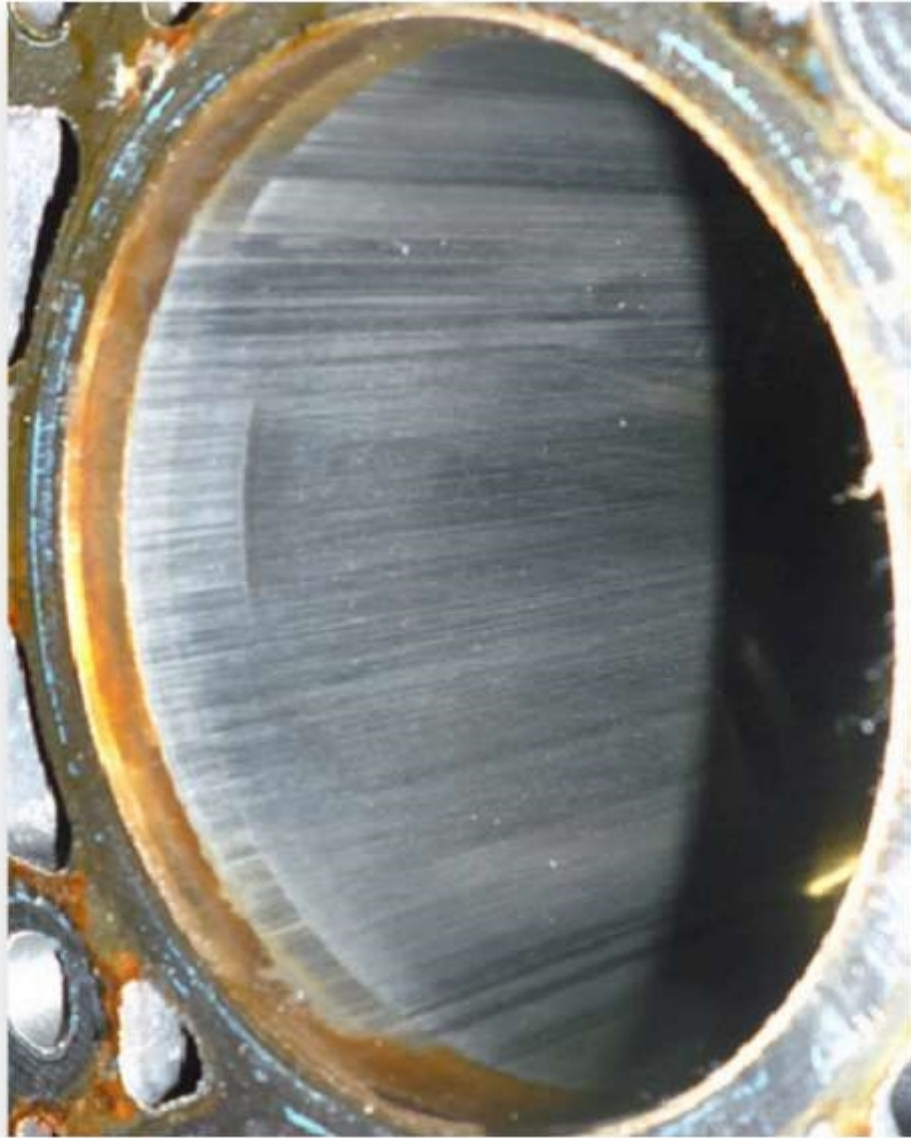
Figure 53

Cylinder Wall Damage (Figure 53)

Root Cause: Fuel/air mixture concerns

- Excess oil consumption
- Lean/rich conditions
- Cylinder misfire

Effect: Catalyst damage

- Catalyst material begins to deteriorate (turns to dust/sand)

- Catalyst material is pulled into the engine

Damage: Cylinder wall

- Cross hatch is polished away
- Vertical scoring
- Bearing damage may be present if catalyst material made it to the engine oil.

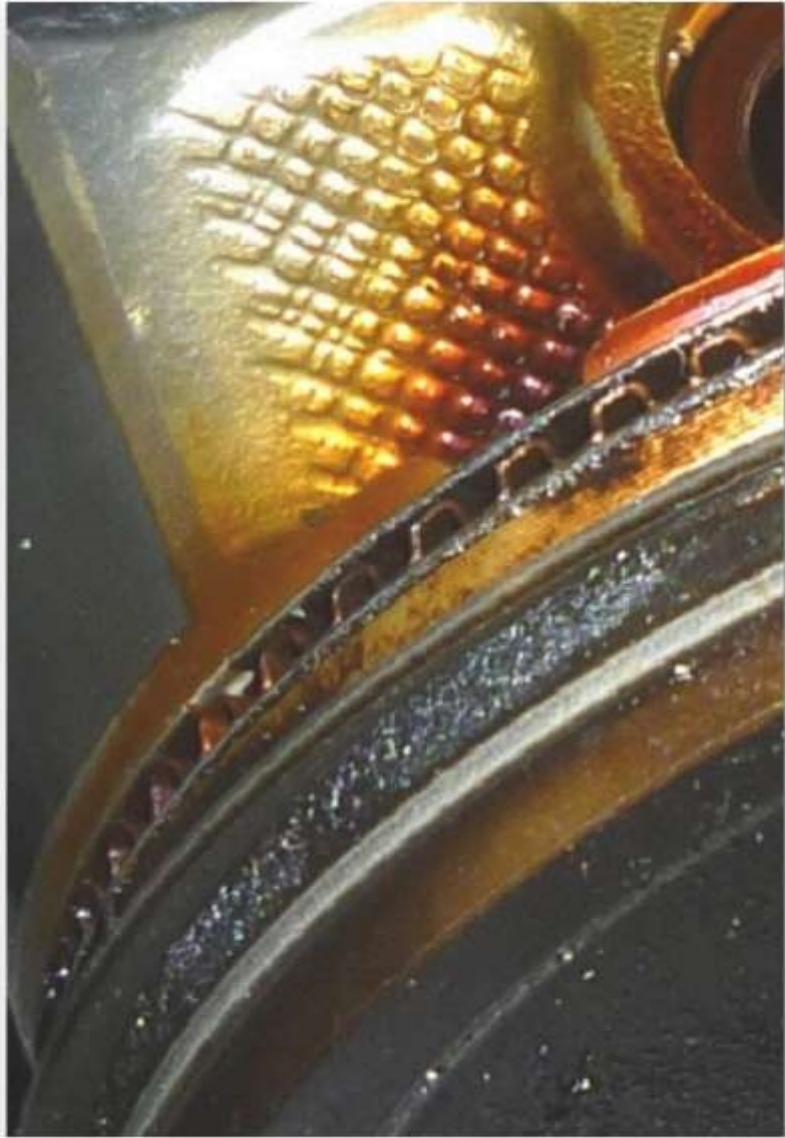
Figure 55

Catalyst material can collect on the sides of the piston damaging cylinder wall surfaces (Figure 55)

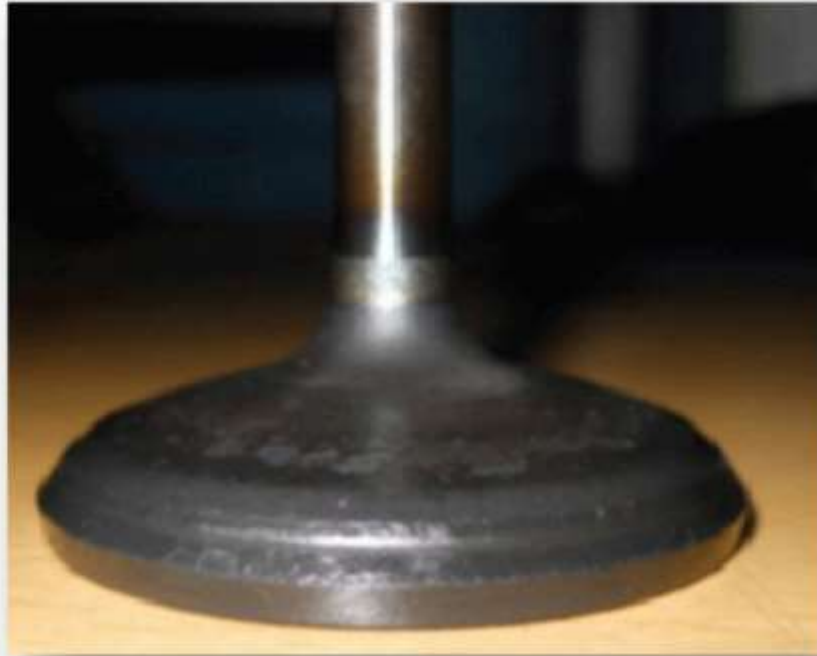
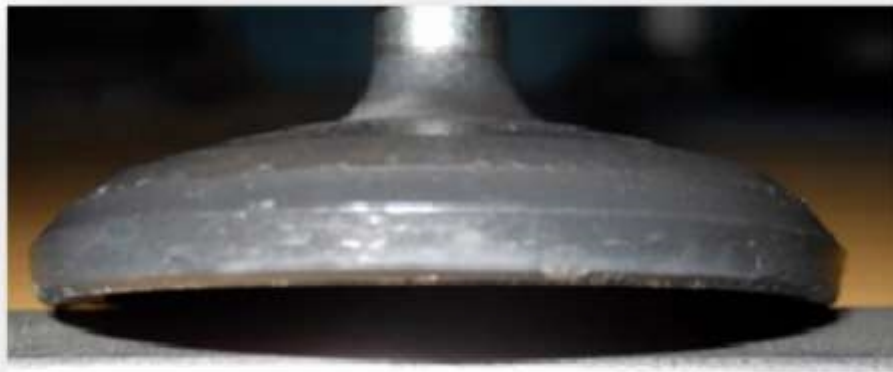
Valve Damage (Figures 56-57)

Root Cause: Lean condition

- Modification or damage to the air induction system

- MAF sensor damage/failure
- Lack of fuel to the cylinder

Effect: Excessive combustion chamber temperatures

- Misfire, lacks power
- Catalyst damage
- Running lean = hot cylinder

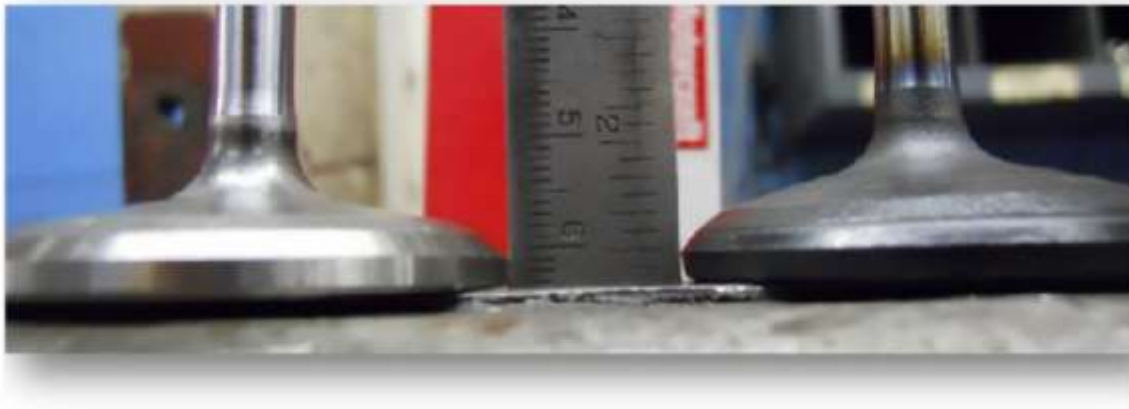
Figure 58

Damage: Valve and valve seat

- Valve tuliping
- Valve seat recession

Excessive lean conditions can cause valves to overheat and soften. Over time, the valve can stretch and deform against the seat causing the valve to “tulip” creating leakage and a misfire. Comparing total valve height of the suspect valve to a known good valve can help identify issues. A height difference in the suspect valve is an indication of valve tuliping. Valve tuliping is the effect, not the root cause of the concern.

If cylinder leakage is present past the valves:

- Check for valves held open by other valvetrain components
- Check for the valve stem sticking in the guide
- Inspect for debris between the valve and seat that could hold the valve open

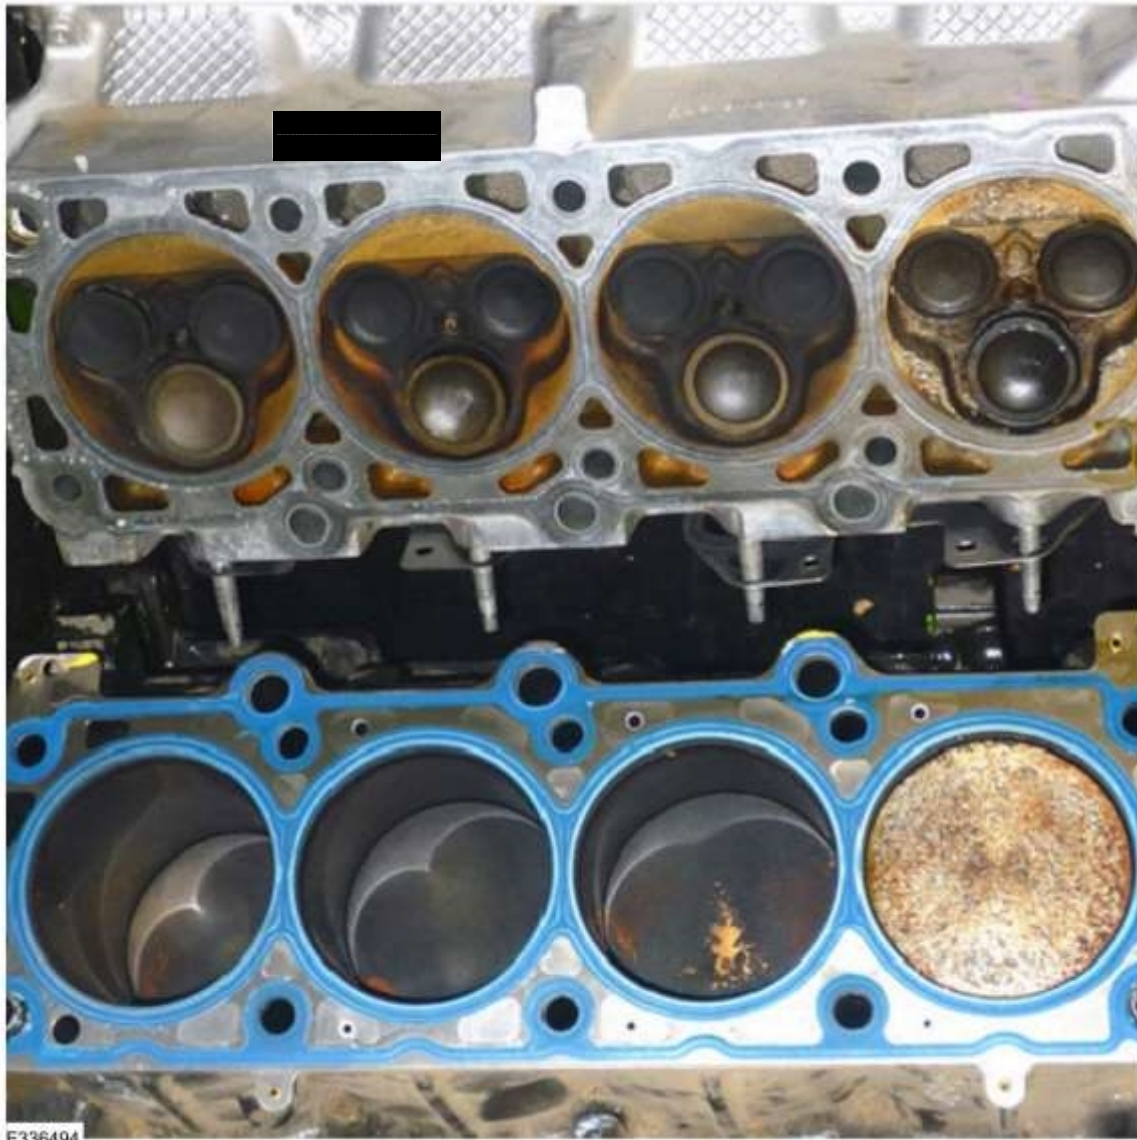
Figure 60

- Foreign object debris can cause metal transfer from the piston to the cylinder head
- This metal debris can also make it to the intake manifold
- The intake manifold must be replaced in these instances to prevent repeat damage

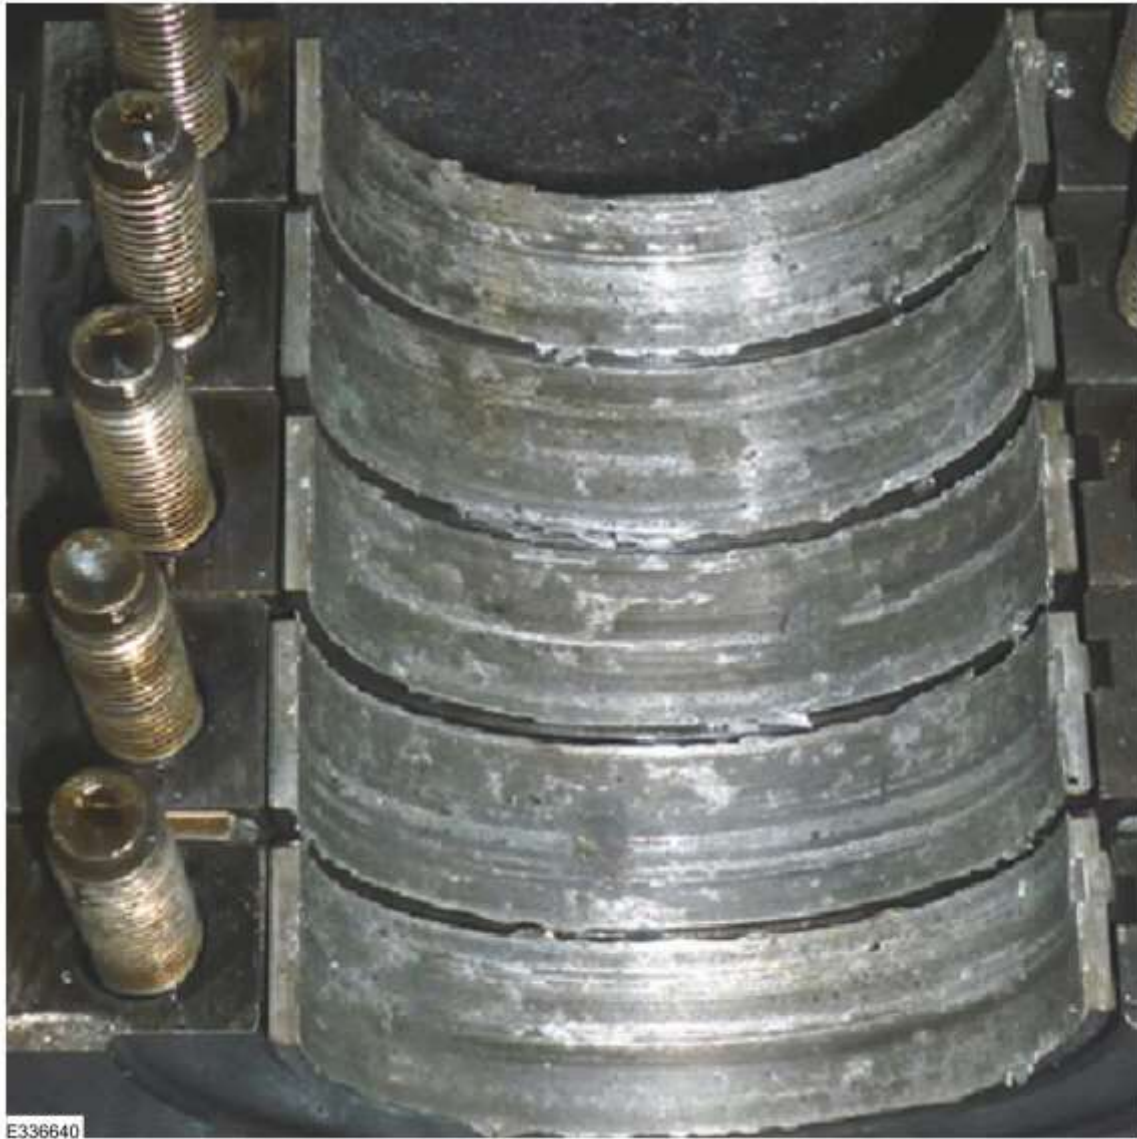
Figure 61

Bearing Damage (Figure 61)

Root Cause: PCV system concerns

- PCV system damaged
- Open breather tube in place of PCV valve
- Lack of oil maintenance

Effect: Oil consumption

- Oil is pulled through the engine and burned off

Damage: Bearing damage

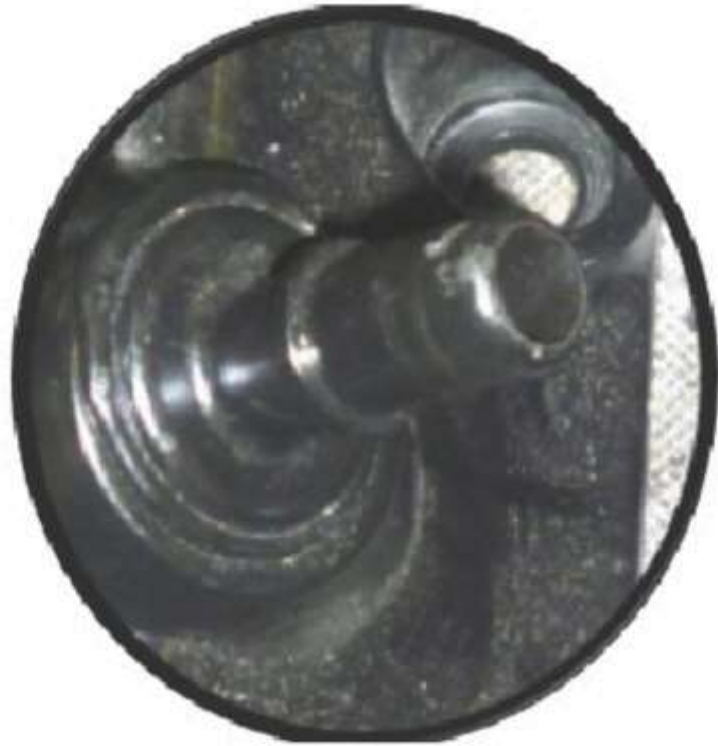
Figure 62

- Bearing and journal damage from lack of lubrication
- An open breather tube fitting mistaken for a PCV valve could be transferred to the new engine leading to repeat bearing failure (Figure 62). During engine replacement, verify the PCV valve is operational and correct for the application.

NOTE: Remanufactured Modular 2V V8 and V10 engines do not come with a PCV valve installed. If there appears to be a valve/tube in place on a new Remanufactured 2V V8 or V10 engine, replace it.

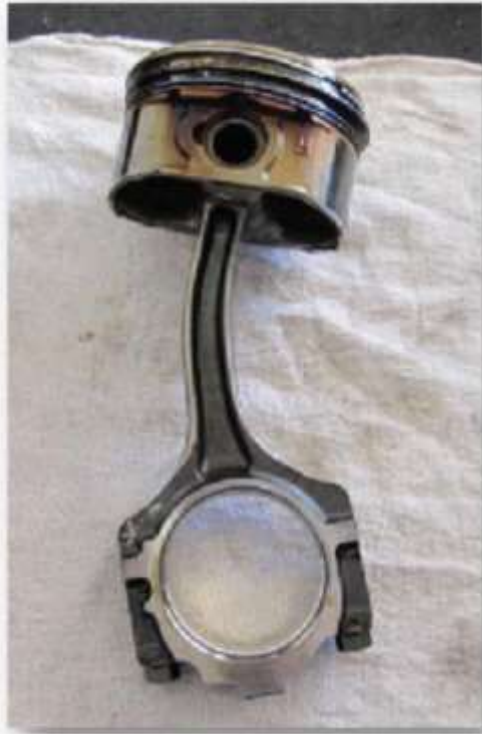
Figure 63

Bent Connecting Rod (Figure 63)

Root Cause: Hydrolocking from liquid ingestion

- Leaking or stuck open fuel injector
- Water ingestion through the air inlet (wet, warped or damaged air filter)

Effect: Hydrolocking

- Liquid cannot be compressed and will prevent the piston from traveling to top dead center (TDC)

Damage: Connecting rod

- Connecting rod will bend or break
- May occur on more than one cylinder

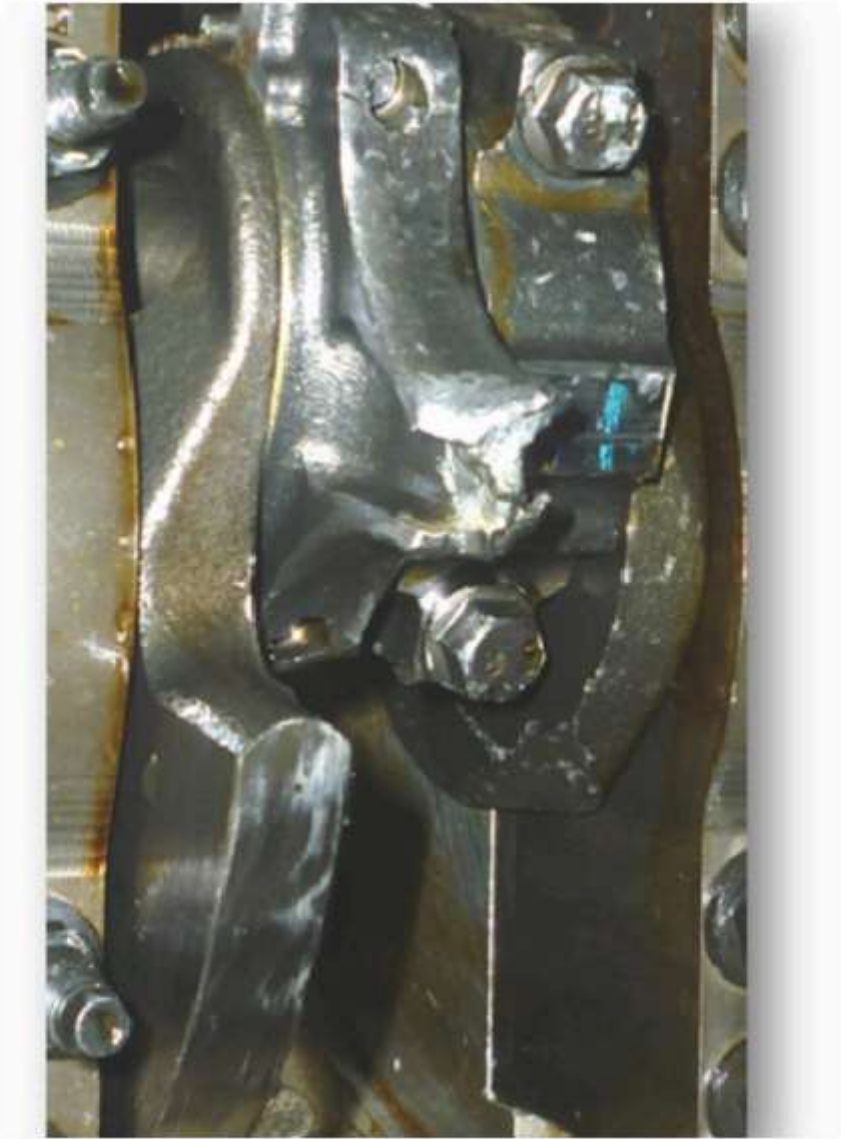
Figures 64

- Since fluids cannot be compressed, the connecting rod typically suffers from a hydrolock event.
