GENERAL SERVICE BULLETIN Engine Failure Analysis

20-7062
23 June 2020

This bulletin is a guide to engine failure analysis and preventing repeat engine failure.

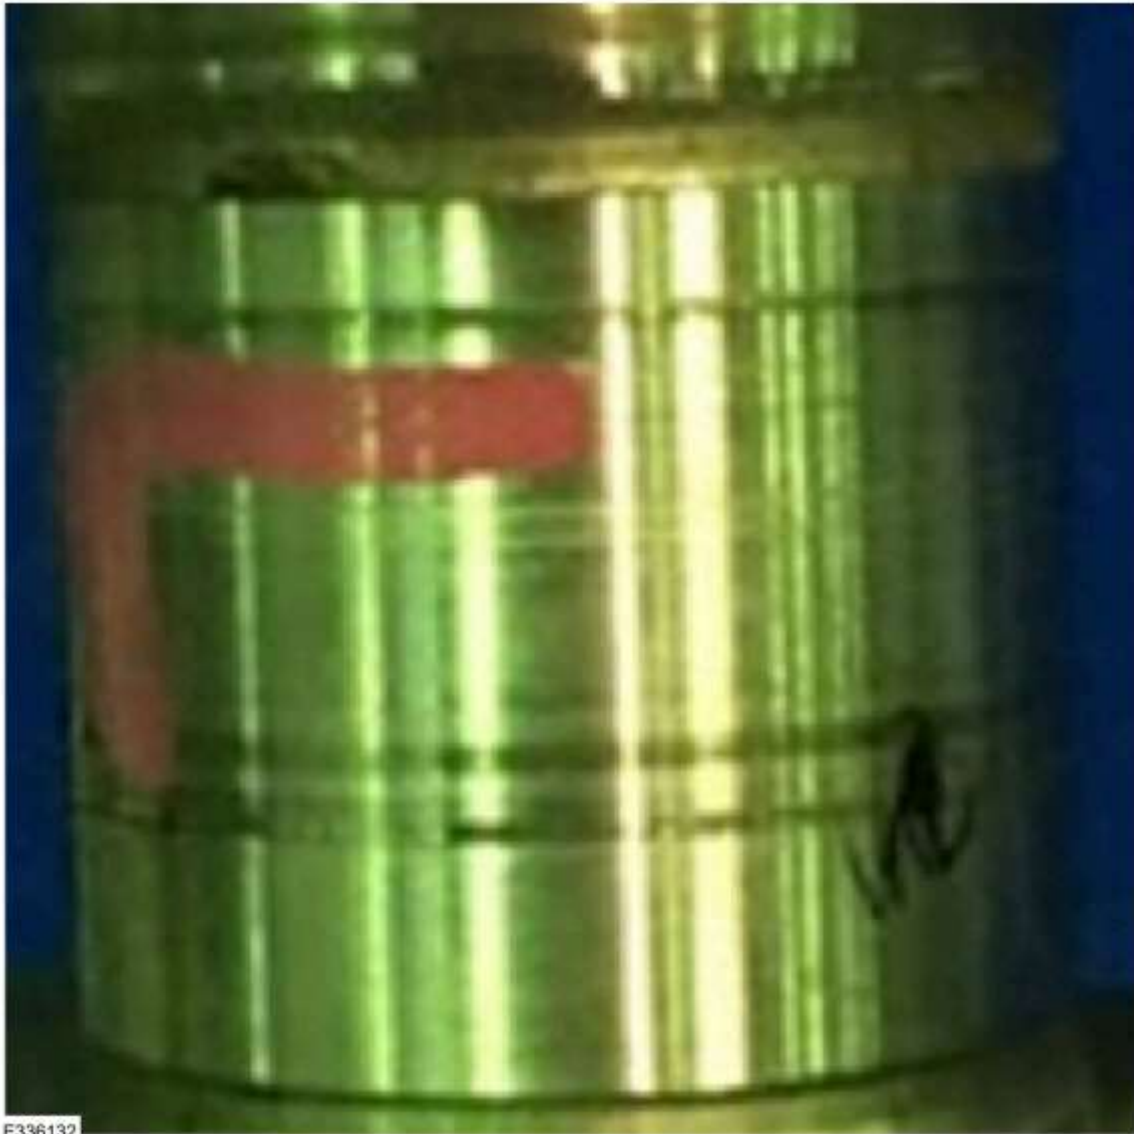
Camshaft Journals and Lobes - Normal Wear: Polishing, discoloration, minor uniform scoring felt with a fingernail (Figures 13-15).

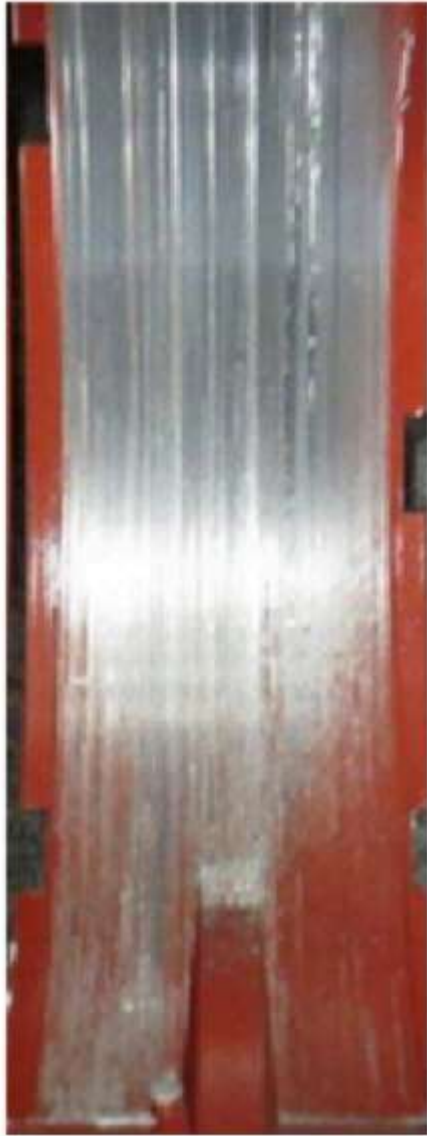
Bearings – Damage: Metal transfer, erosion, material loss, coolant contamination, deep scoring, cracking, spun bearing (Figures 23-27).

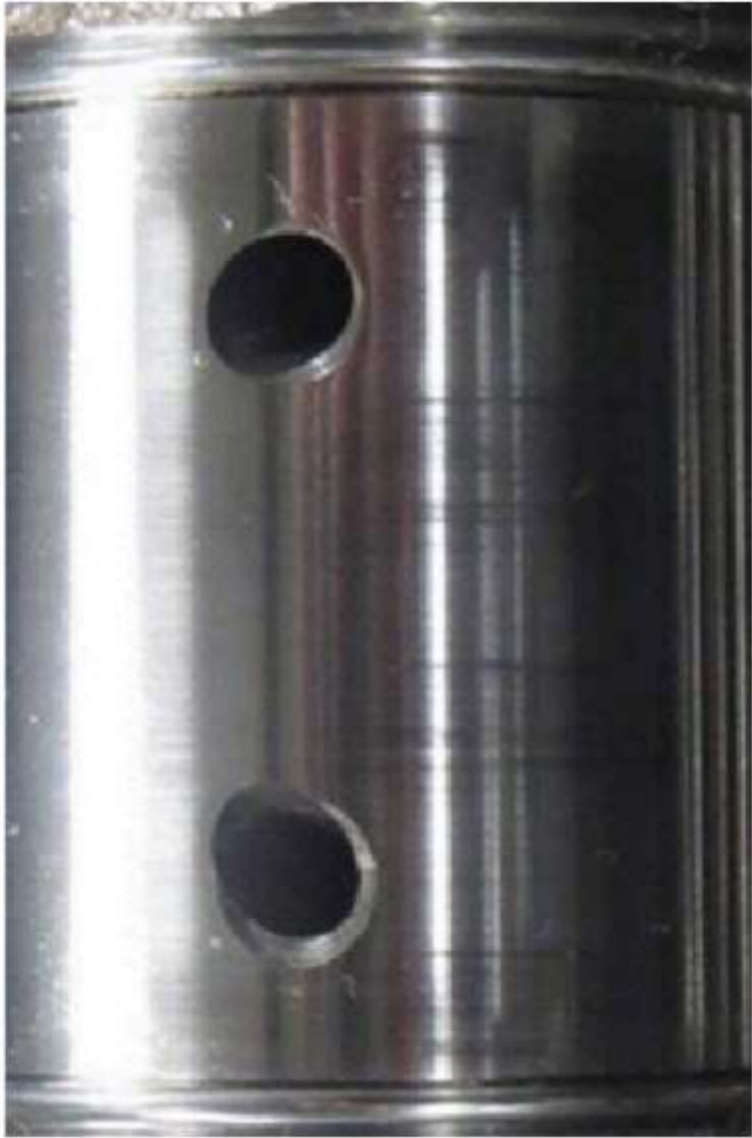
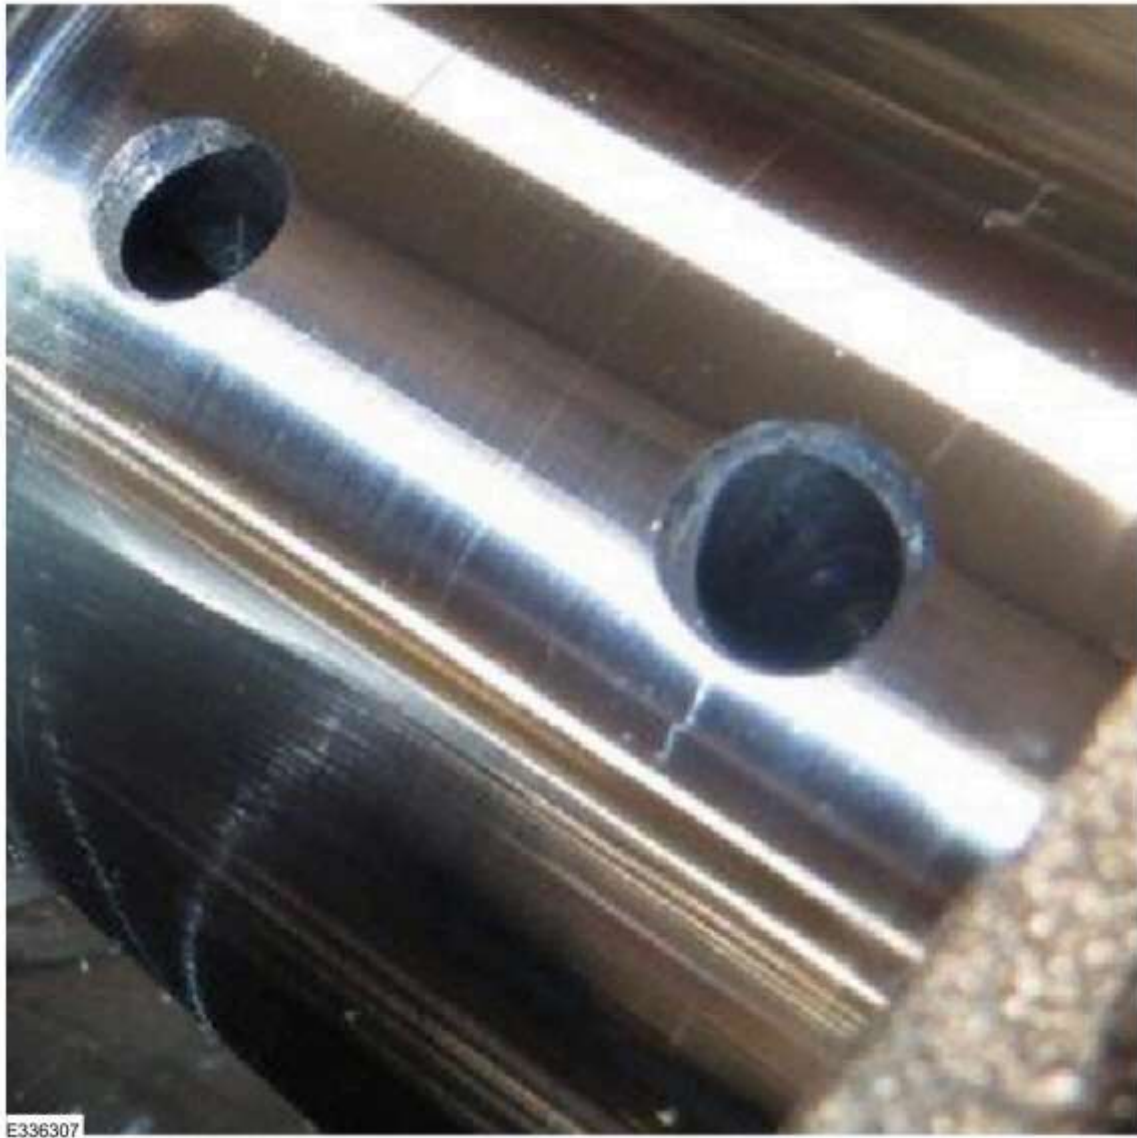
Crankshaft – Normal Wear: Discoloration, polishing, light scratches (Figures 28-29).

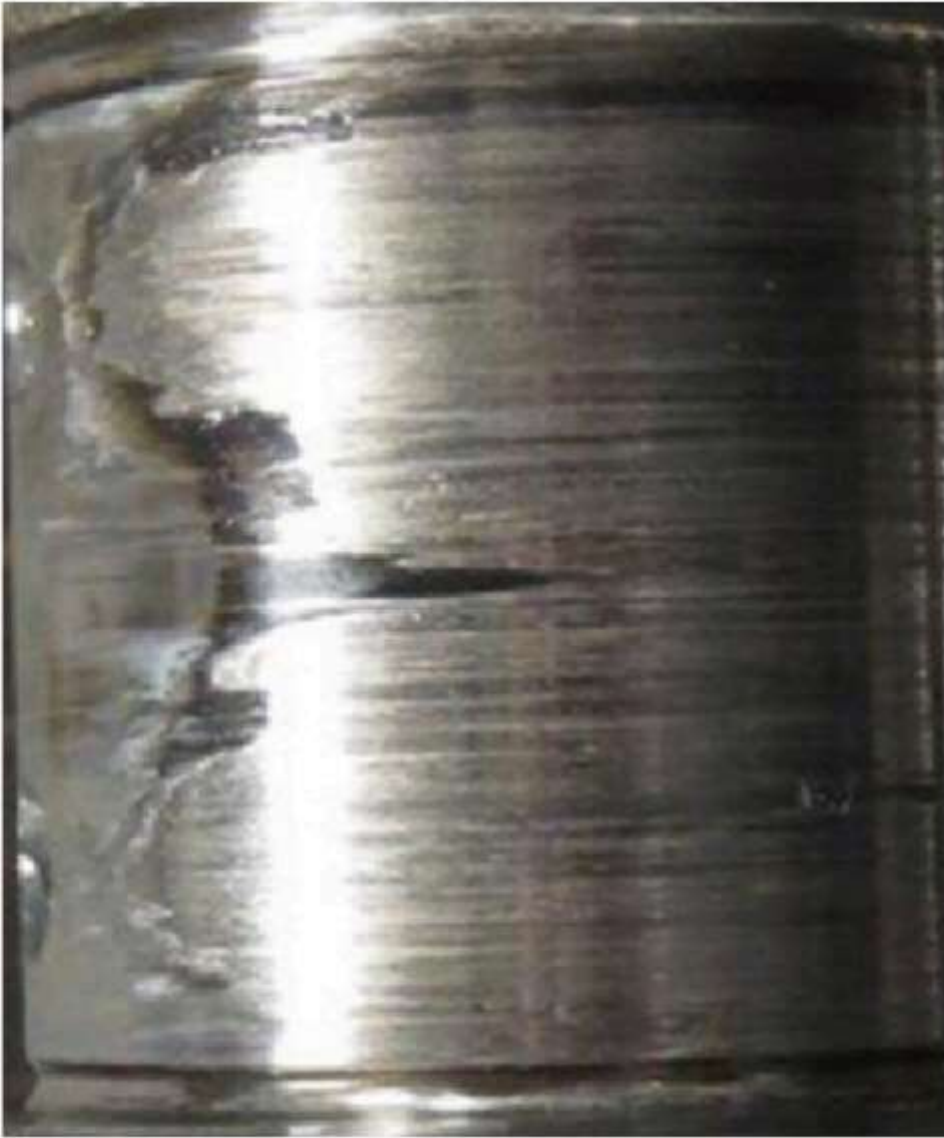
Crankshaft – Damage: Material loss, deep scoring, material transfer (Figures 30-32).

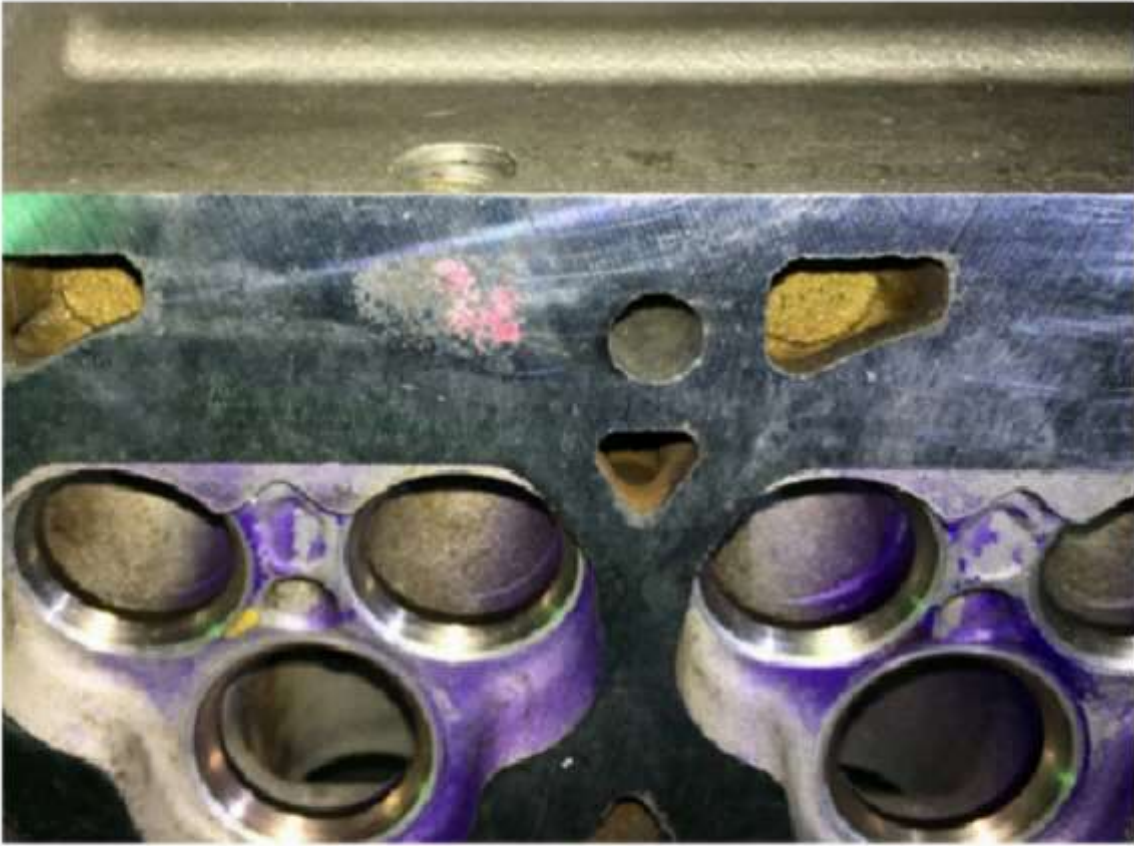
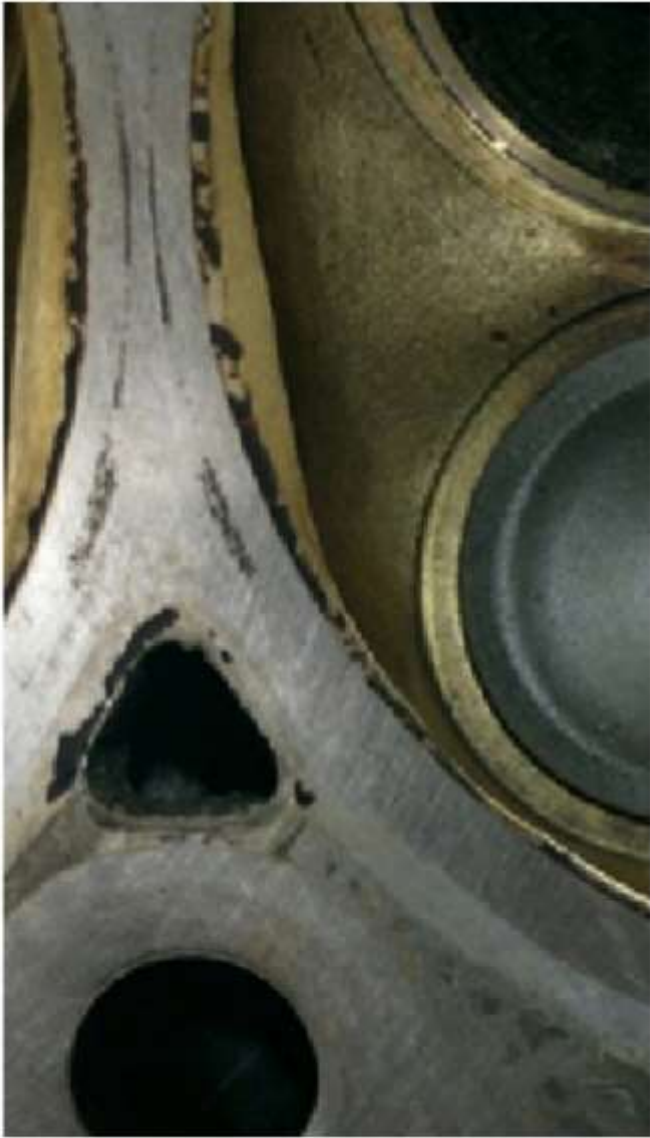
Head and Block Surface – Normal Wear: Porosity outside sealing surfaces, gasket surface discoloration, light scratches (Figures 33-34).

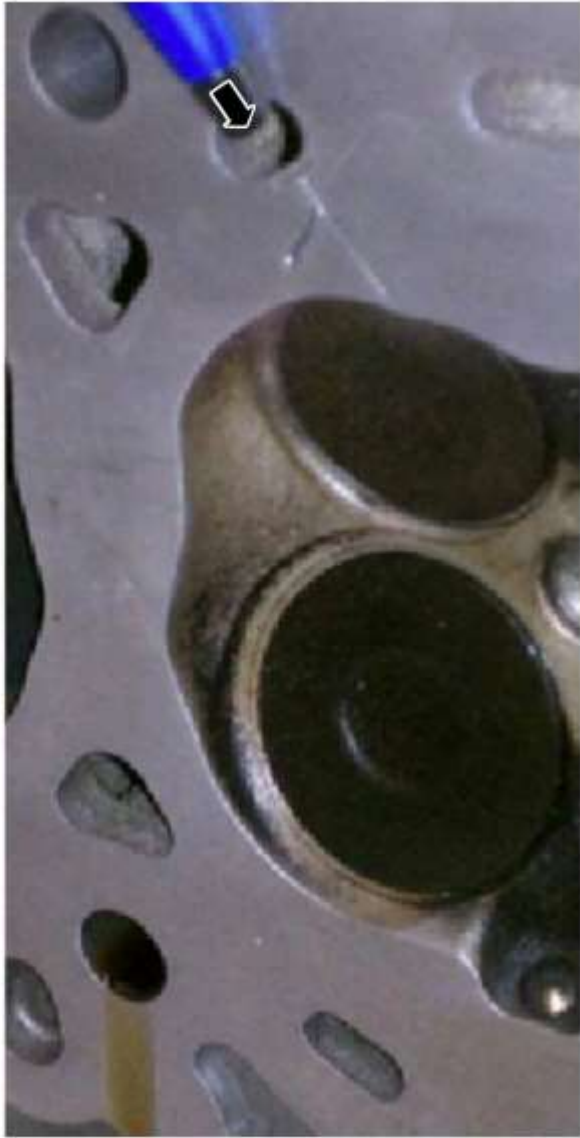
Head and Block Surface – Damage: Porosity on sealing surfaces, deep gouges, material transfer, warpage (Figures 35-37).

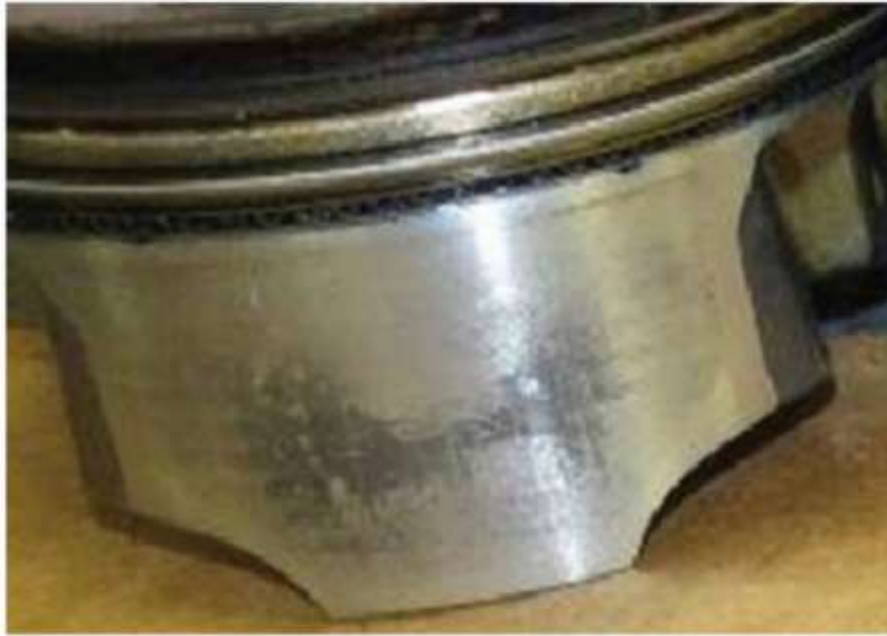
Piston Skirt – Damage: Deep scoring, severe coating wear (Figure 46-47).

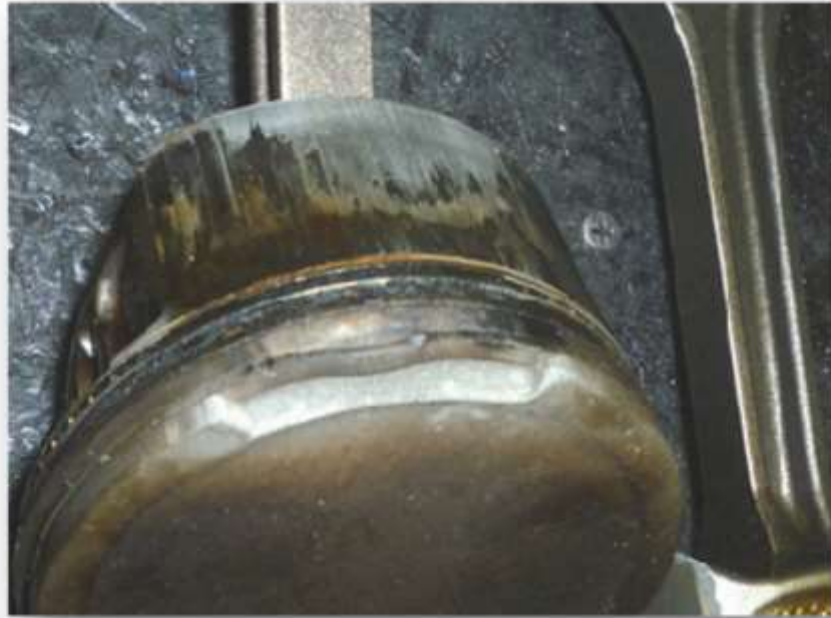
Root Cause: Lean conditions or modifications (Figures 48-49)

- Modifications (timing, CNG, incorrect spark plugs)
 - Overboost (supercharger/turbocharger)
 - PCM performance chip/programmer
- Lean conditions
 - Mass air flow (MAF) sensor failure
 - Damaged air intake

Effect: High cylinder pressure or spark knock

- Excessive combustion temperatures
- Excessive cylinder pressure
- Pre-ignition
- Excessive levels of detonation (low octane/poor fuel quality)

Damage: Piston and cylinder wall

- Spark plug electrode damage
- Hole in piston (pre-ignition)
- Piston ring land damage (detonation)

- Pitted piston face
- Cylinder wall scoring

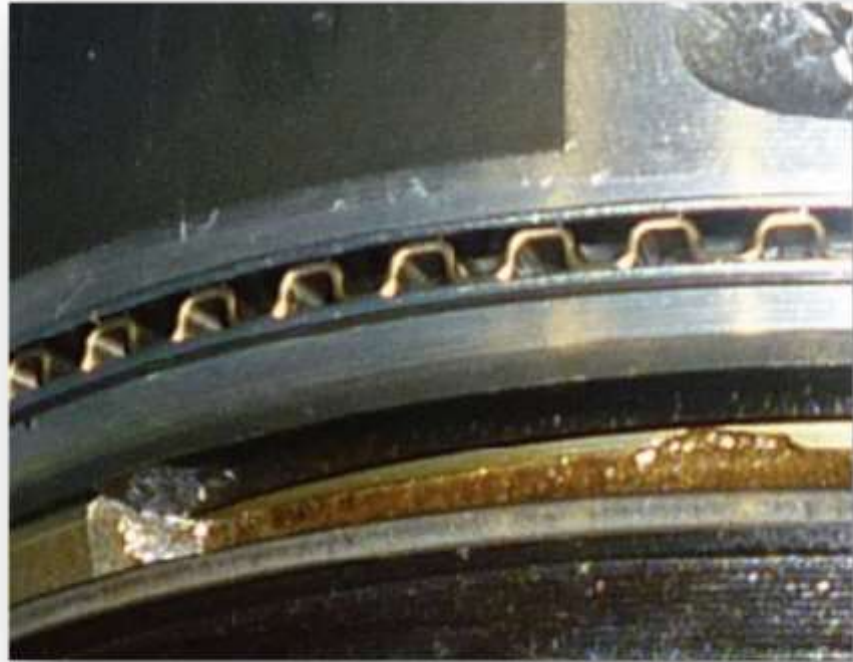
Figure 52

Excess detonation causes excess cylinder pressure spikes leading to piston ring land fractures (second ring land is damaged). (Figure 52)

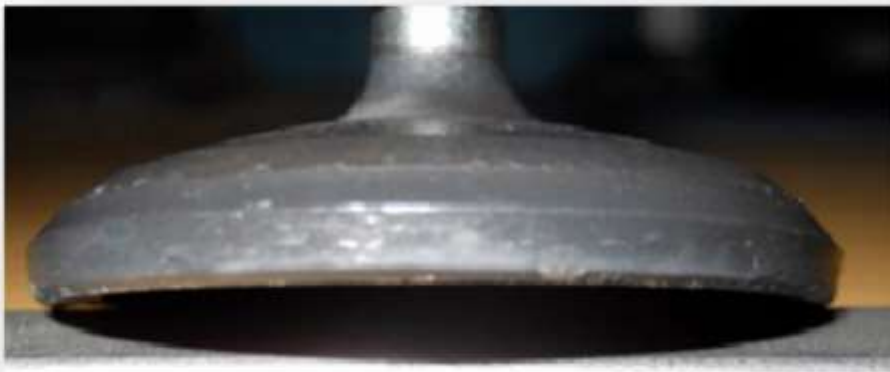
Valve Damage (Figures 56-57)

Root Cause: Lean condition

- Modification or damage to the air induction system

- MAF sensor damage/failure
- Lack of fuel to the cylinder

Effect: Excessive combustion chamber temperatures

- Misfire, lacks power
- Catalyst damage
- Running lean = hot cylinder

Damage: Valve and valve seat

- Valve tuliping
- Valve seat recession

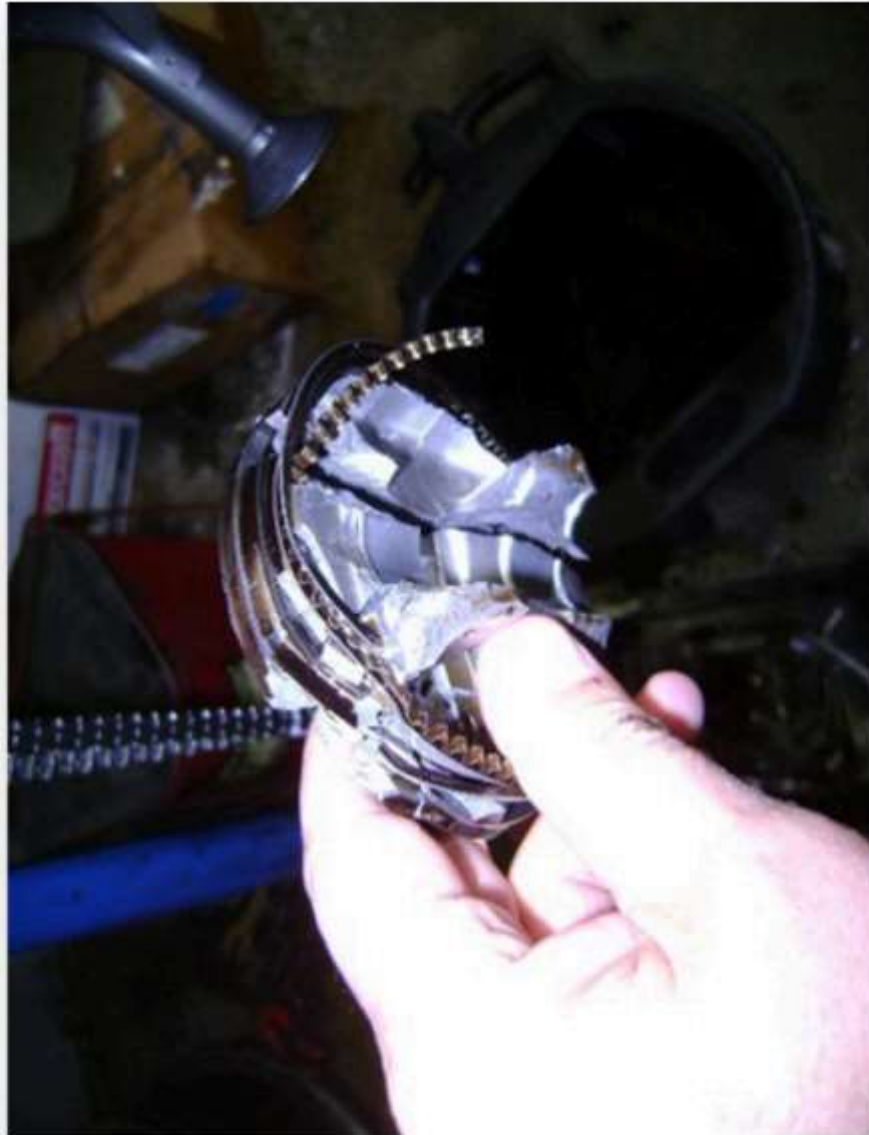
Foreign Object Debris (Figure 59)

Root Cause: Combustion chamber damage

- Broken piston/rings
- Broken valves
- Dropped valve seats

Effect: Debris transfer

- Original intake manifold transferred to the new engine
- Intake manifolds cannot be cleaned in these instances and require replacement

Damage: Repeat engine failure

- Engine vacuum dislodges debris left in the manifold
- Debris will enter the combustion chamber and cause piston/cylinder damage

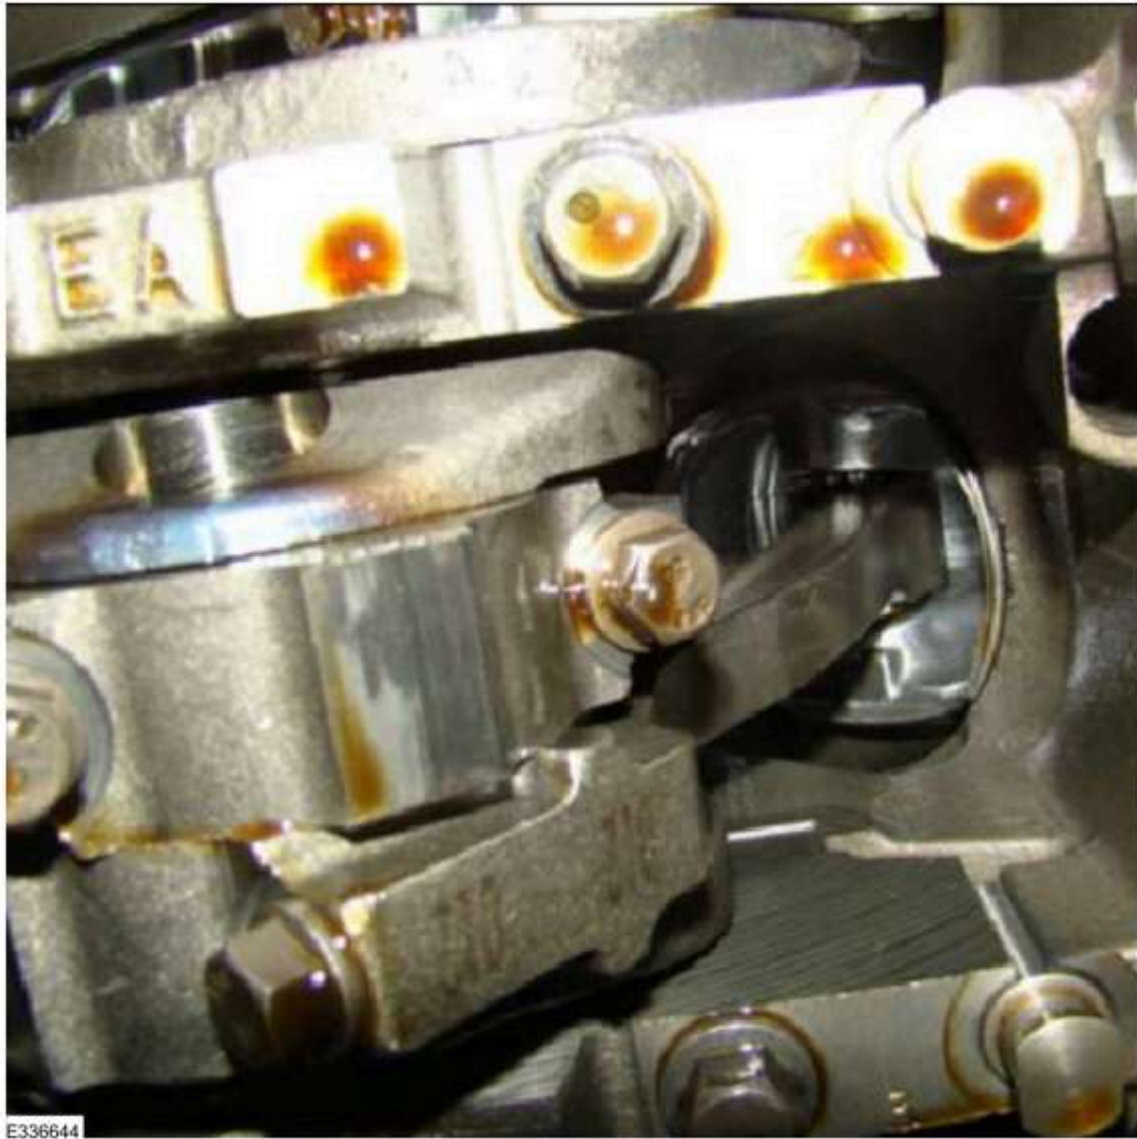
- Since fluids cannot be compressed, the connecting rod typically suffers from a hydrolock event.
