22-7078

GENERAL SERVICE BULLETIN

Various Vehicles - Engine Failure Analysis

This bulletin is a guide to engine failure analysis and preventing repeat engine failure.

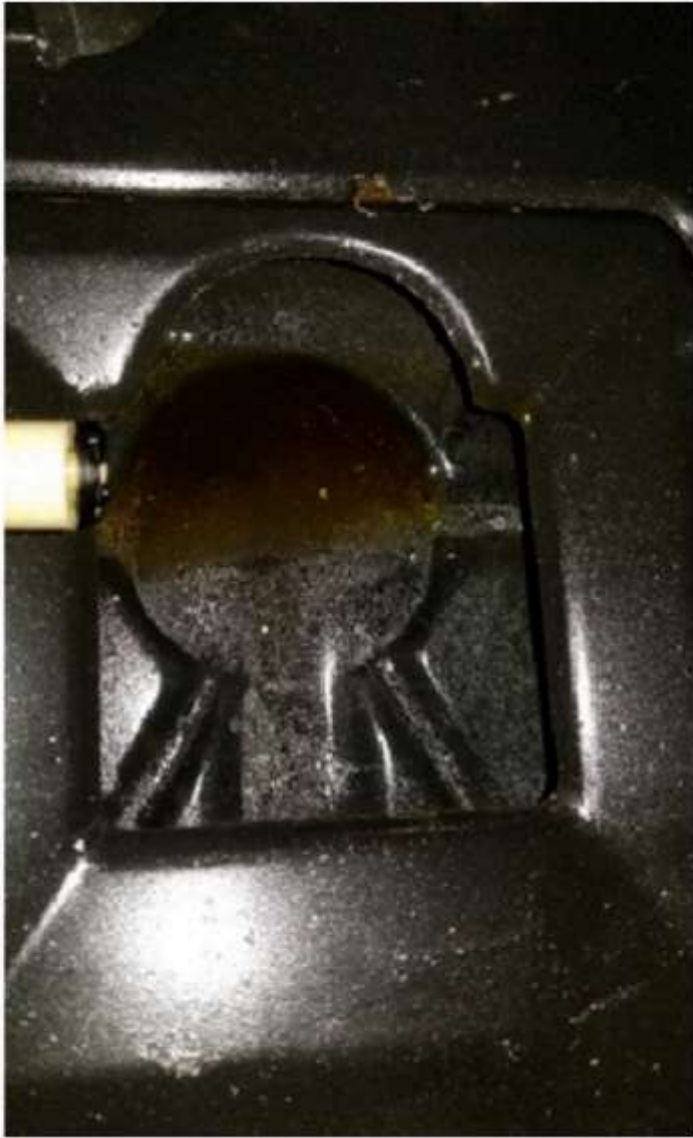
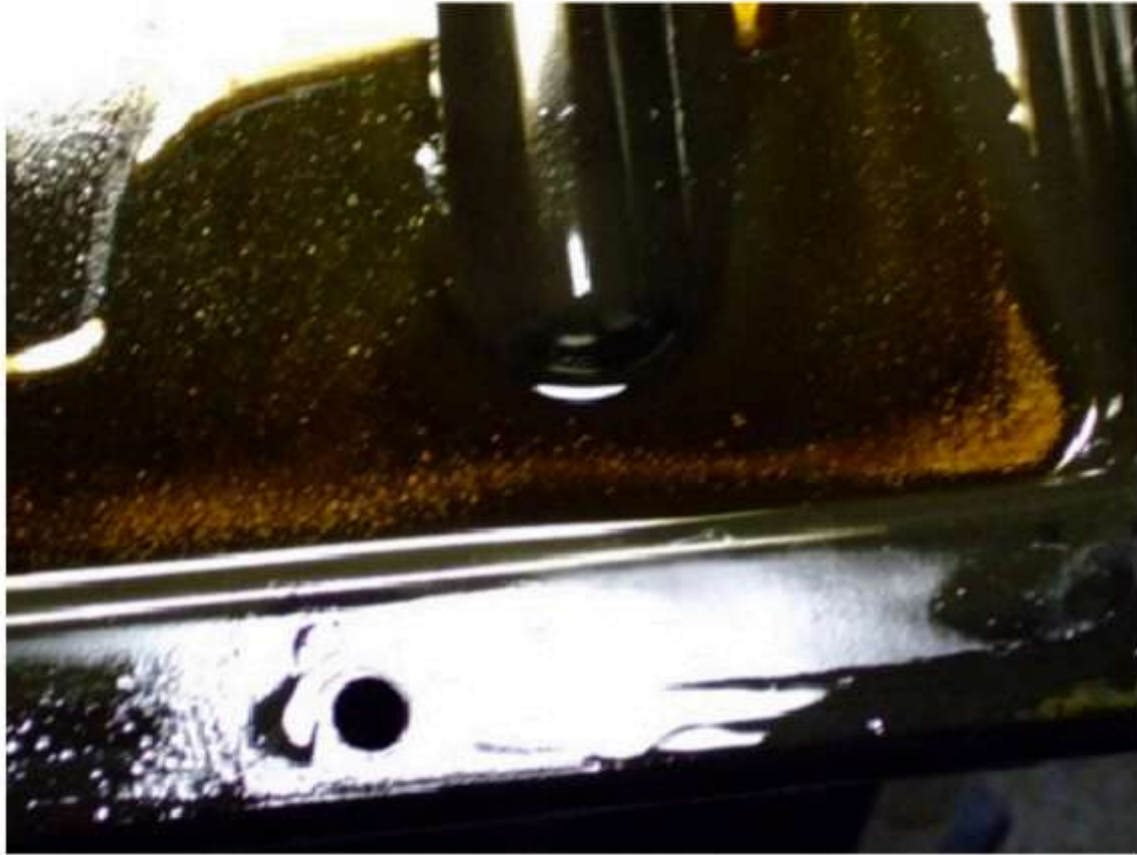
Some metal in the oil pan and filter is expected and considered normal (Figures 1-2).

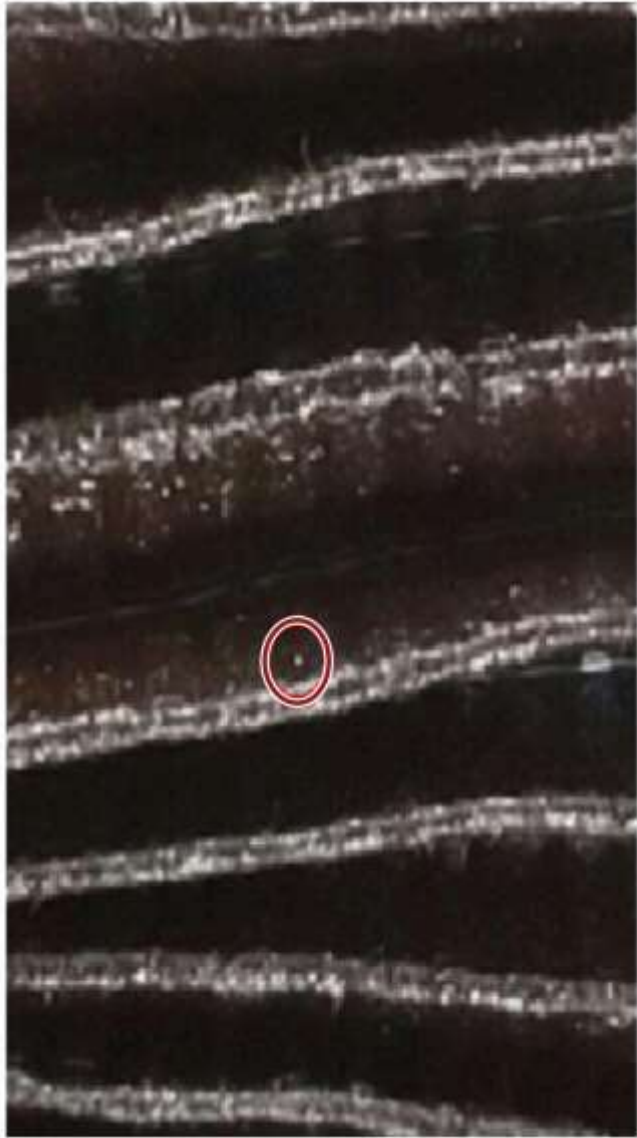
Figure 3

Some metal shavings in the oil filter are not a concern (Figure 3).

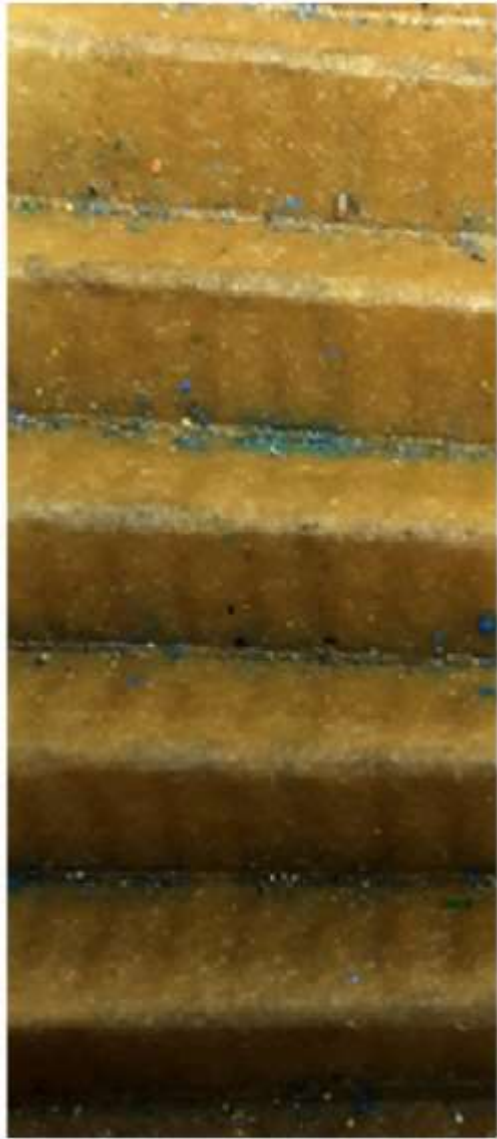
Figure 4

Small specs of metal in the filter media is normal (Figure 4).

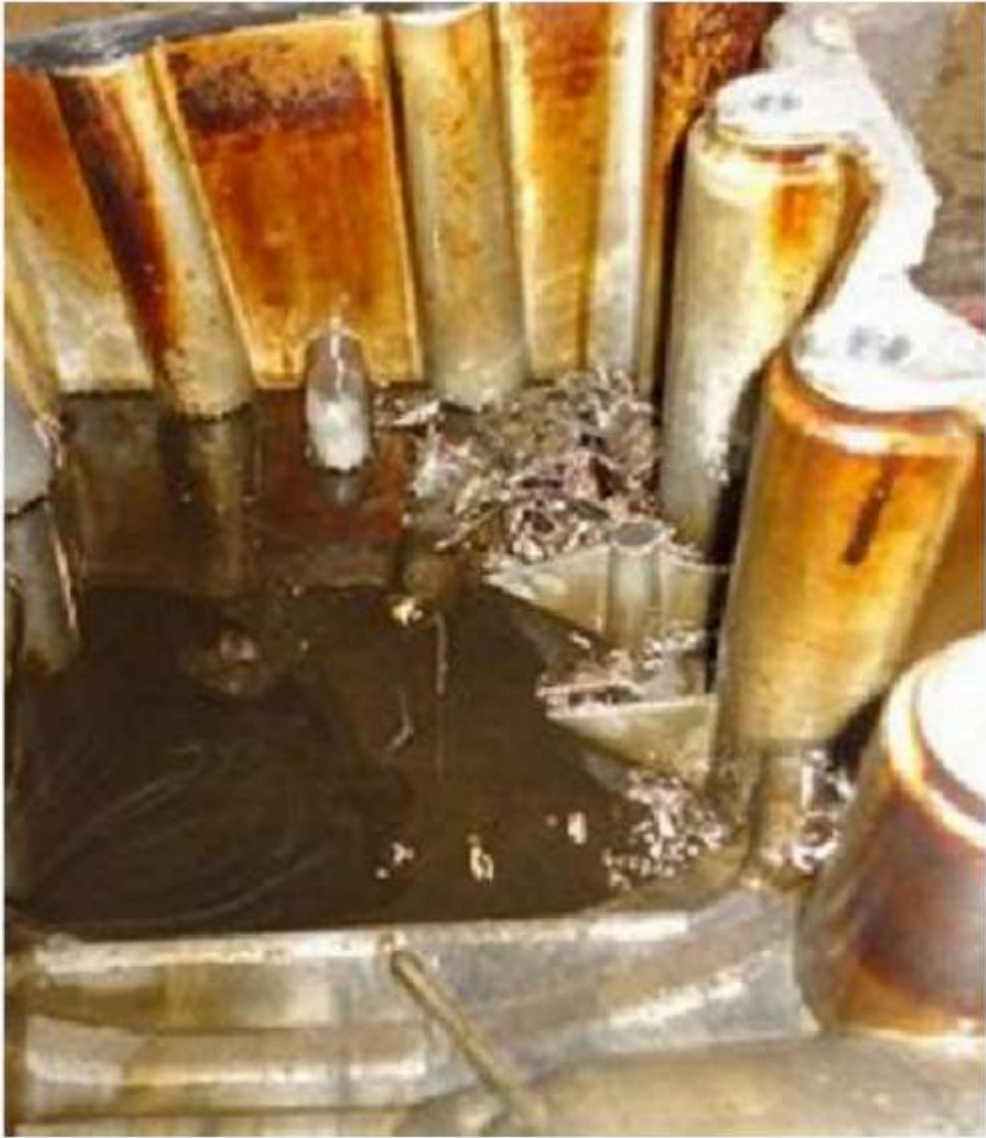
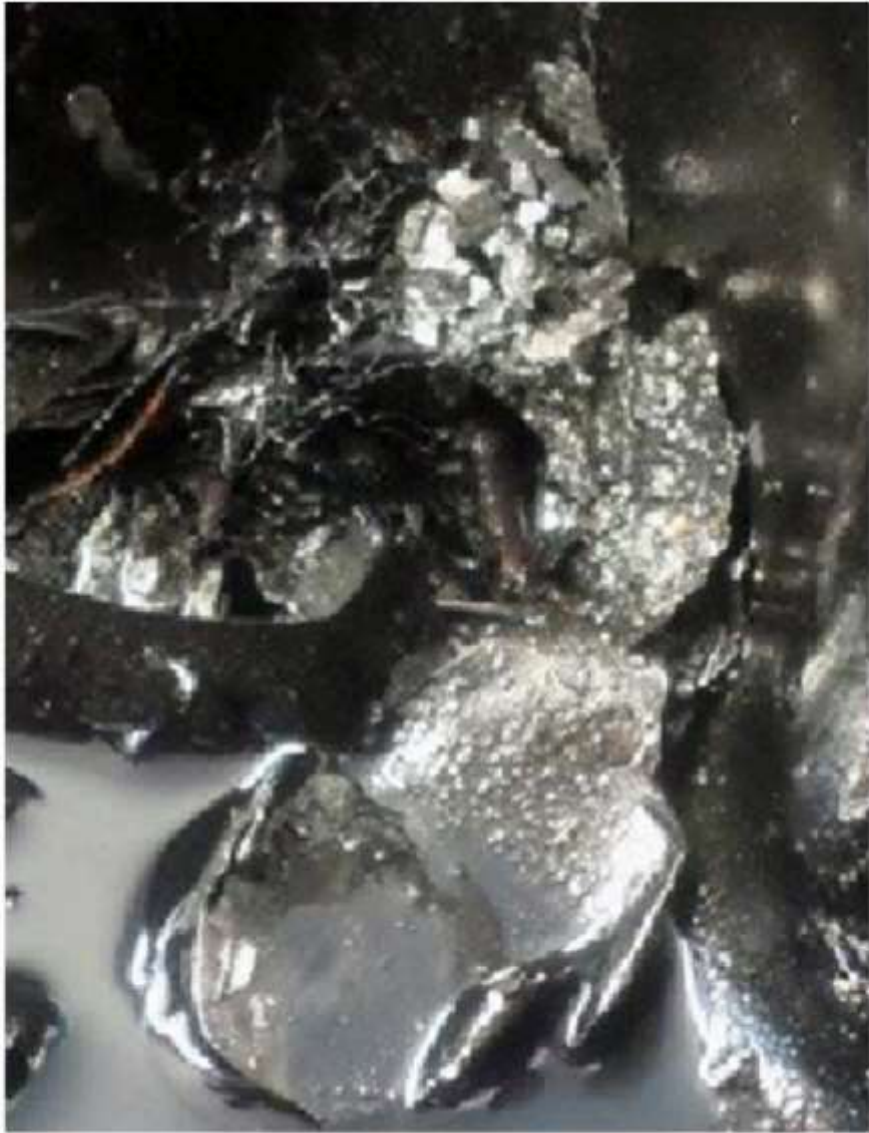
Large chunks of metal in the pan and/or filter merit further root cause investigation (Figures 5-6).

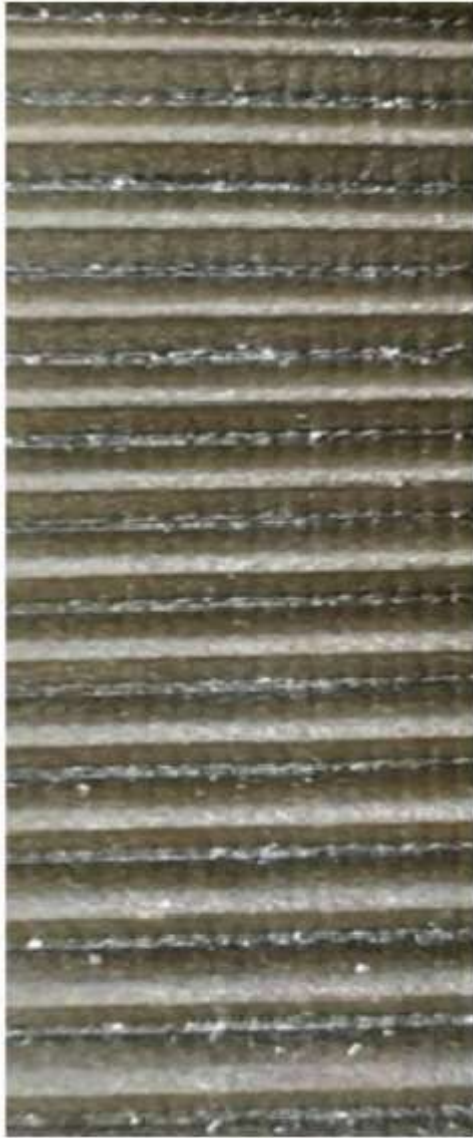
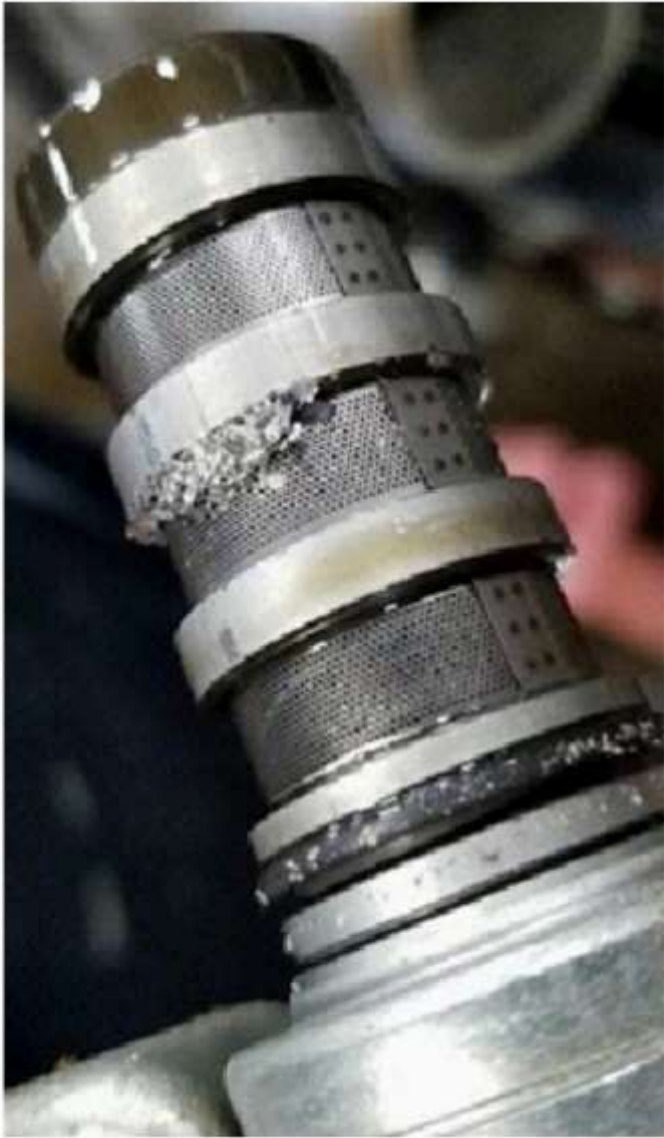
Excessive amounts of metal in the oil filter and/or screens require further root cause investigation (Figures 7-8).

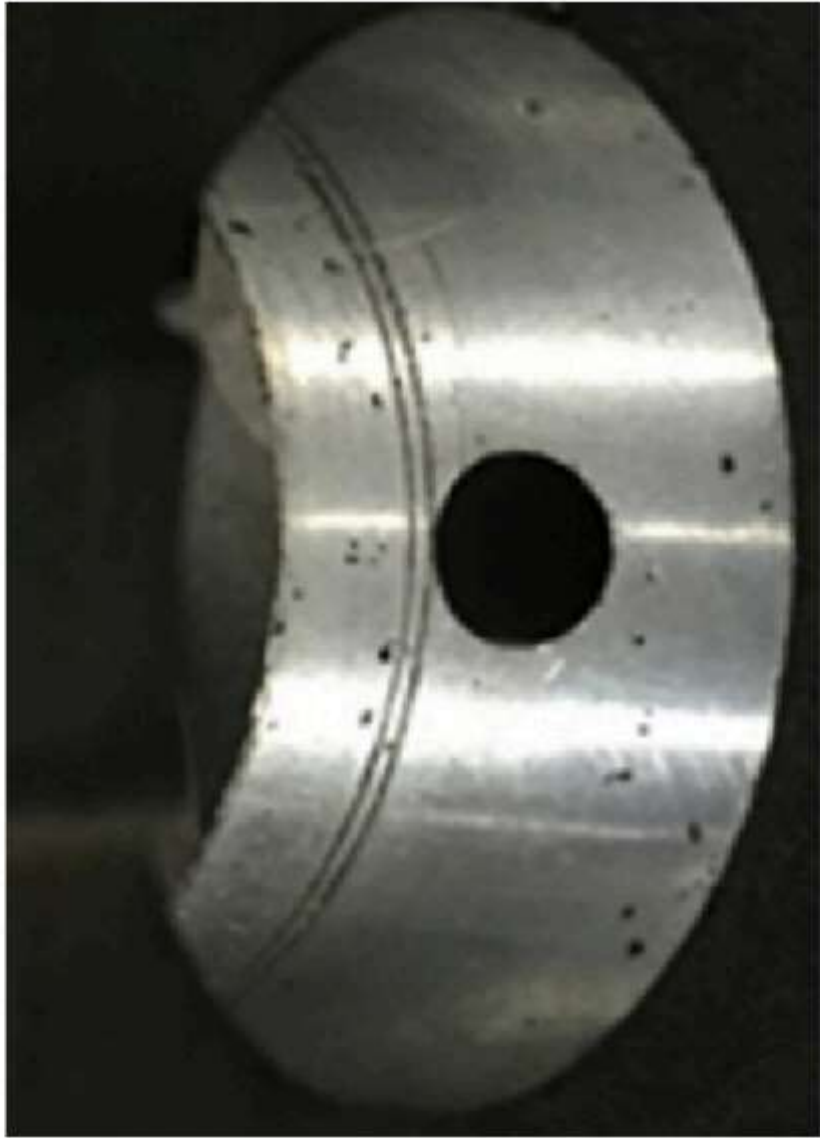
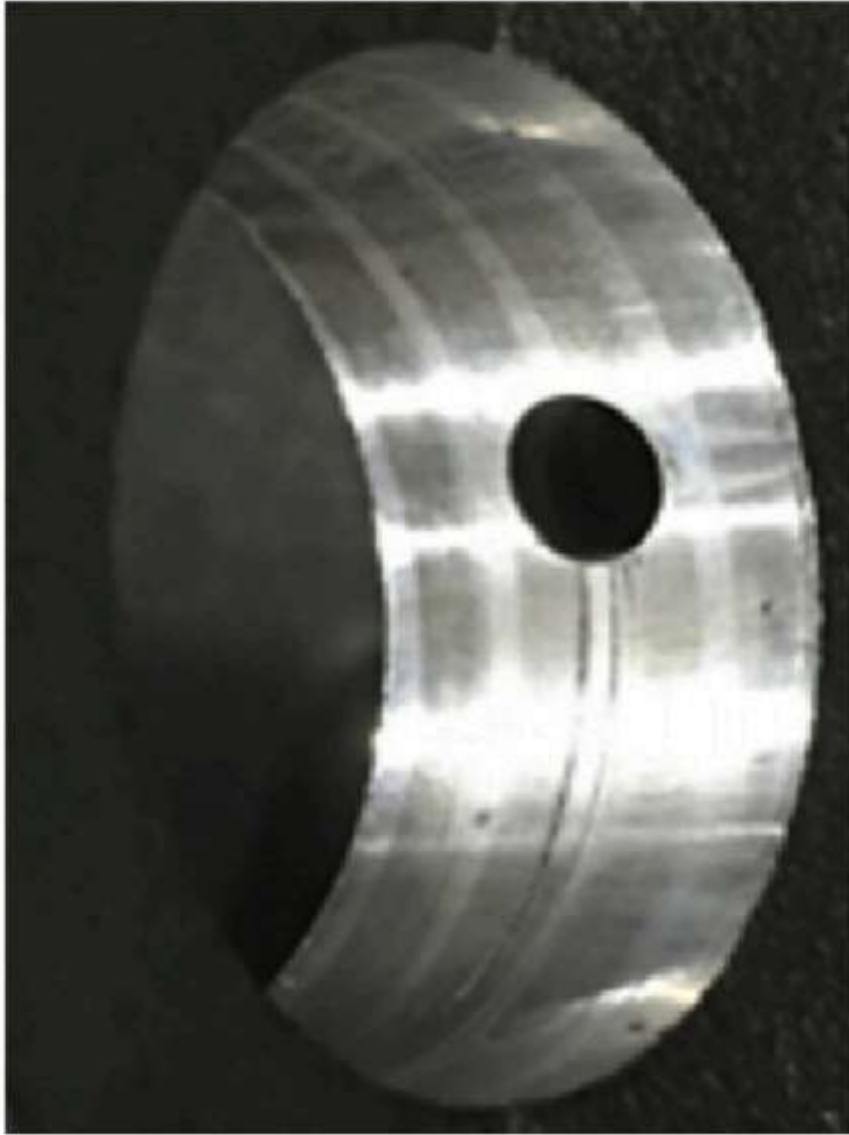
Cam Bore – Normal Wear: Polishing, discoloration, slight porosity or minor scoring (Figures 9-10).

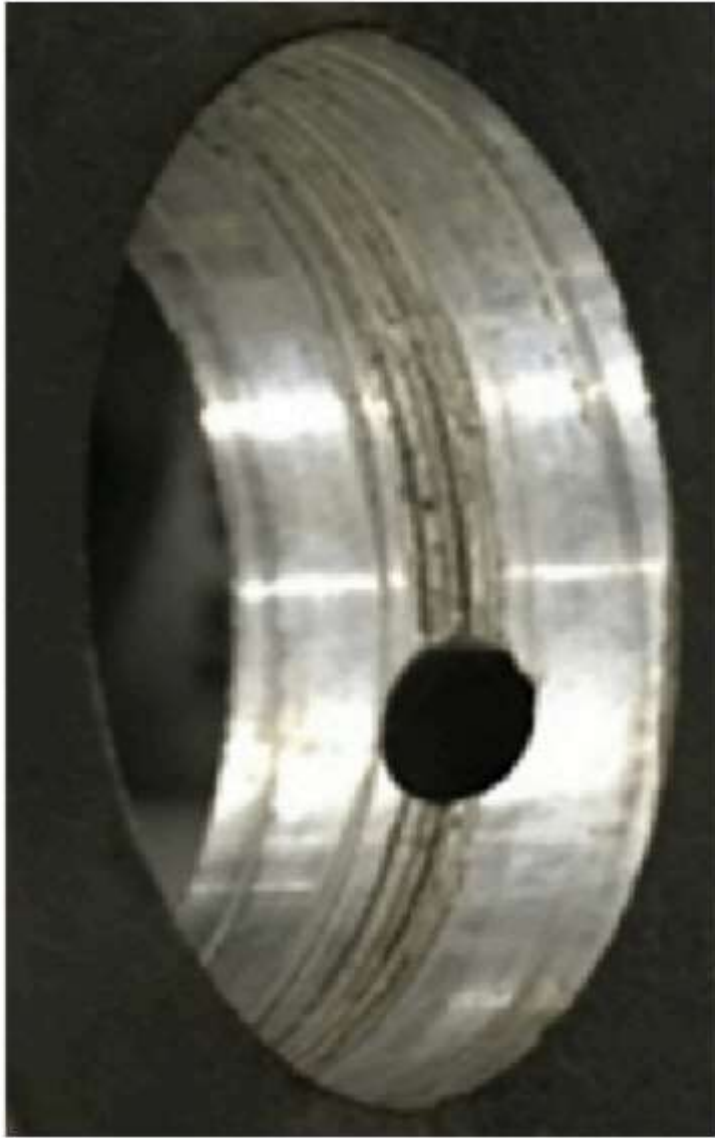
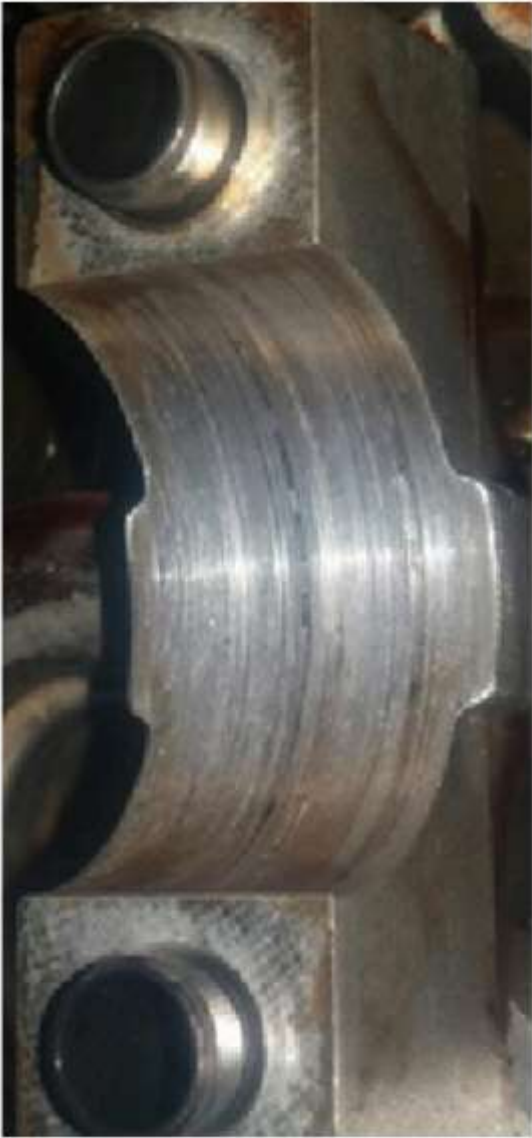
Cam Bore – Damage: Material loss, deep scoring and severe porosity (Figures 11-12).

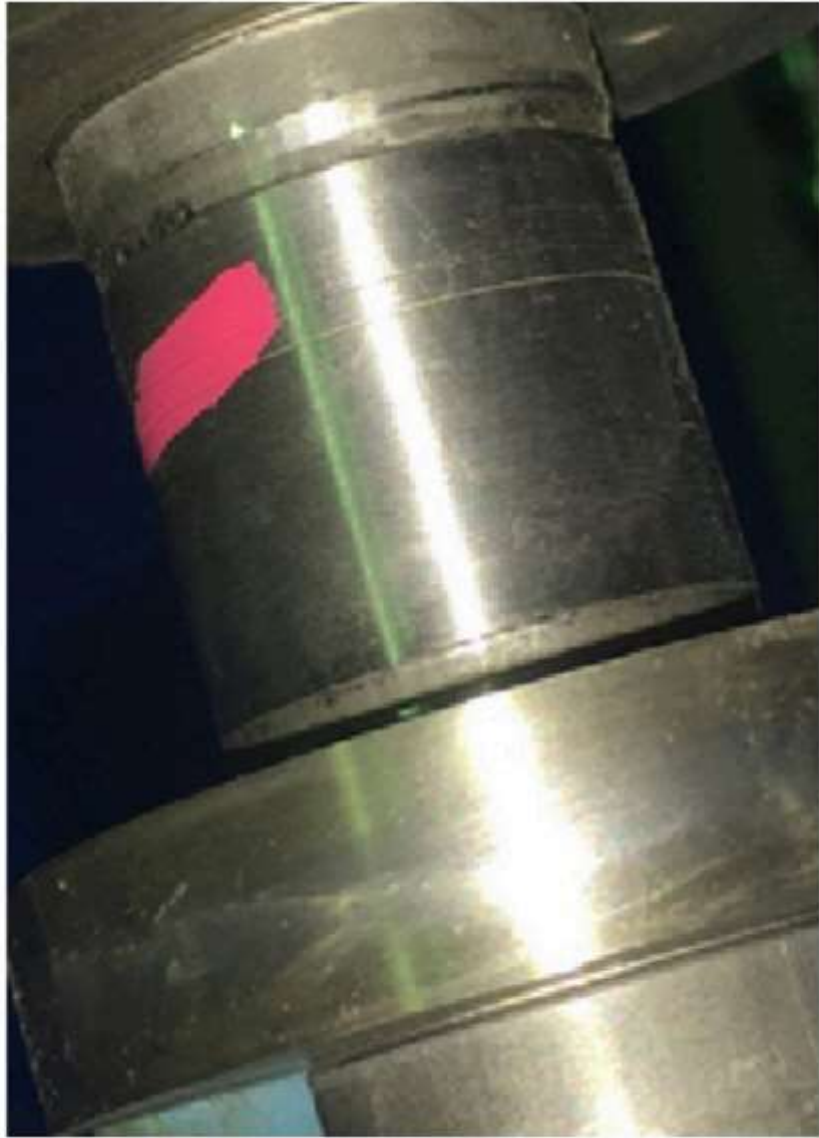
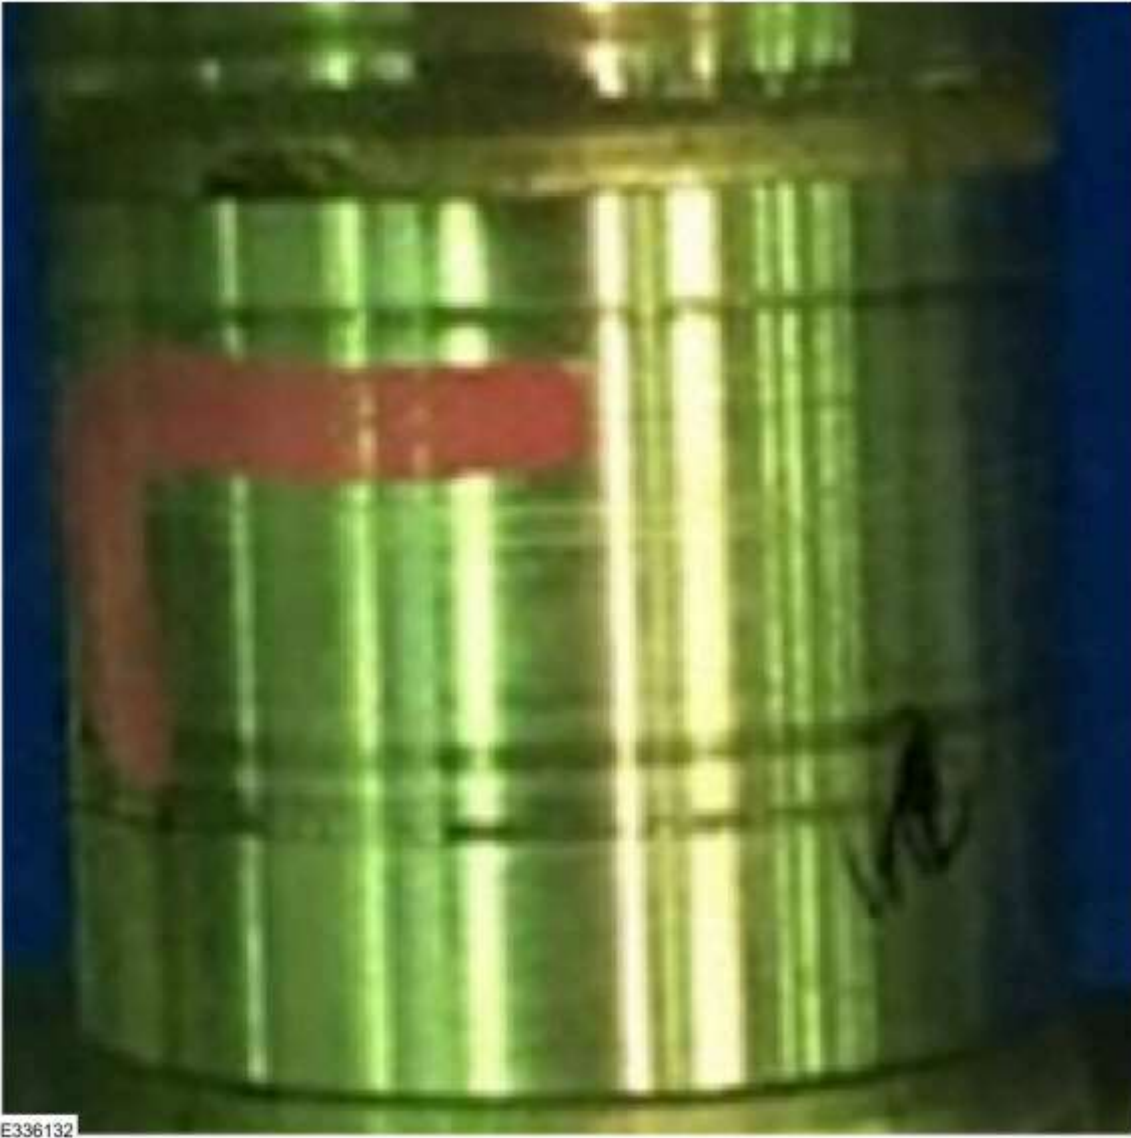
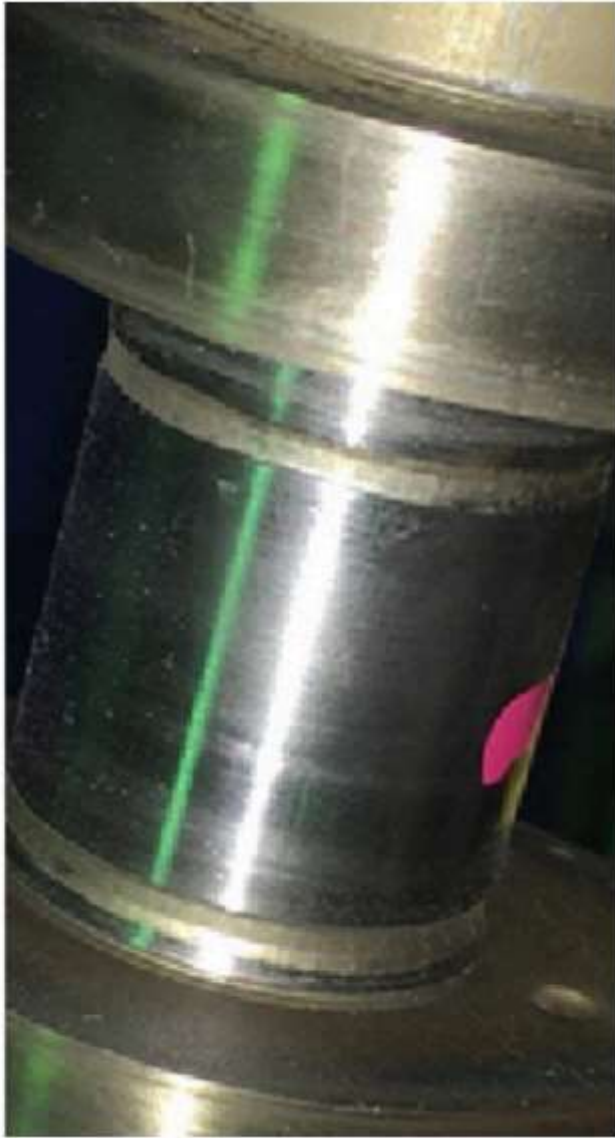
Camshaft Journals and Lobes - Normal Wear: Polishing, discoloration, minor uniform scoring felt with a fingernail (Figures 13-15).

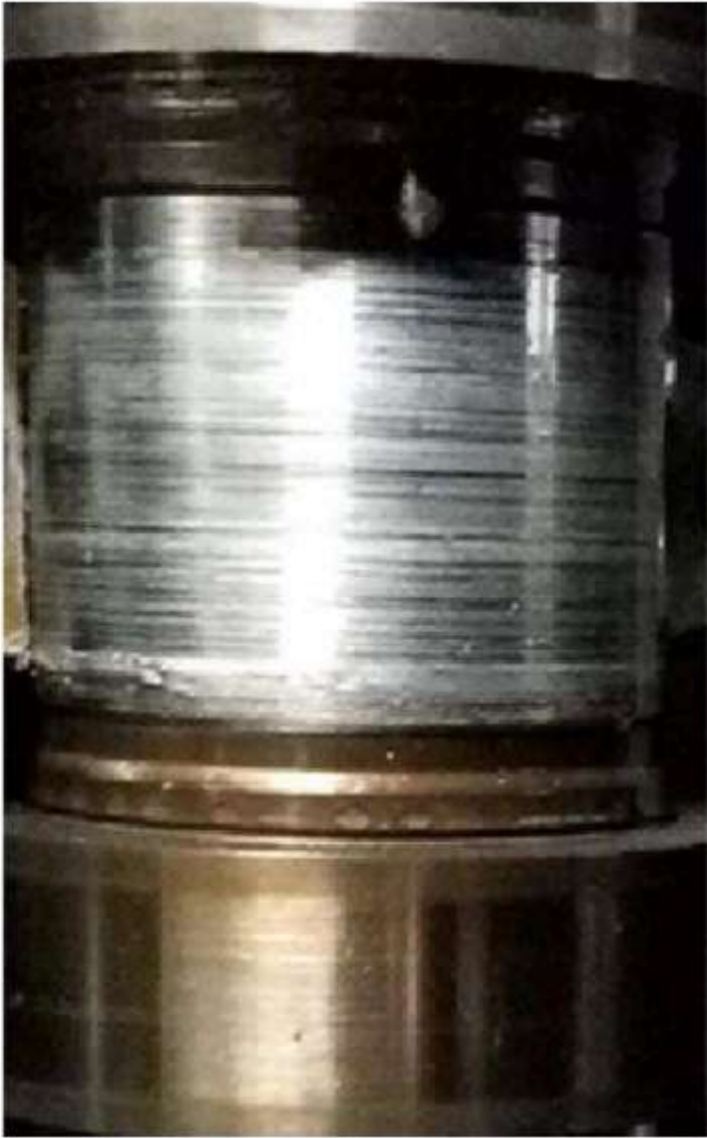
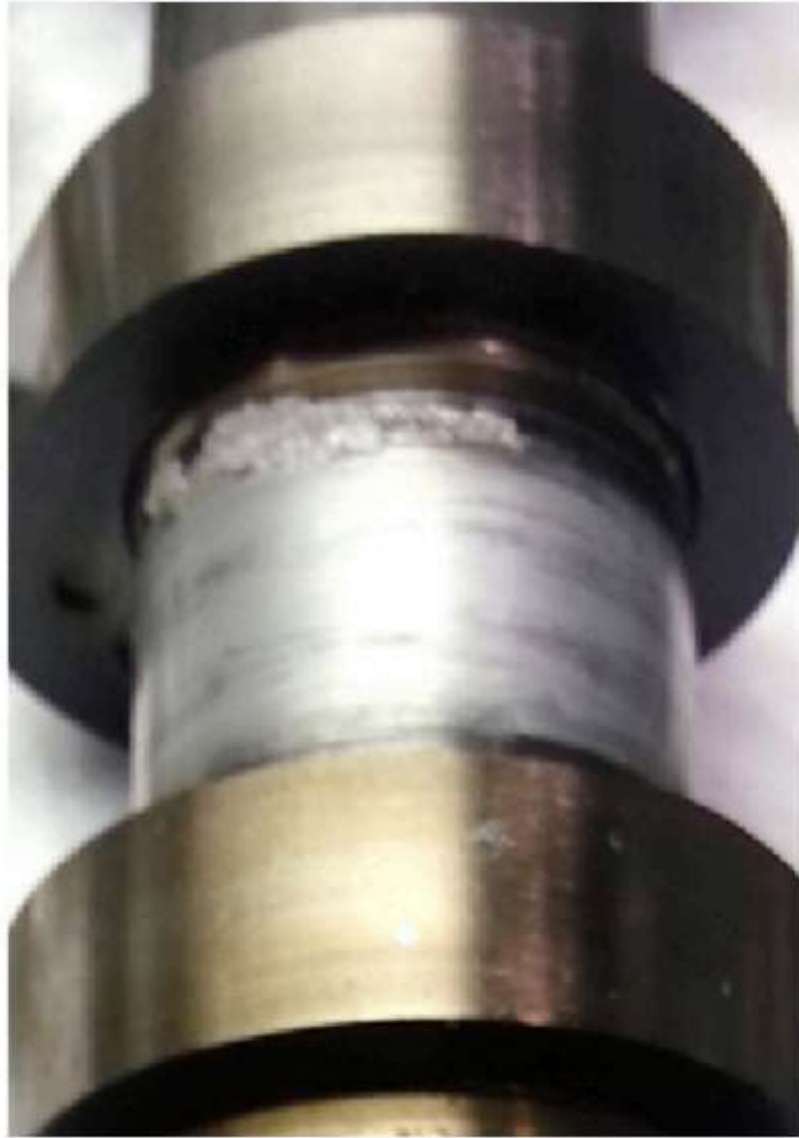
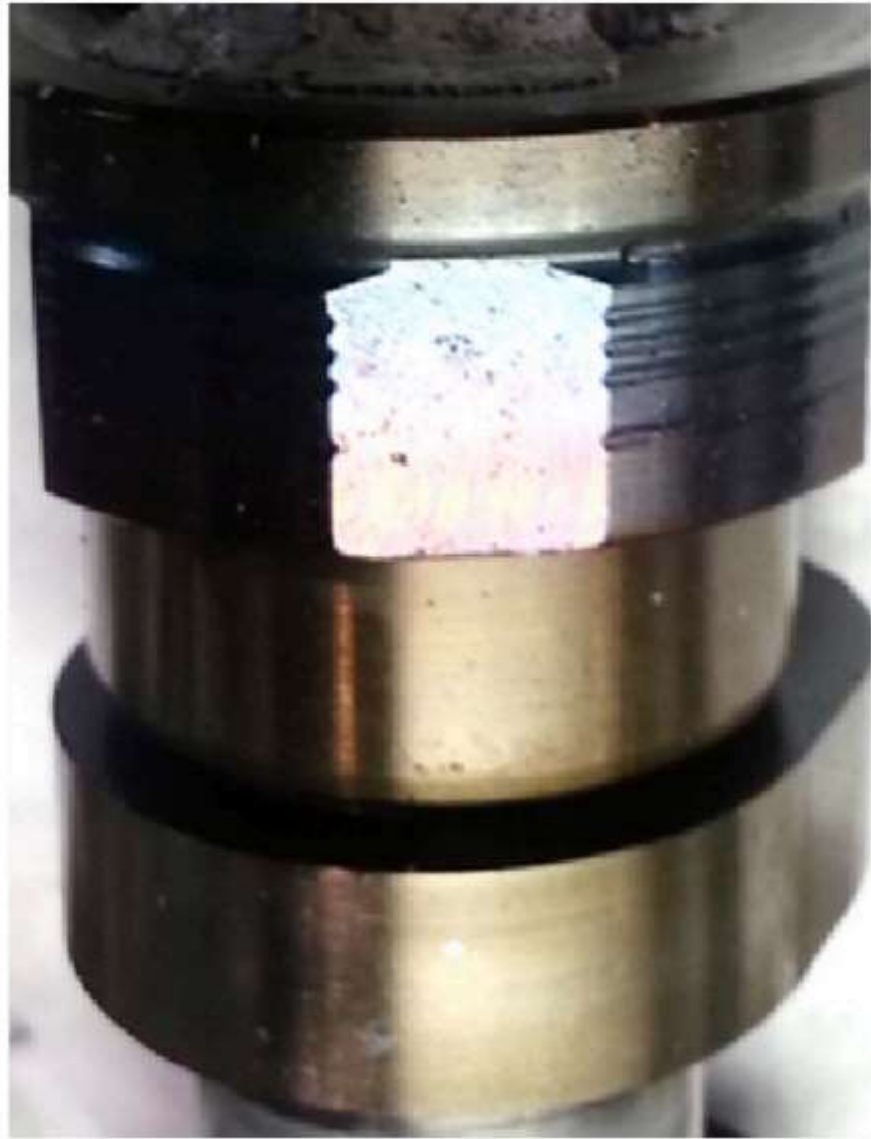
Camshaft Journals and Lobes – Damage: Material loss/transfer, deep scoring or bluing of the metal are all signs of damage (Figures 16-18).

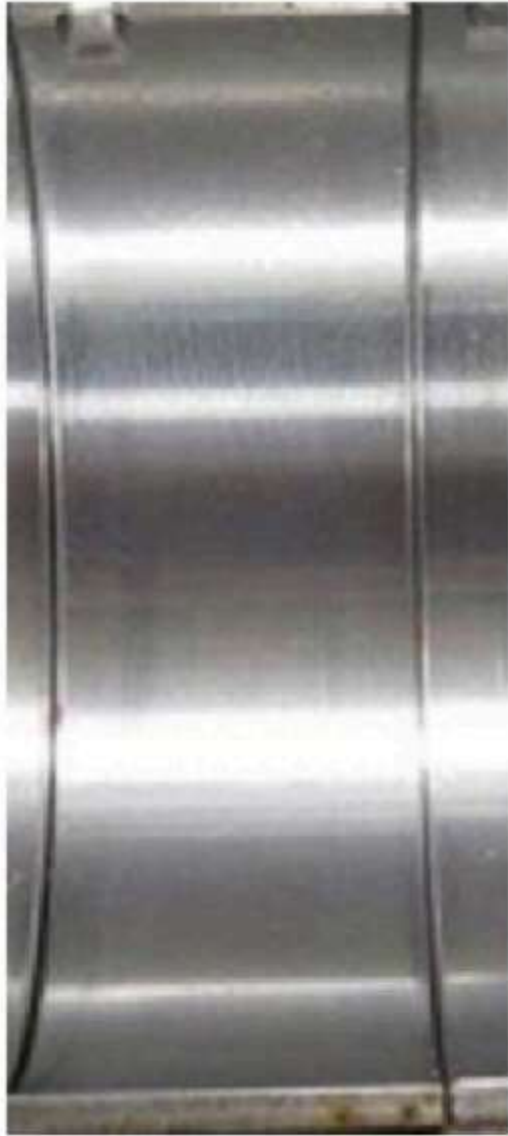
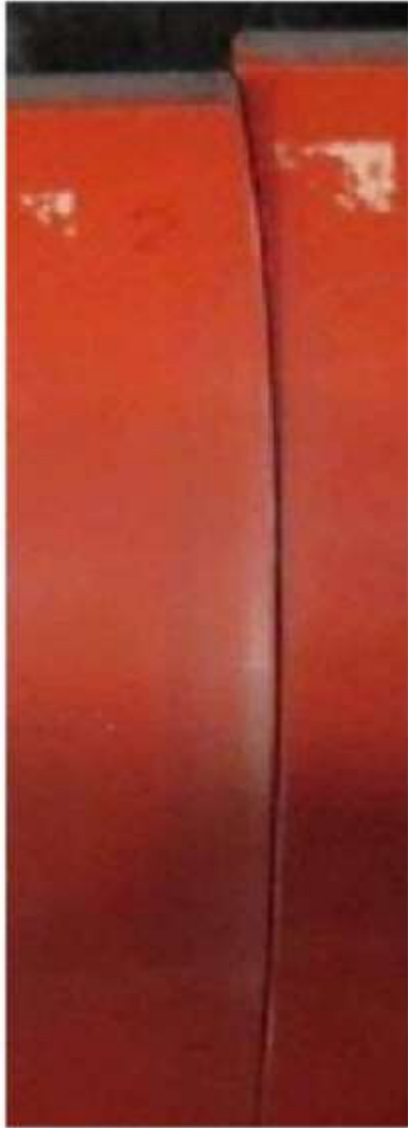
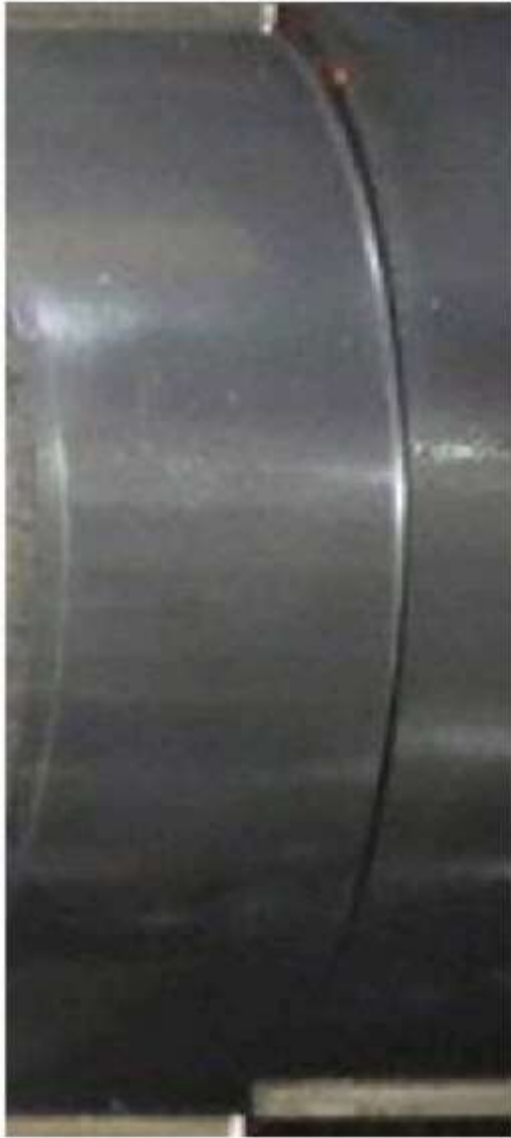
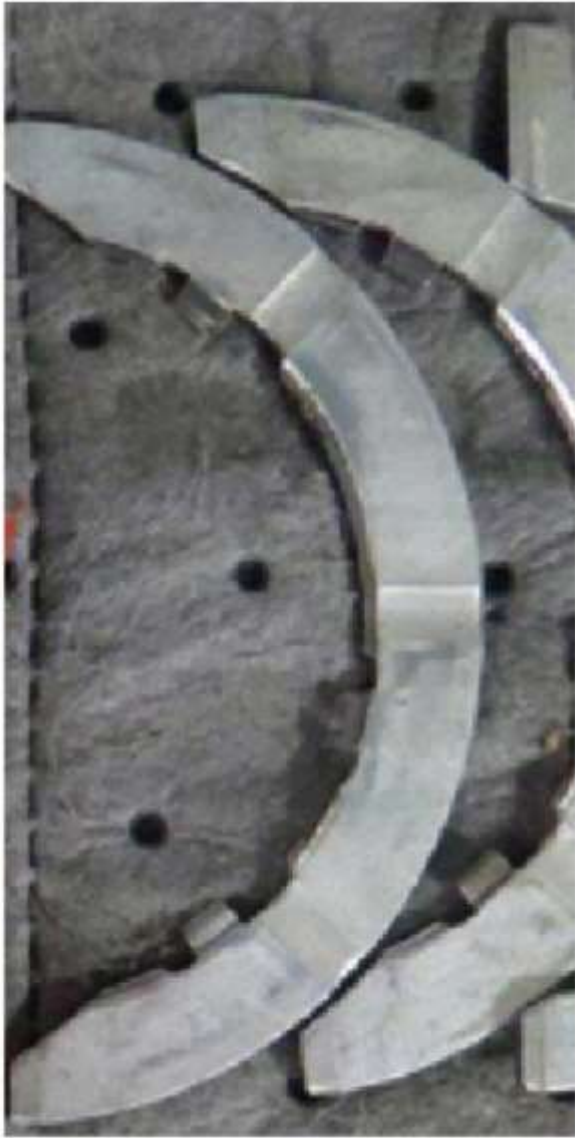
Bearings – Normal Wear: Polishing, discoloration, light scoring, light contact with red coating (Figures 19-22).

NOTE: Bearings are designed to manage some debris; therefore, some light scoring found on the bearing surface is not necessarily an indication of engine failure or root cause determination.

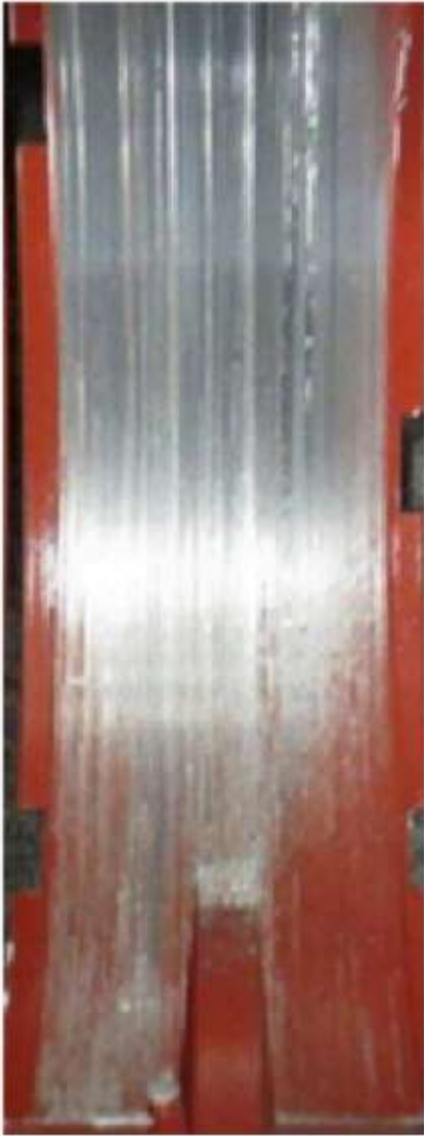
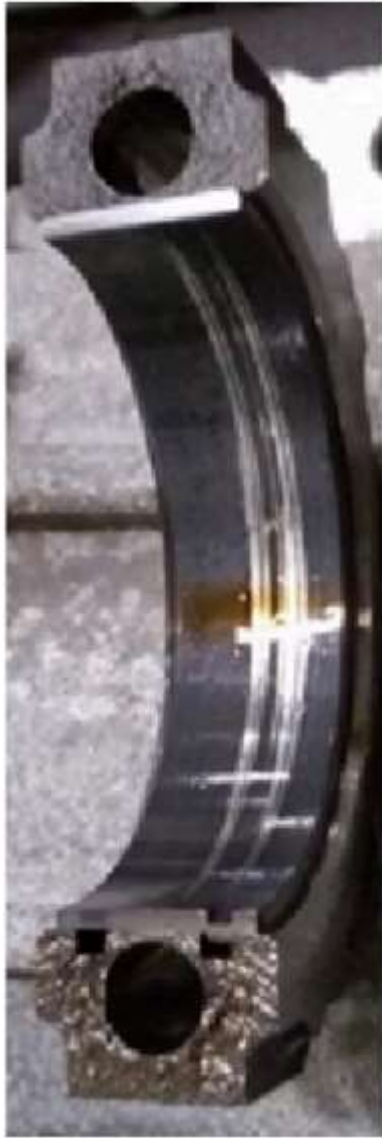
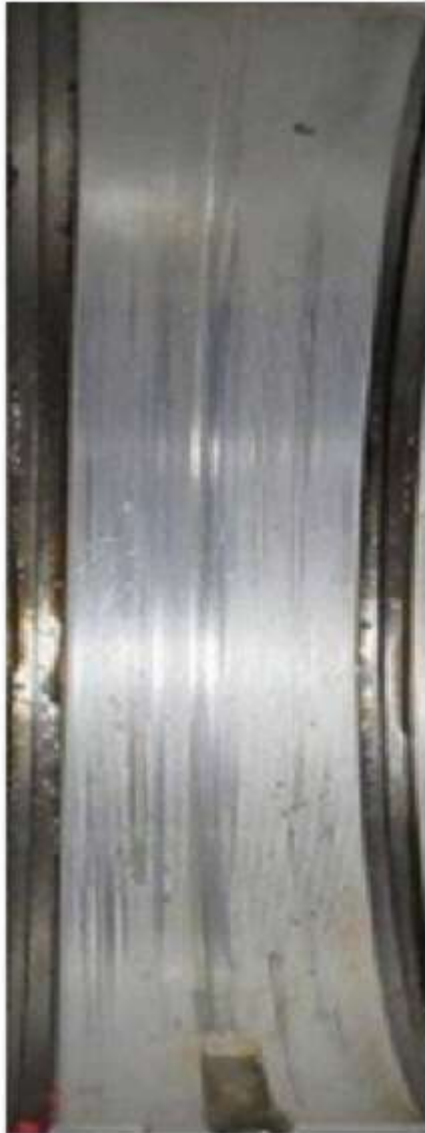
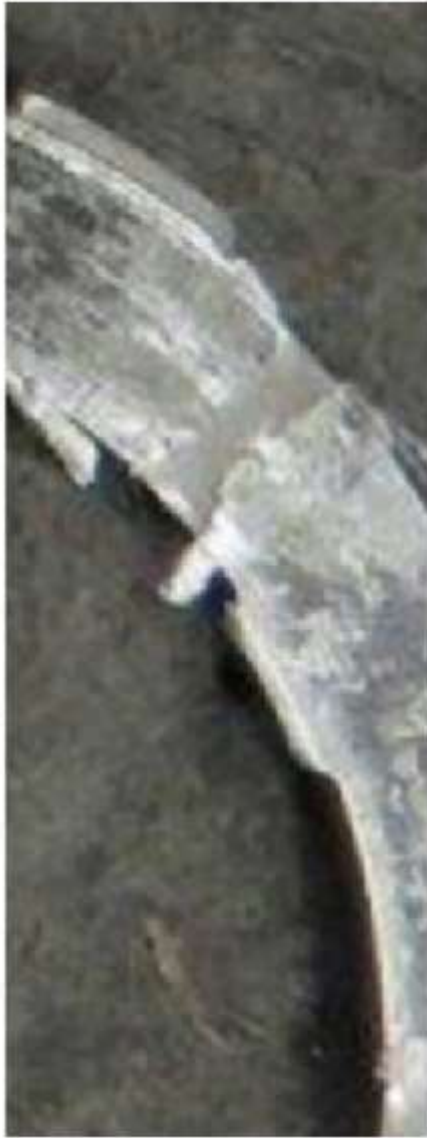
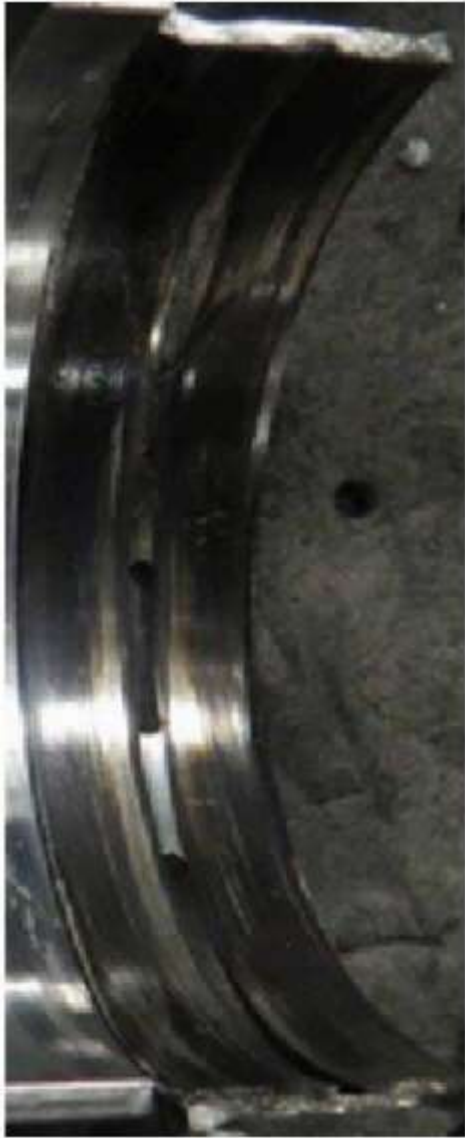
Bearings – Damage: Metal transfer, erosion, material loss, coolant contamination, deep scoring, cracking, spun bearing (Figures 23-27).

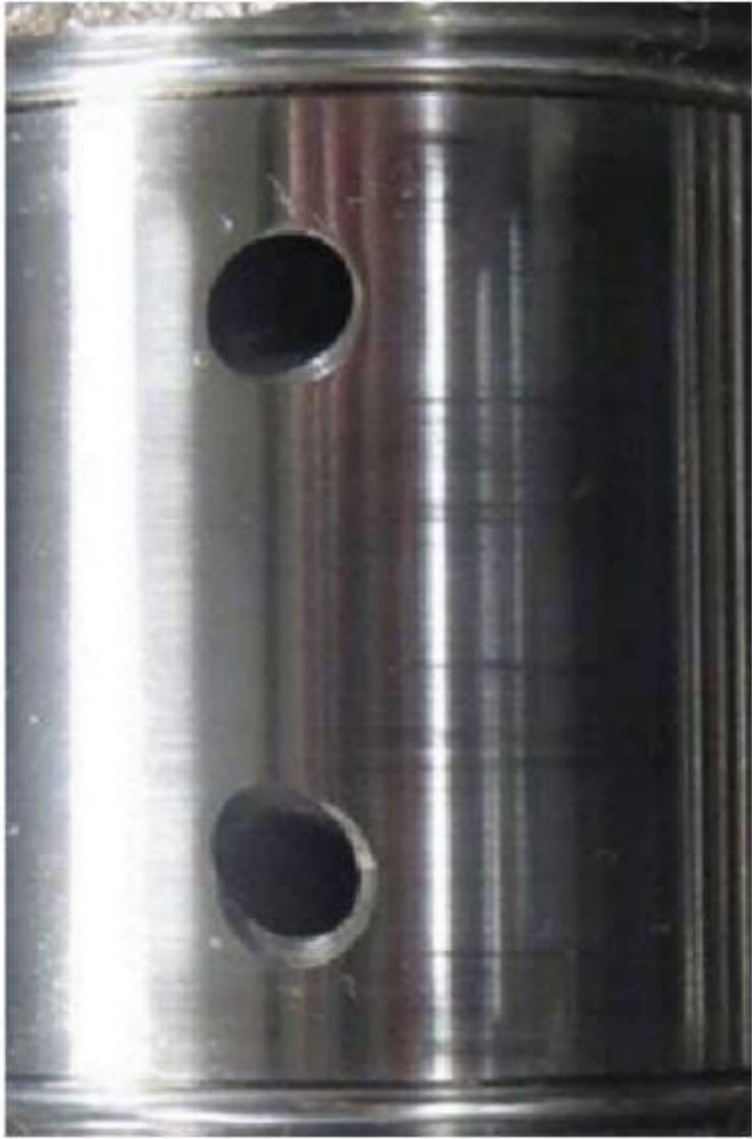
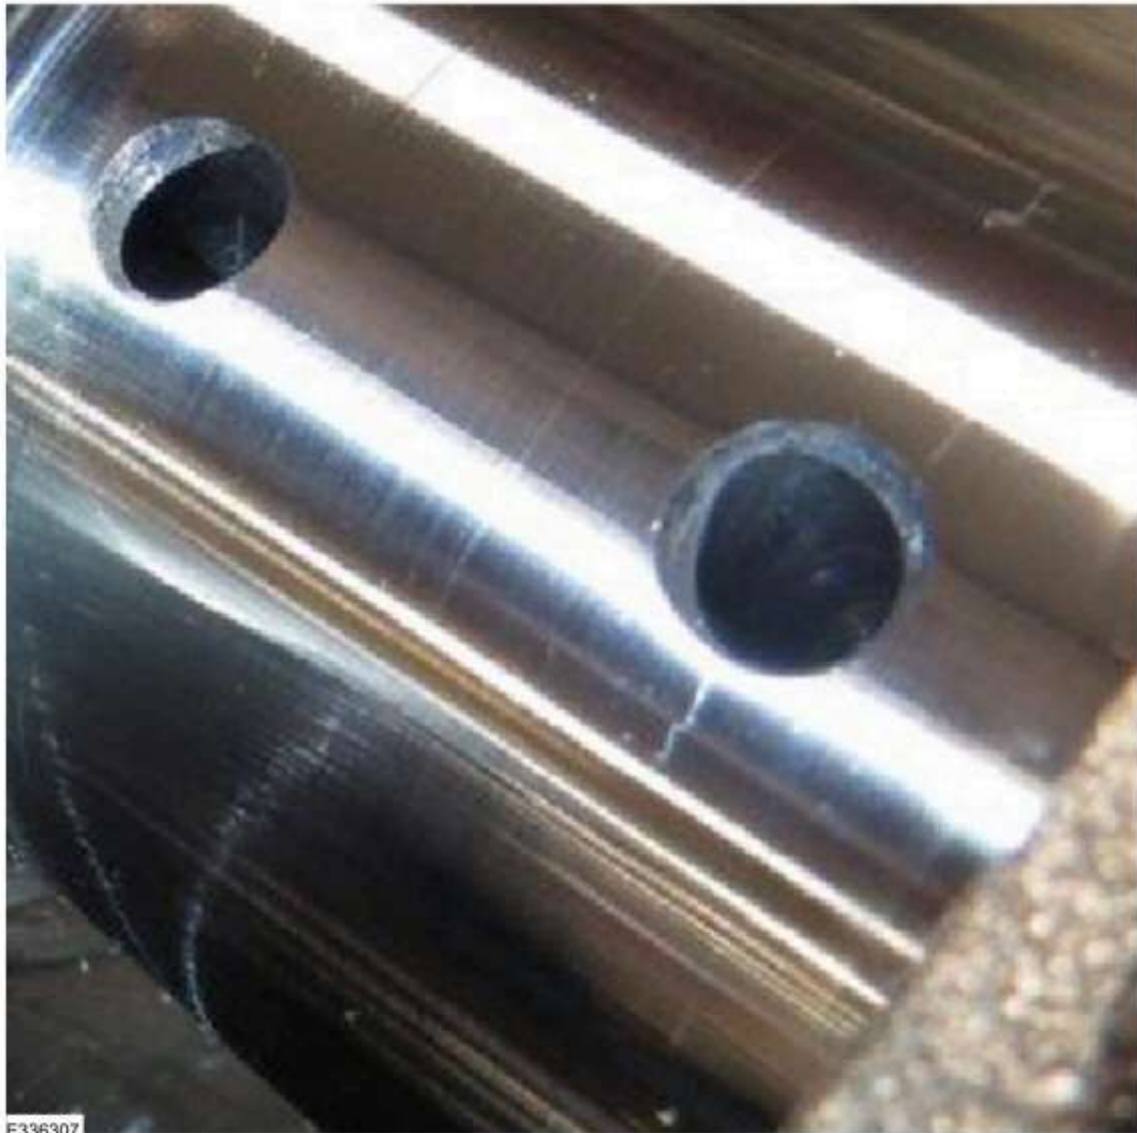
Crankshaft – Normal Wear: Discoloration, polishing, light scratches (Figures 28-29).
