22-7078

GENERAL SERVICE BULLETIN

Various Vehicles - Engine Failure Analysis

This bulletin is a guide to engine failure analysis and preventing repeat engine failure.

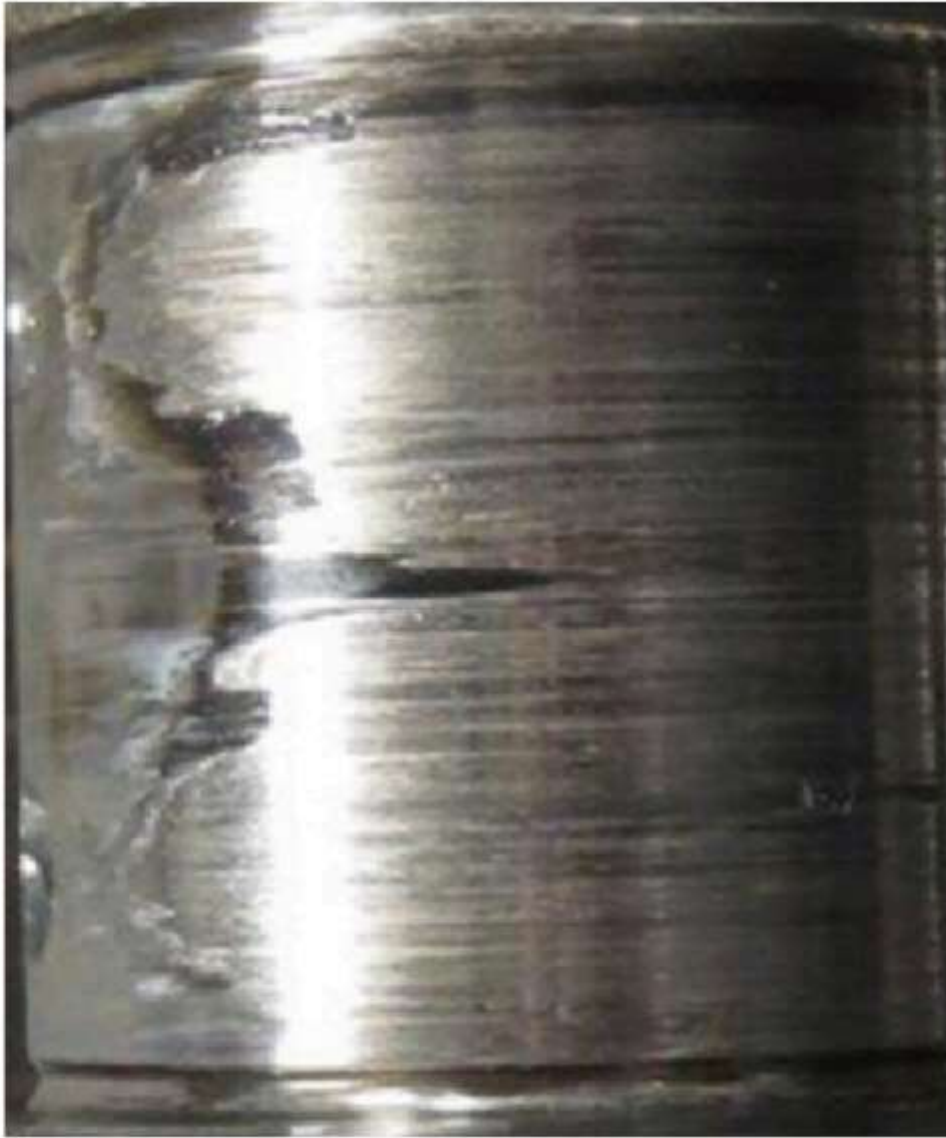
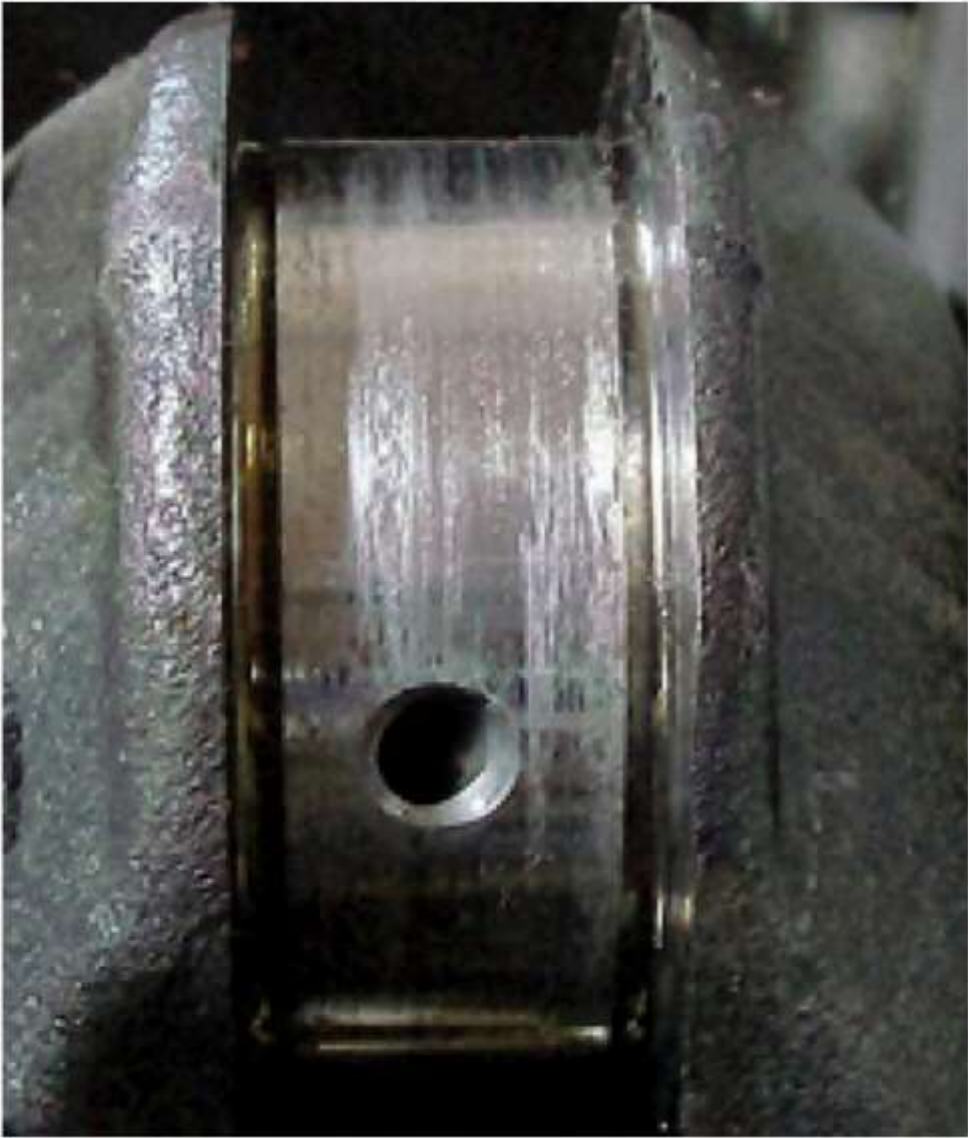
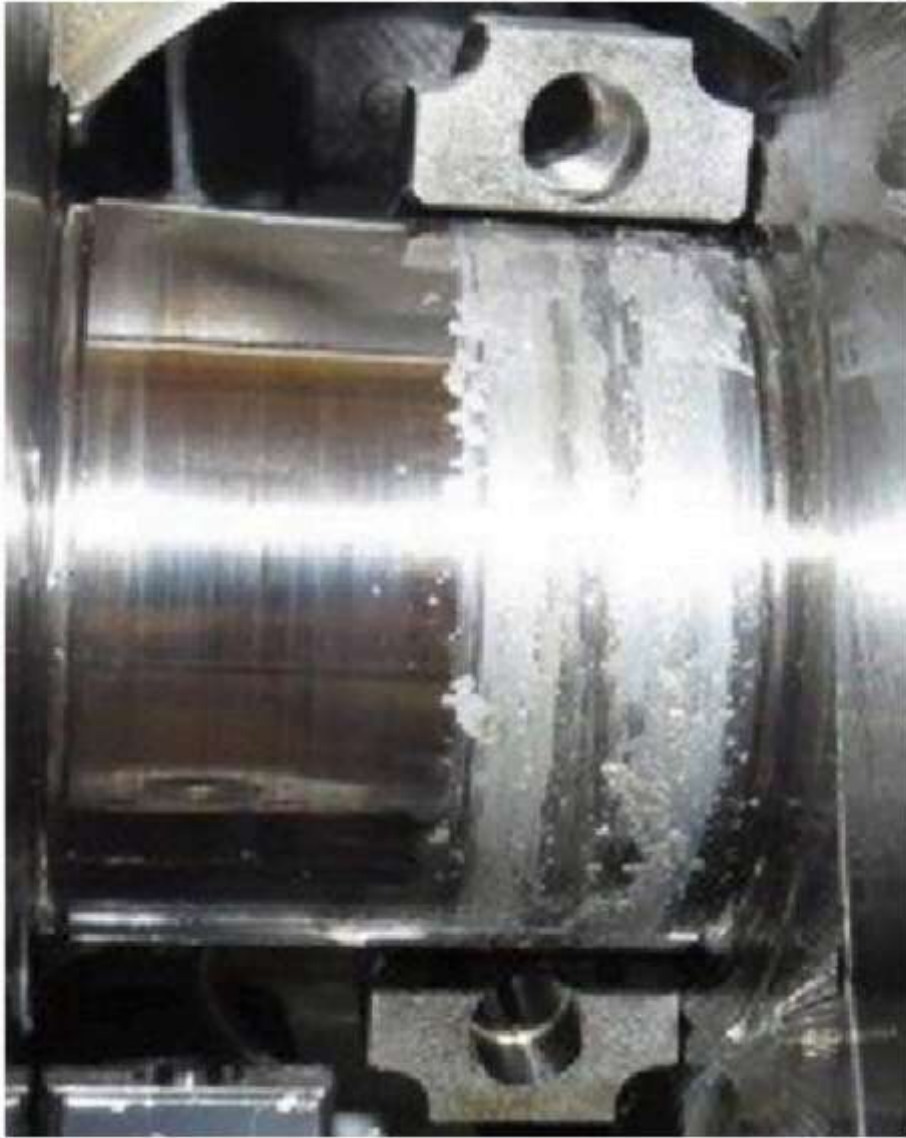
Crankshaft – Damage: Material loss, deep scoring, material transfer (Figures 30-32).

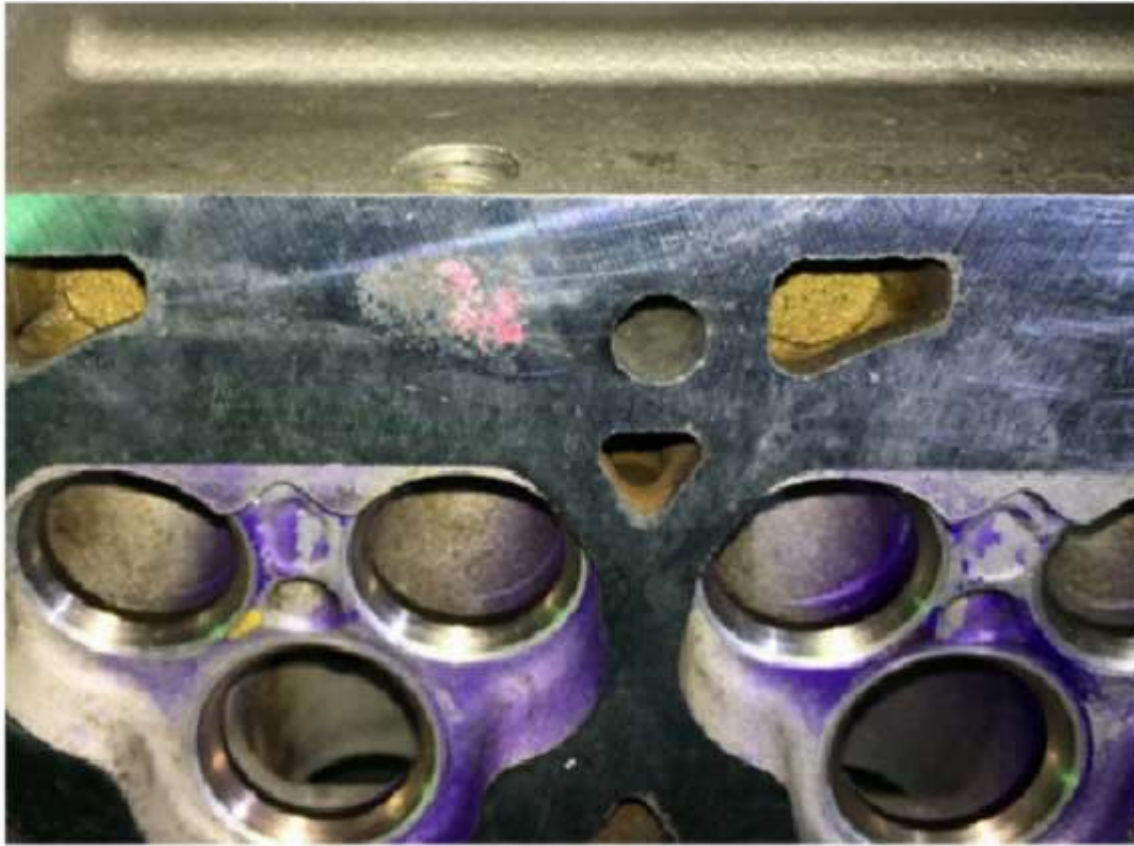
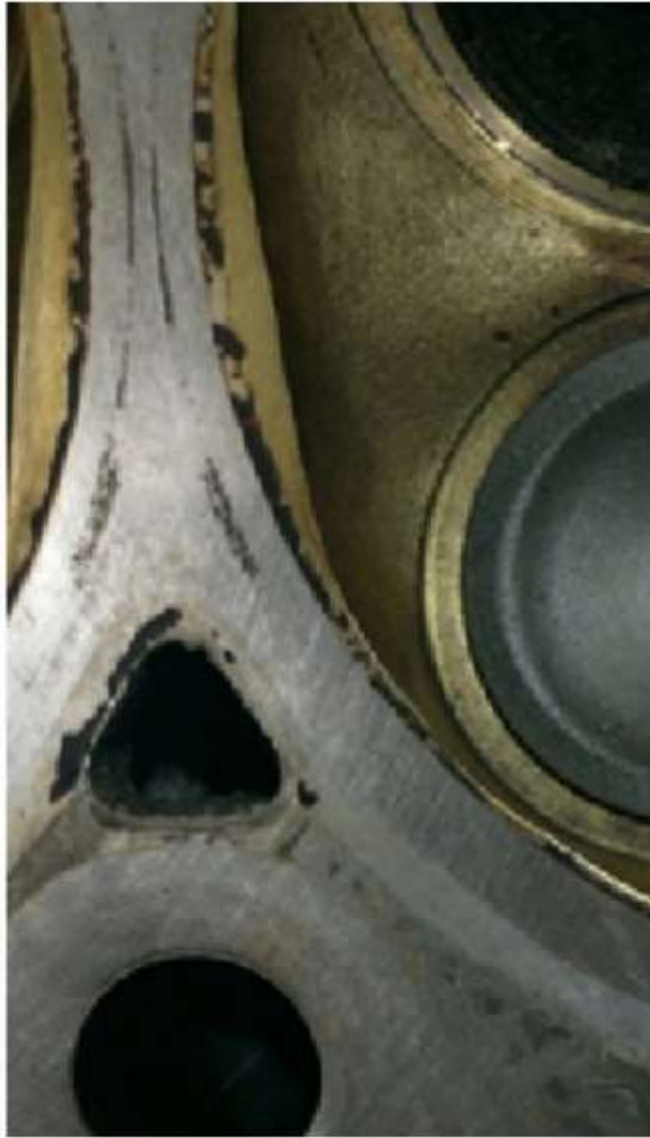
Head and Block Surface – Normal Wear: Porosity outside sealing surfaces, gasket surface discoloration, light scratches (Figures 33-34).

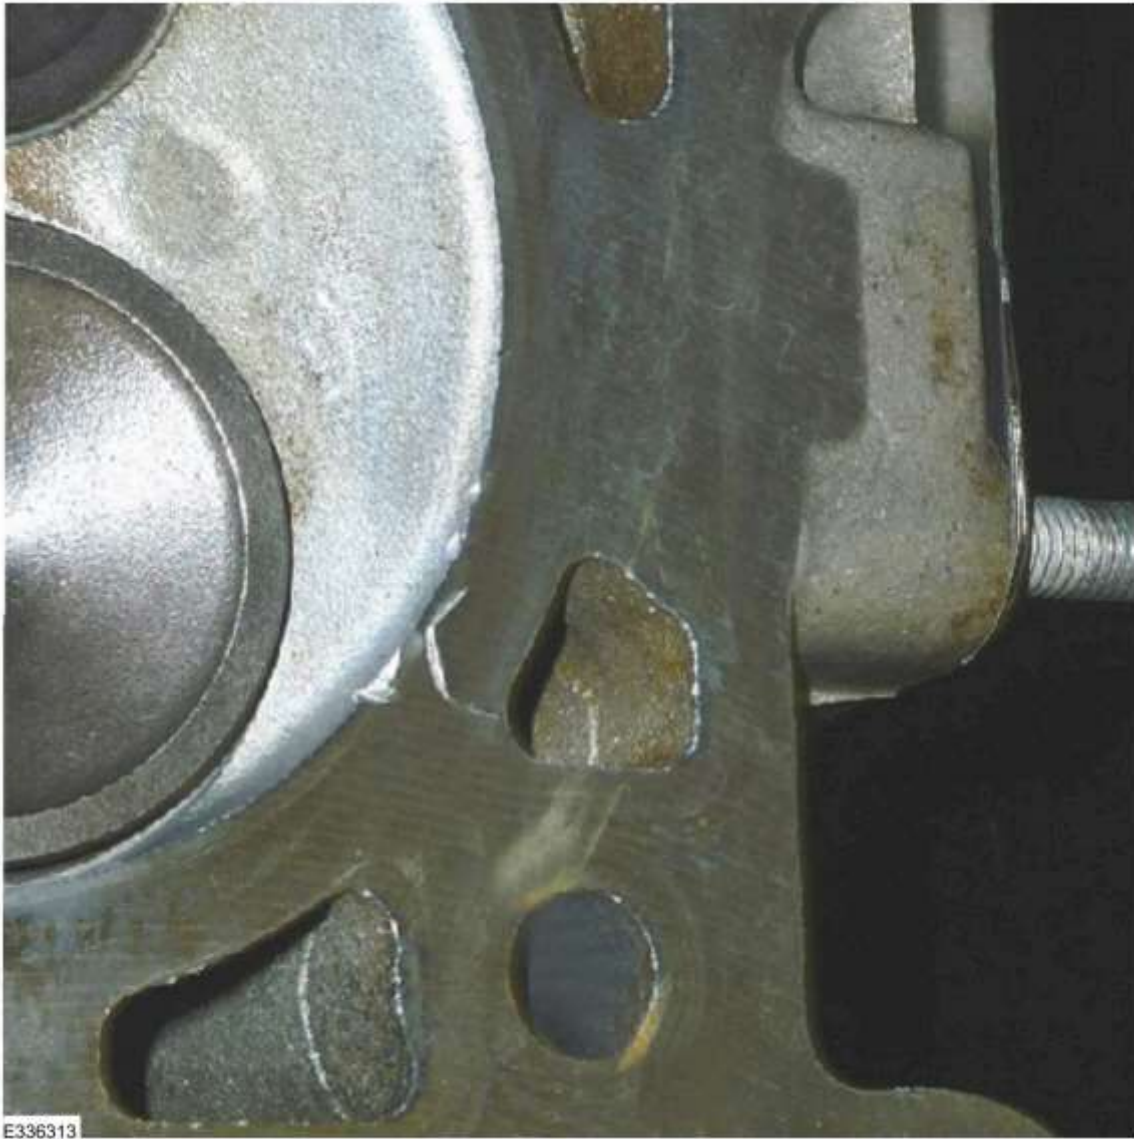
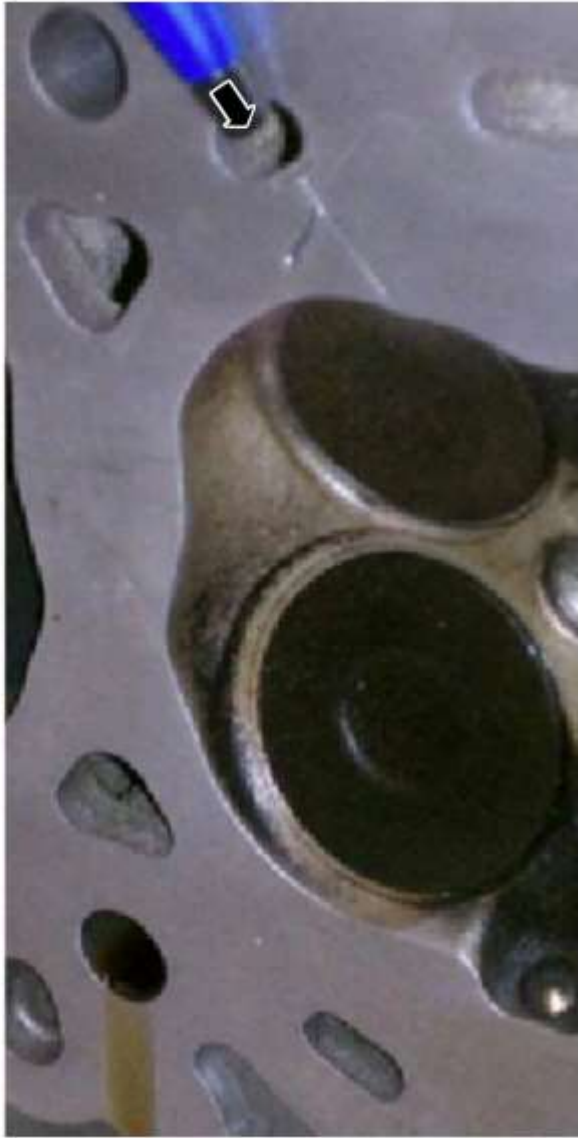
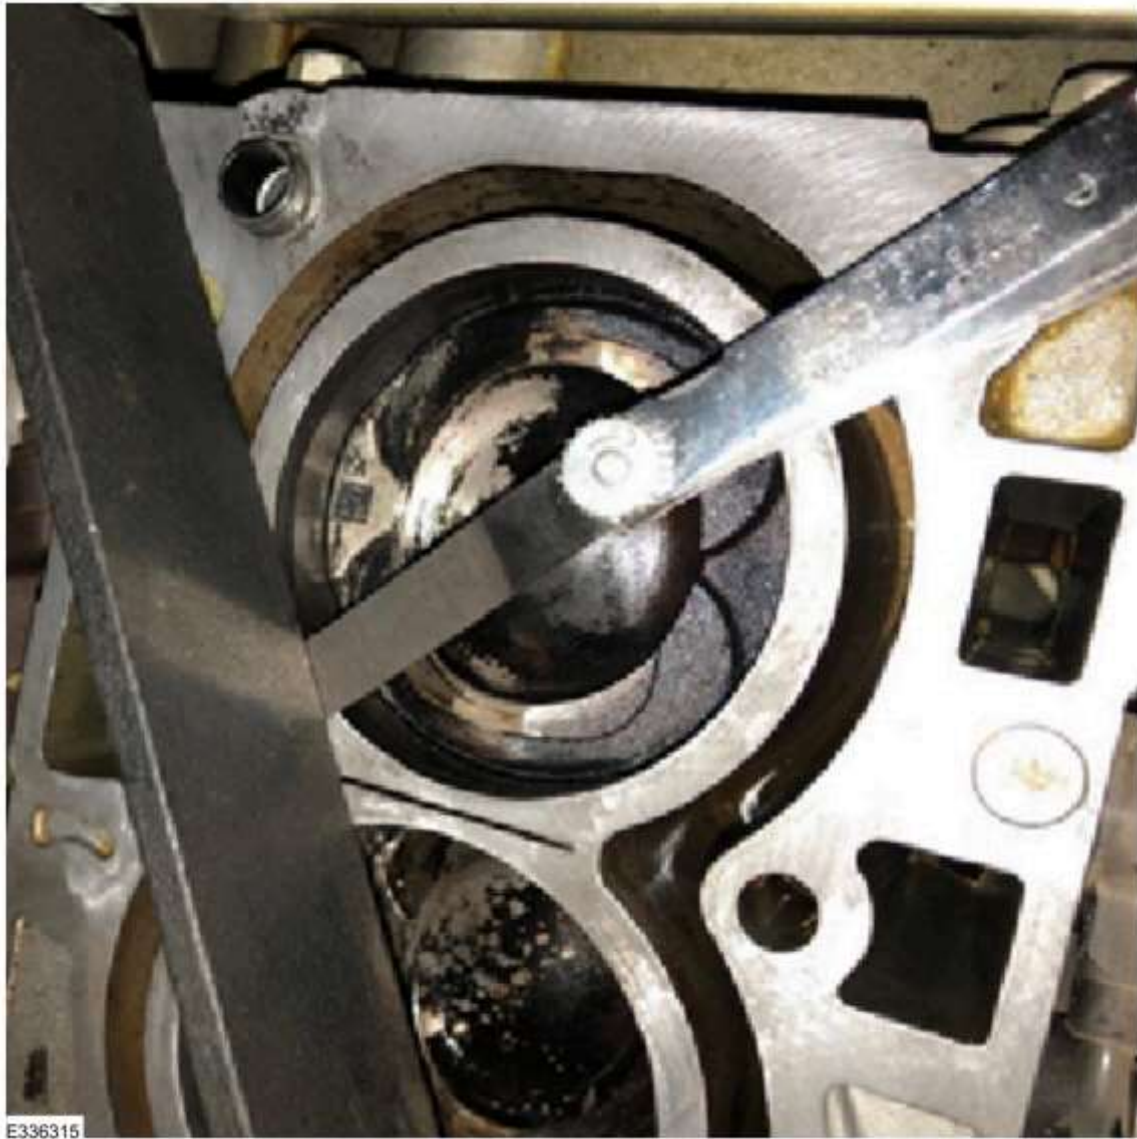
Head and Block Surface – Damage: Porosity on sealing surfaces, deep gouges, material transfer, warpage (Figures 35-37).

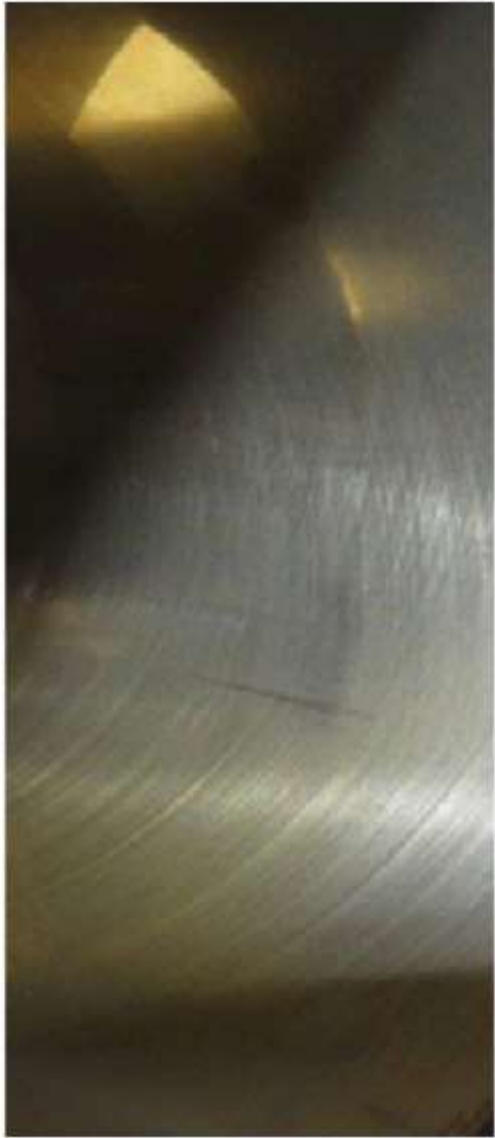
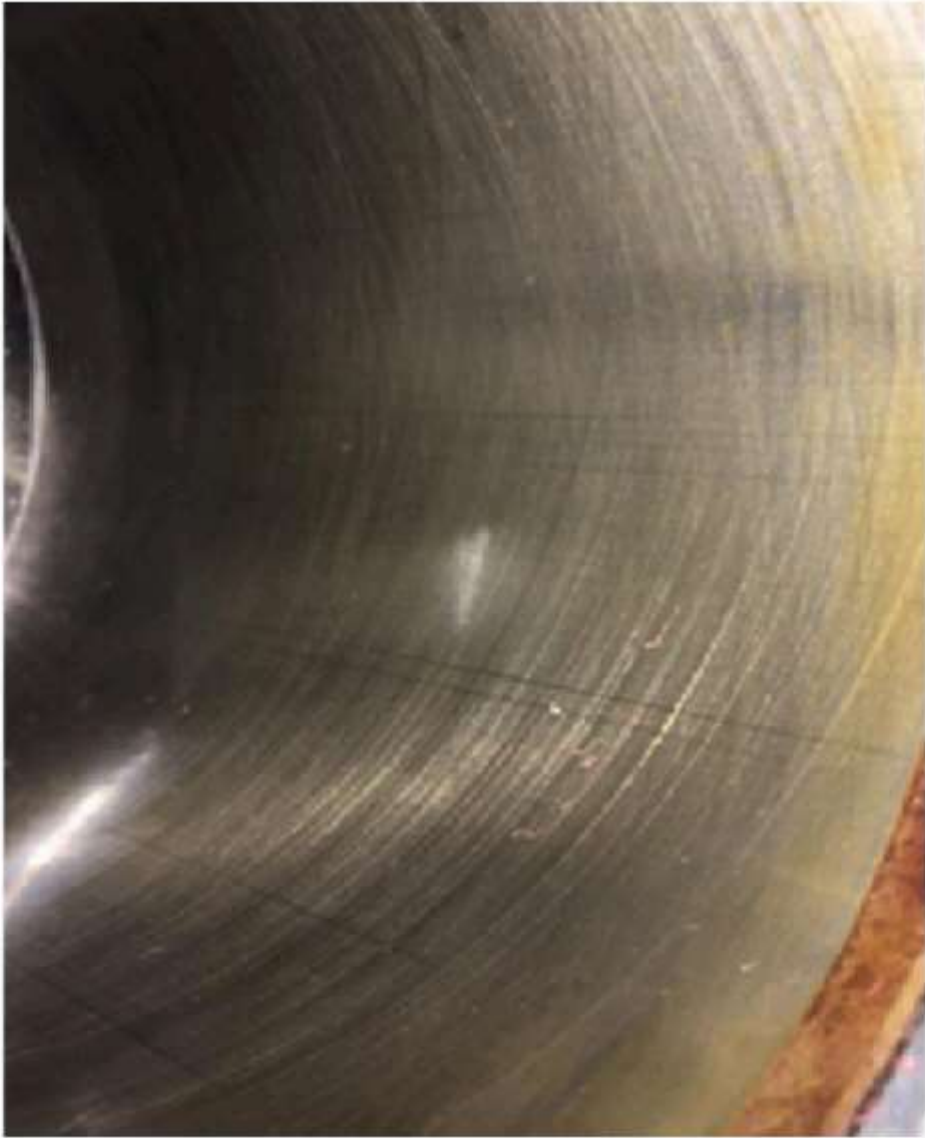
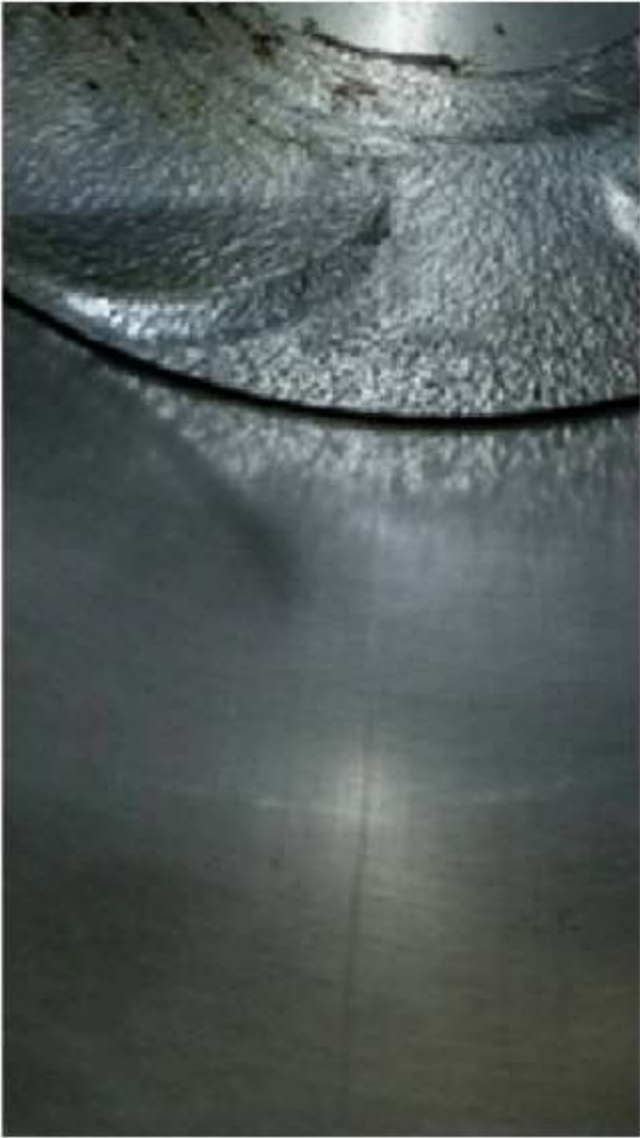
Cylinder Wall – Normal Wear: Slight polishing and/or discoloration, vertical streaking, slight scoring, cross hatch present, light staining (Figures 38-40).

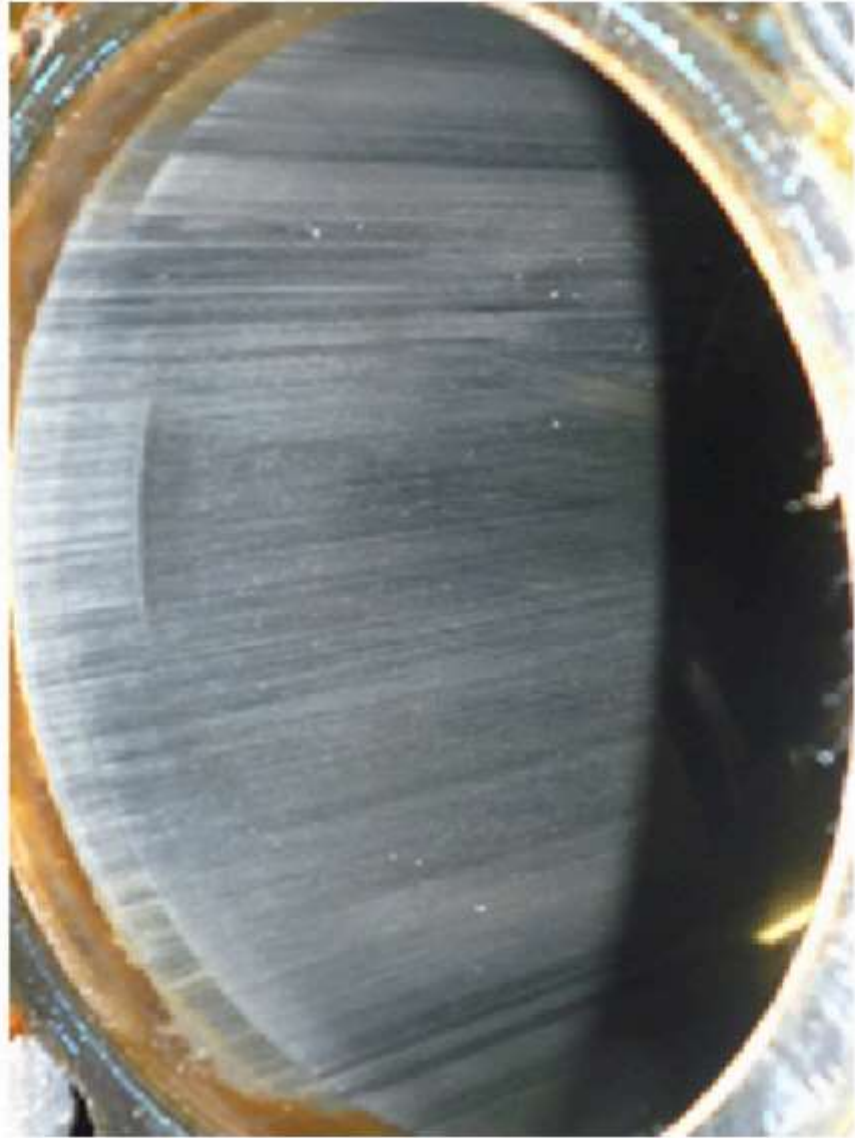
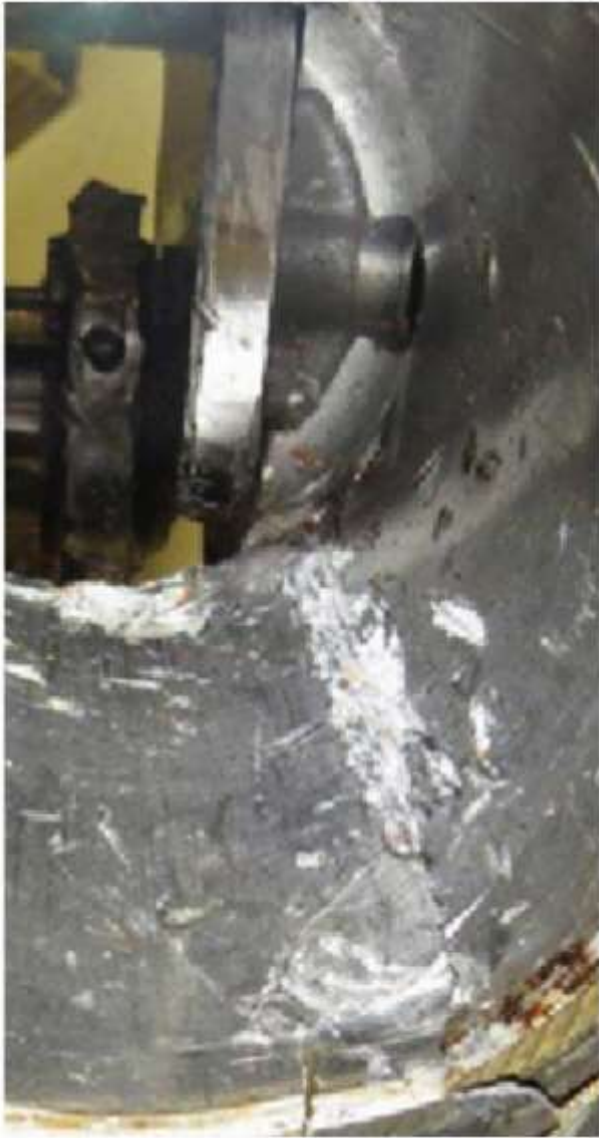
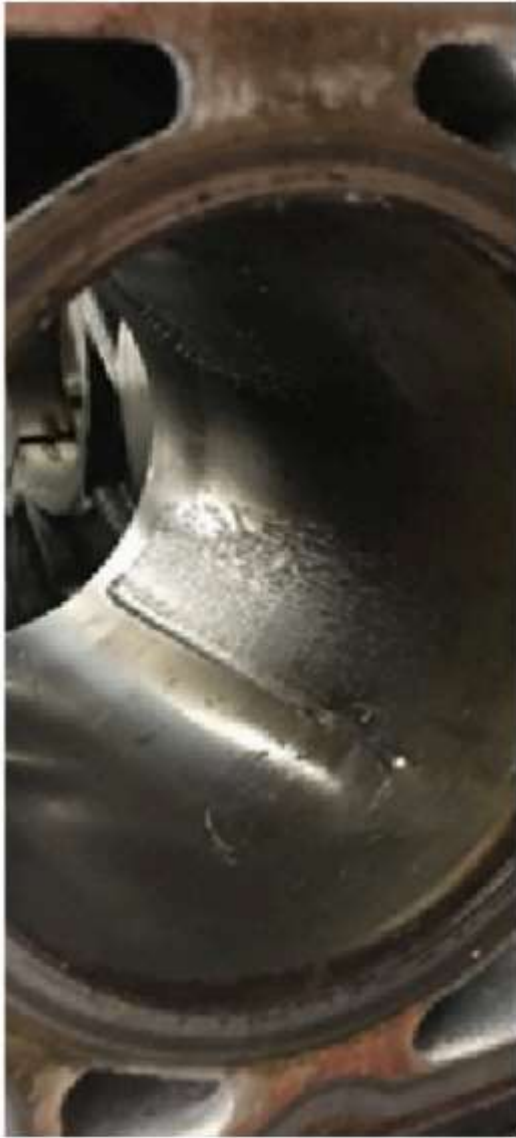
Cylinder Wall – Damage: Deep gouging, impact marks, loss of crosshatch, cracks (Figures 41-43).

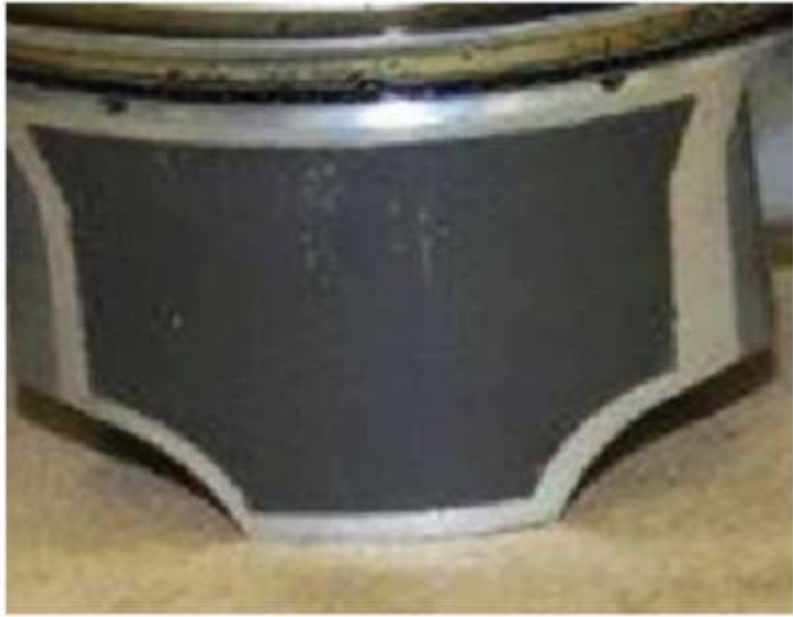
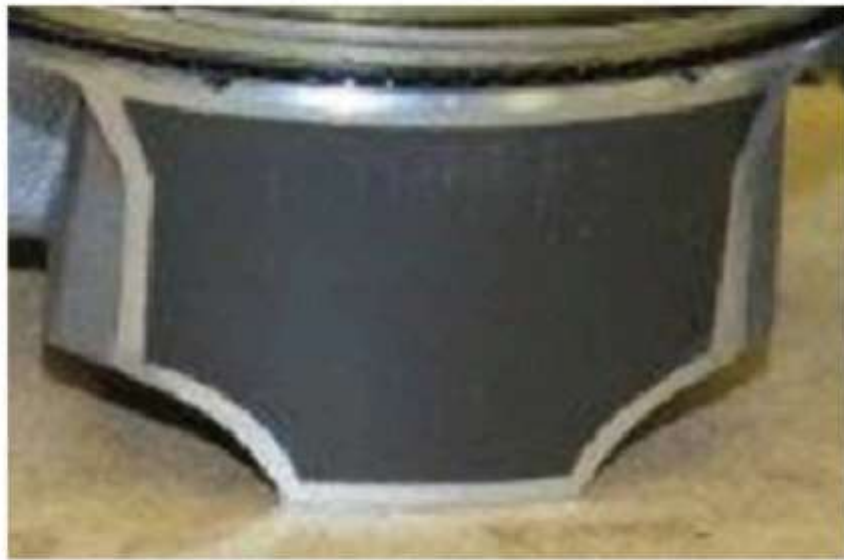
Piston Skirt – Normal Wear: Light wear of the coating (Figures 44-45).
Figure 44

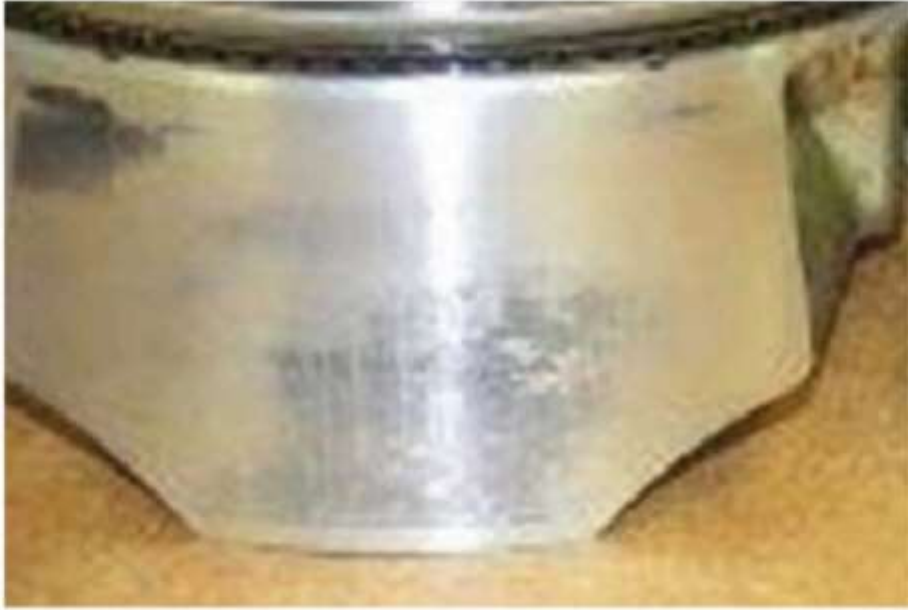
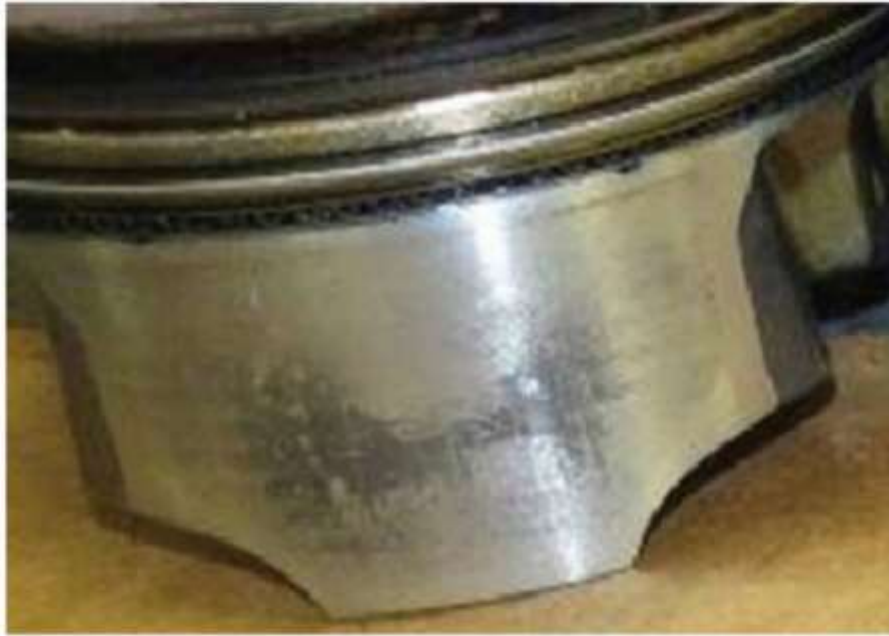
Piston Skirt – Damage: Deep scoring, severe coating wear (Figure 46-47).

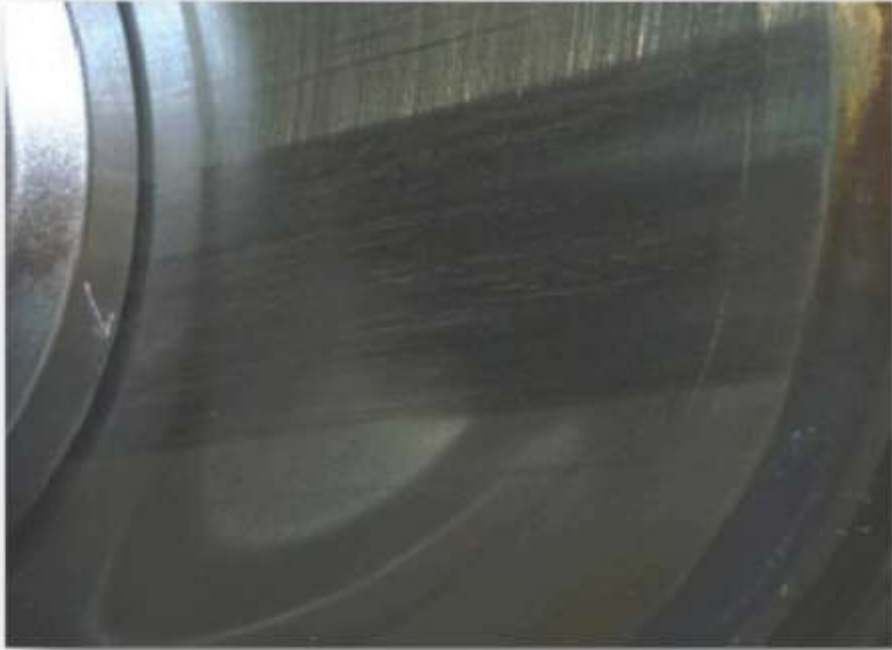
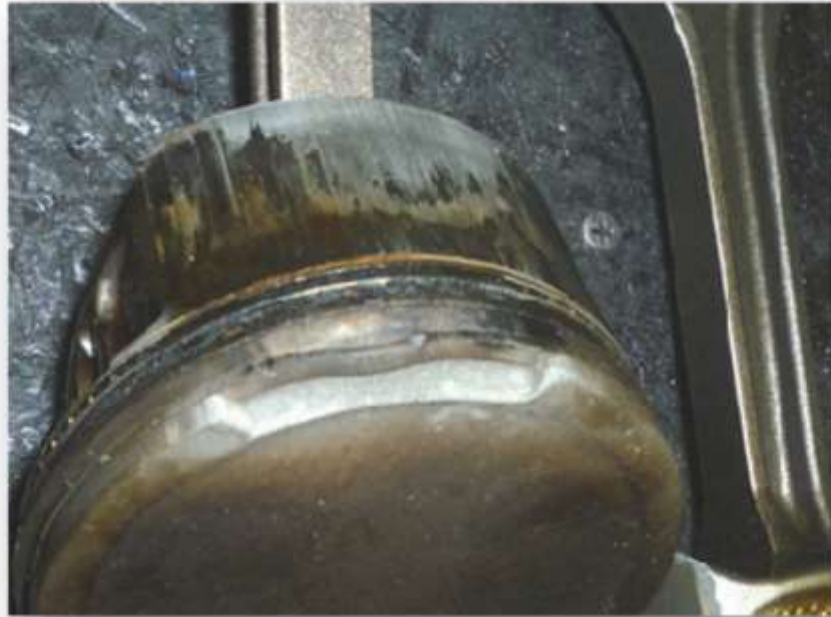
Root Cause: Lean conditions or modifications (Figures 48-49)

- Modifications (timing, CNG, incorrect spark plugs)
 - Overboost (supercharger/turbocharger)
 - PCM performance chip/programmer
- Lean conditions
 - Mass air flow (MAF) sensor failure
 - Damaged air intake

Effect: High cylinder pressure or spark knock

- Excessive combustion temperatures
- Excessive cylinder pressure
- Pre-ignition
- Excessive levels of detonation (low octane/poor fuel quality)

Damage: Piston and cylinder wall

- Spark plug electrode damage
- Hole in piston (pre-ignition)
- Piston ring land damage (detonation)

- Pitted piston face
- Cylinder wall scoring

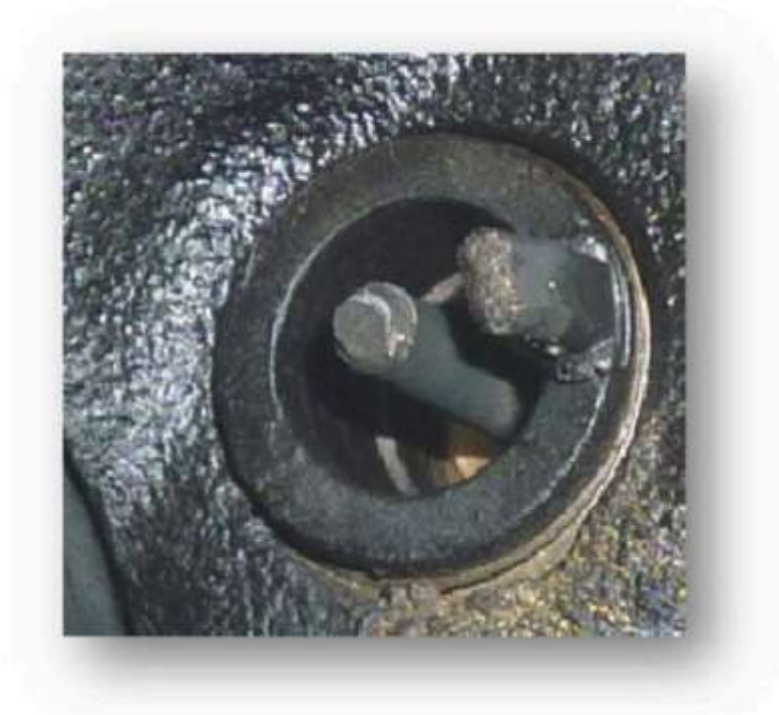
Figure 50

Spark plug damage (porcelain fracture or melted electrode) is an indication of excess detonation (Figure 50)

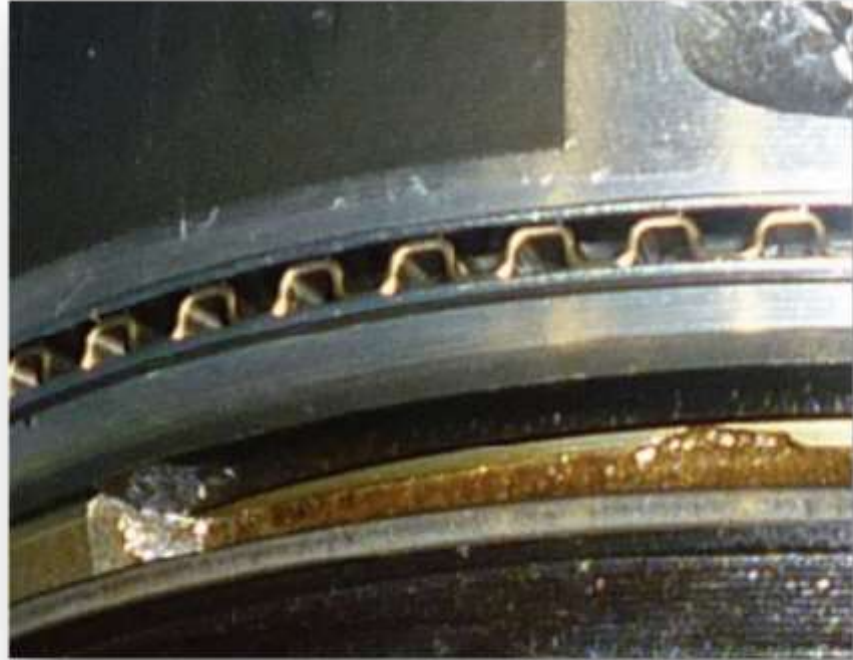
Figure 52

Excess detonation causes excess cylinder pressure spikes leading to piston ring land fractures (second ring land is damaged). (Figure 52)

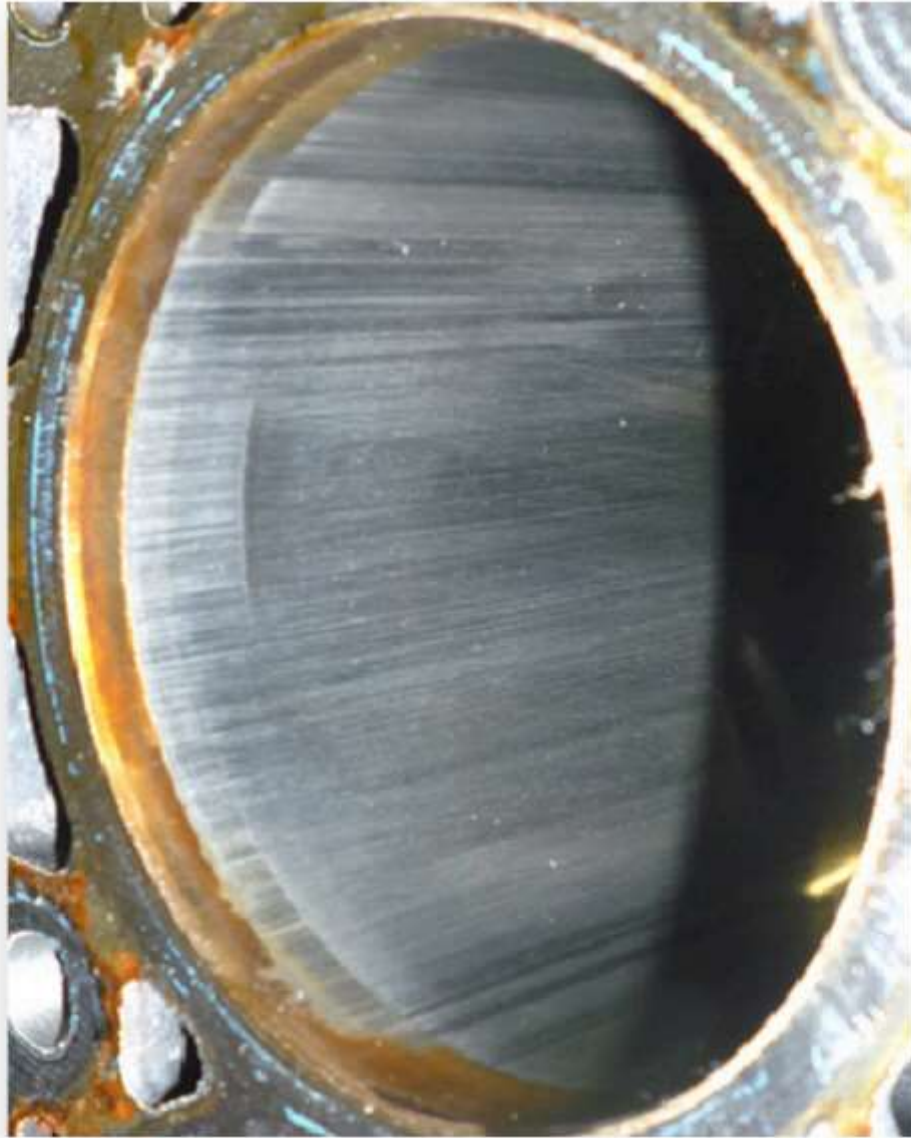
Figure 53

Cylinder Wall Damage (Figure 53)

Root Cause: Fuel/air mixture concerns

- Excess oil consumption
- Lean/rich conditions
- Cylinder misfire

Effect: Catalyst damage

- Catalyst material begins to deteriorate (turns to dust/sand)

- Catalyst material is pulled into the engine

Damage: Cylinder wall

- Cross hatch is polished away
- Vertical scoring
- Bearing damage may be present if catalyst material made it to the engine oil.

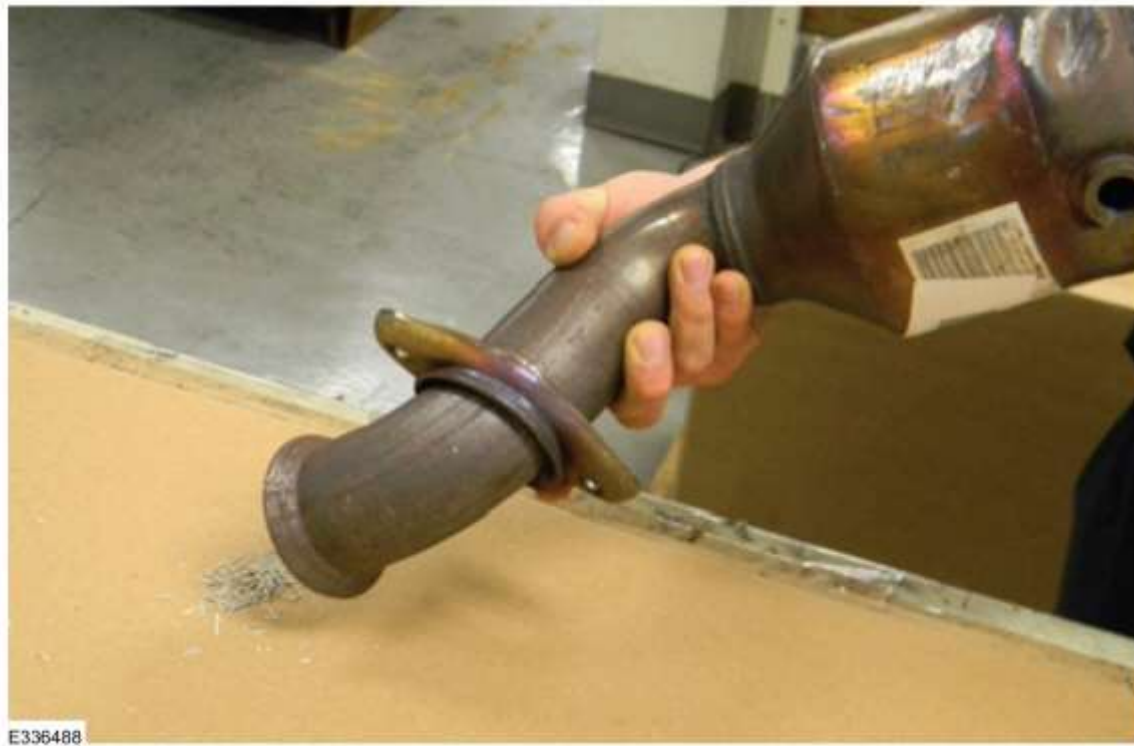
Figure 54

Check for catalyst debris by shaking out the converter onto a clean surface (Figure 54)

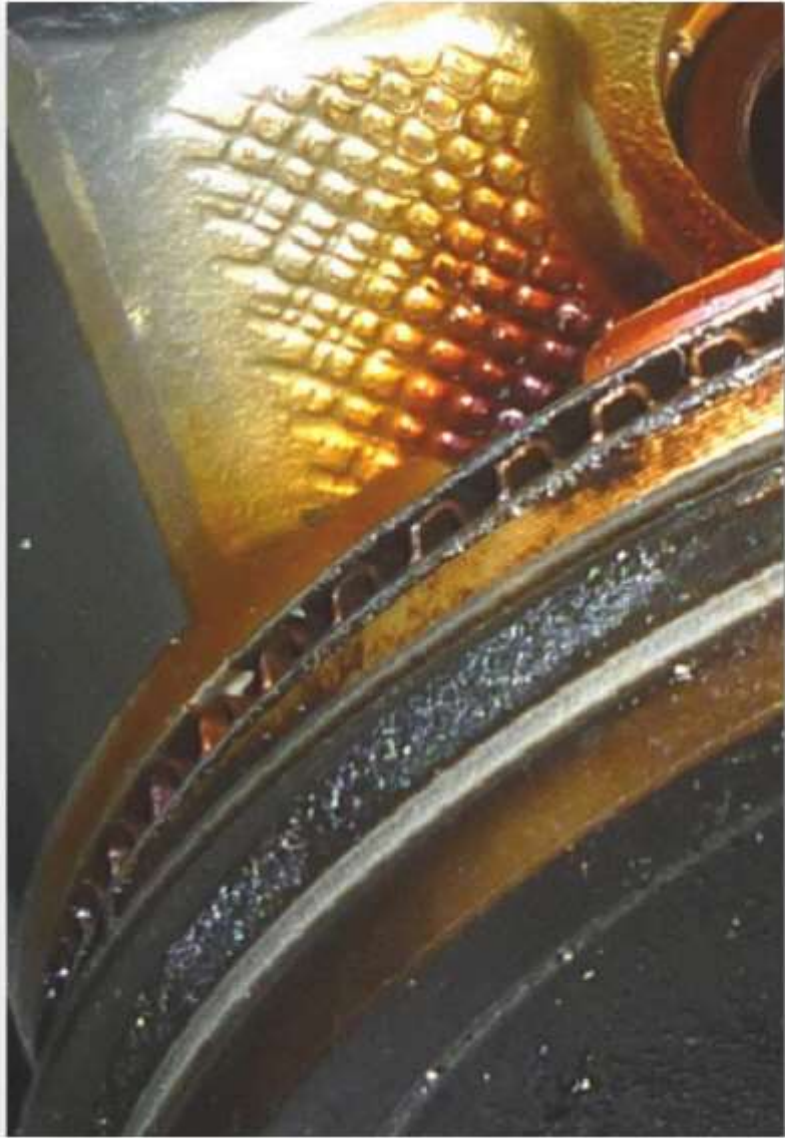
Figure 55

Catalyst material can collect on the sides of the piston damaging cylinder wall surfaces (Figure 55)

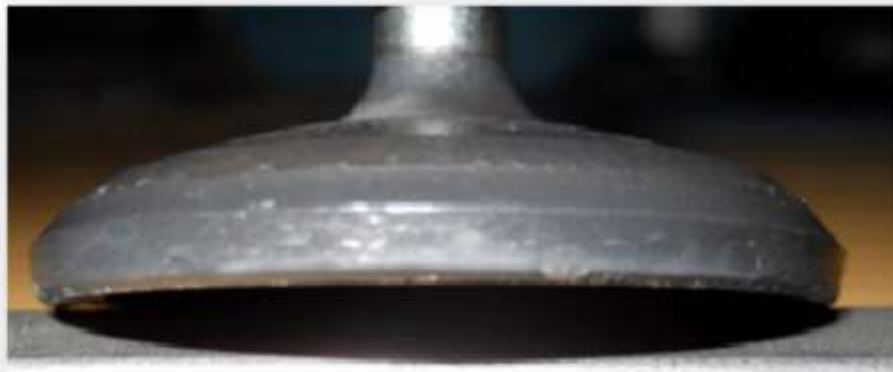
Valve Damage (Figures 56-57)

Root Cause: Lean condition

- Modification or damage to the air induction system

- MAF sensor damage/failure
- Lack of fuel to the cylinder

Effect: Excessive combustion chamber temperatures

- Misfire, lacks power
- Catalyst damage
- Running lean = hot cylinder

Damage: Valve and valve seat

- Valve tuliping
- Valve seat recession

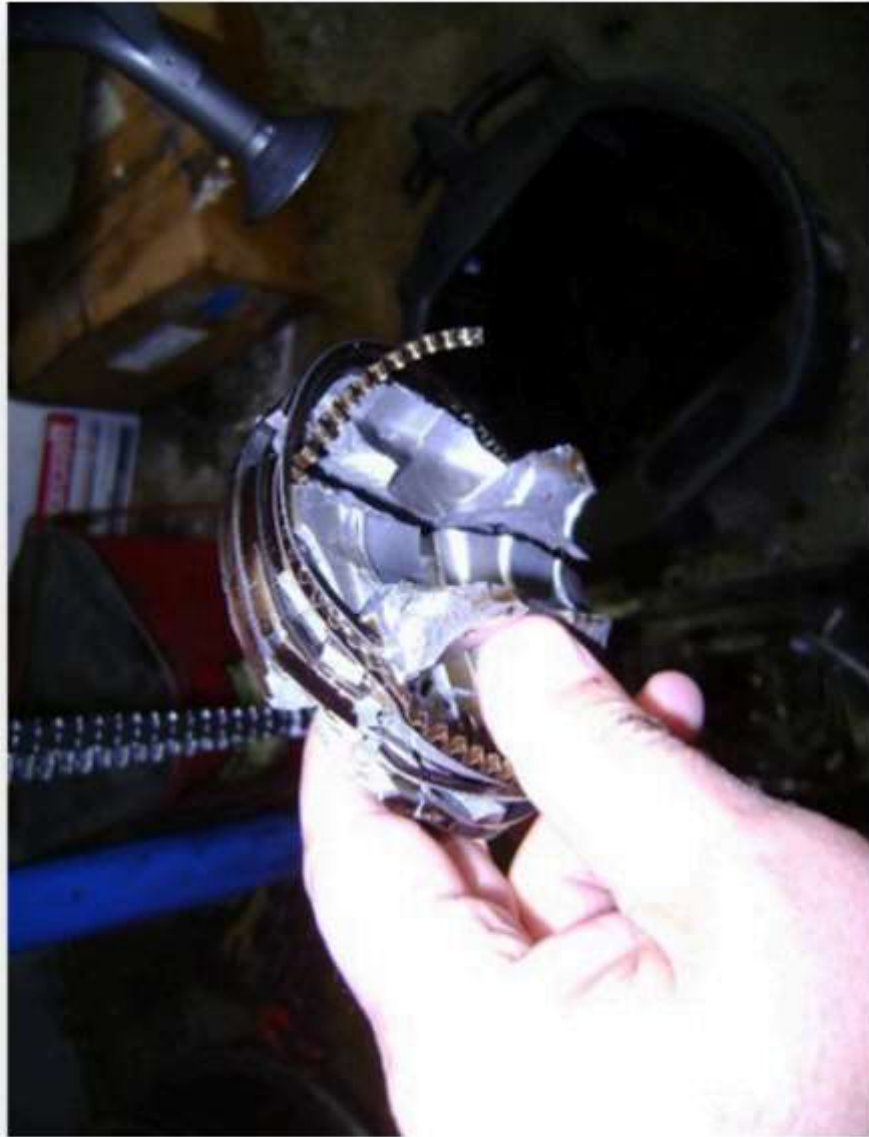
Figure 59

Foreign Object Debris (Figure 59)

Root Cause: Combustion chamber damage

- Broken piston/rings
- Broken valves
- Dropped valve seats

Effect: Debris transfer

- Original intake manifold transferred to the new engine
- Intake manifolds cannot be cleaned in these instances and require replacement

Damage: Repeat engine failure

- Engine vacuum dislodges debris left in the manifold
- Debris will enter the combustion chamber and cause piston/cylinder damage
