22-7078

GENERAL SERVICE BULLETIN

Various Vehicles - Engine Failure Analysis

This bulletin is a guide to engine failure analysis and preventing repeat engine failure.

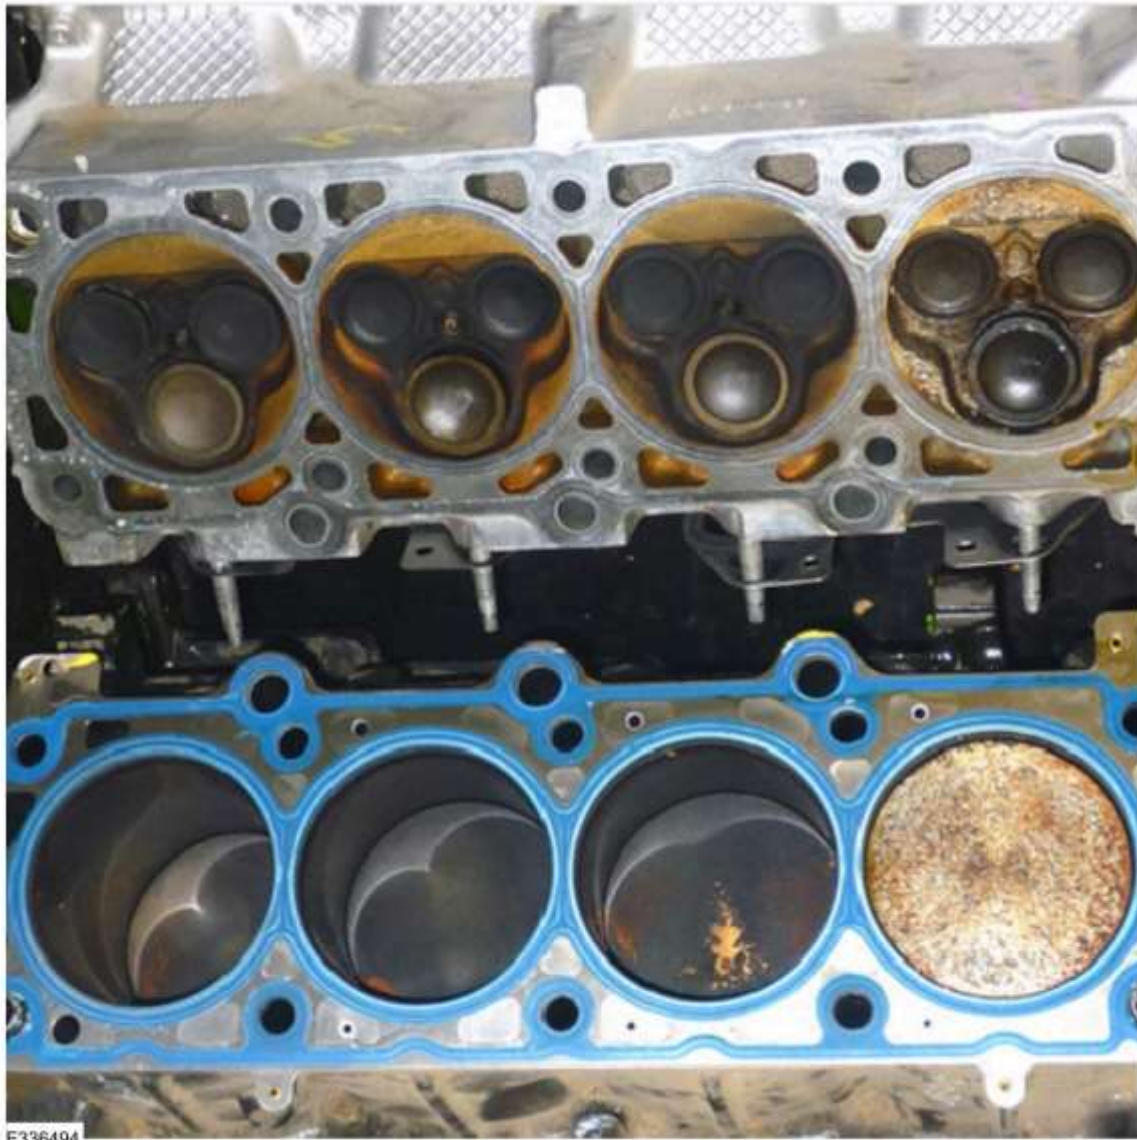
Figure 60

- Foreign object debris can cause metal transfer from the piston to the cylinder head
- This metal debris can also make it to the intake manifold
- The intake manifold must be replaced in these instances to prevent repeat damage

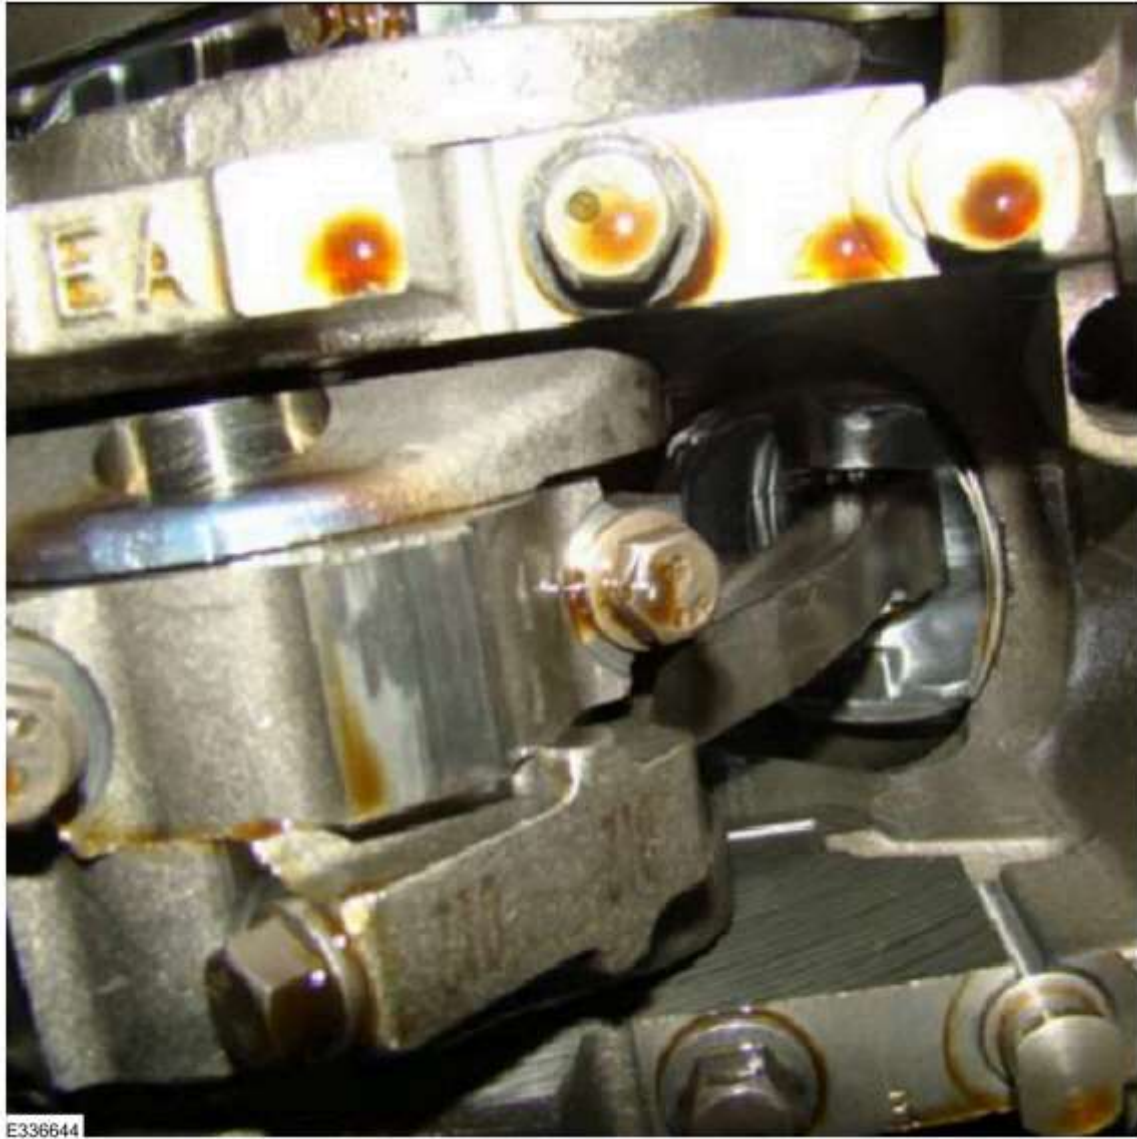
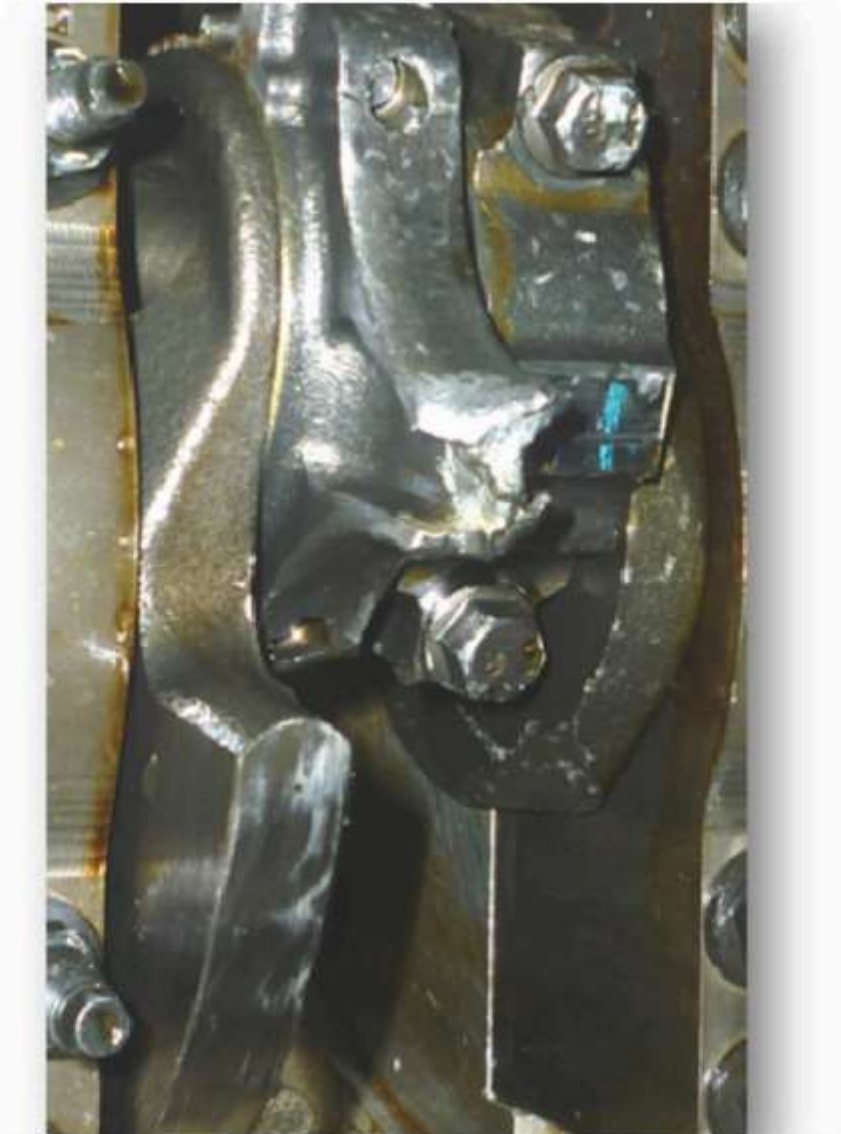
- Since fluids cannot be compressed, the connecting rod typically suffers from a hydrolock event.
