ORIGINAL CREATION DATE:	08/30/2023
REVISION DATE:	09/11/2023
SUBJECT:	400V E2Ver1 Body and ESM Software Update
RATIONALE:	Updates to vehicle response when certain fault codes associated with battery pack liquid accumulation and/or a thermal event are detected.
VINs or MODELS AFFECTED:	Service Specified Buses
COMPLETE BY:	Earliest Service Opportunity
SERVICE CAMPAIGN #:	SC-23-126
NHTSA RECALL NUMBER:	22V887
REMEDY KIT NAME / NUMBER:	065660
ESTIMATED LABOR TIME:	.75
LABOR OP CODE:	HB49V

400V E2Ver1 Body and ESM Software Update

**Proterra – 40 V E2 er1 Bod and ESM Software Update
(Service Campaign SC-2 -126)**

NHTSA ID: 22V8

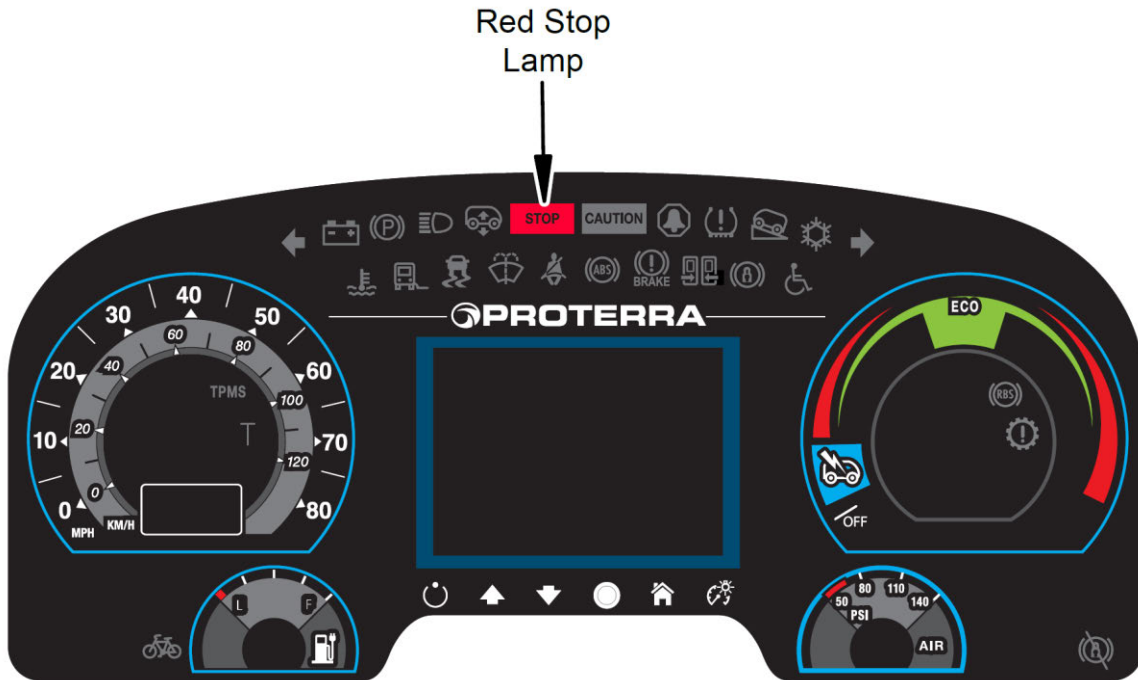
Figure 1 – Red Stop Lamp on Original Dash

Critical battery faults which indicate the potential for a thermal event will result in a Fast Flash Red Stop Lamp in the vehicle dash that blinks at a rate of two times per second, and an audible alarm that pulses twice per second (collectively, the “Critical Battery Fault Warnings”). *Critical Battery Fault Warnings indicate a critical battery failure which could result in a thermal event.* When the Critical Battery Fault Warnings are active, please immediately follow the procedures set forth in the Operator/Driver Guidelines section below, as well as the instructions in any applicable sections of the Proterra Driver’s manual.

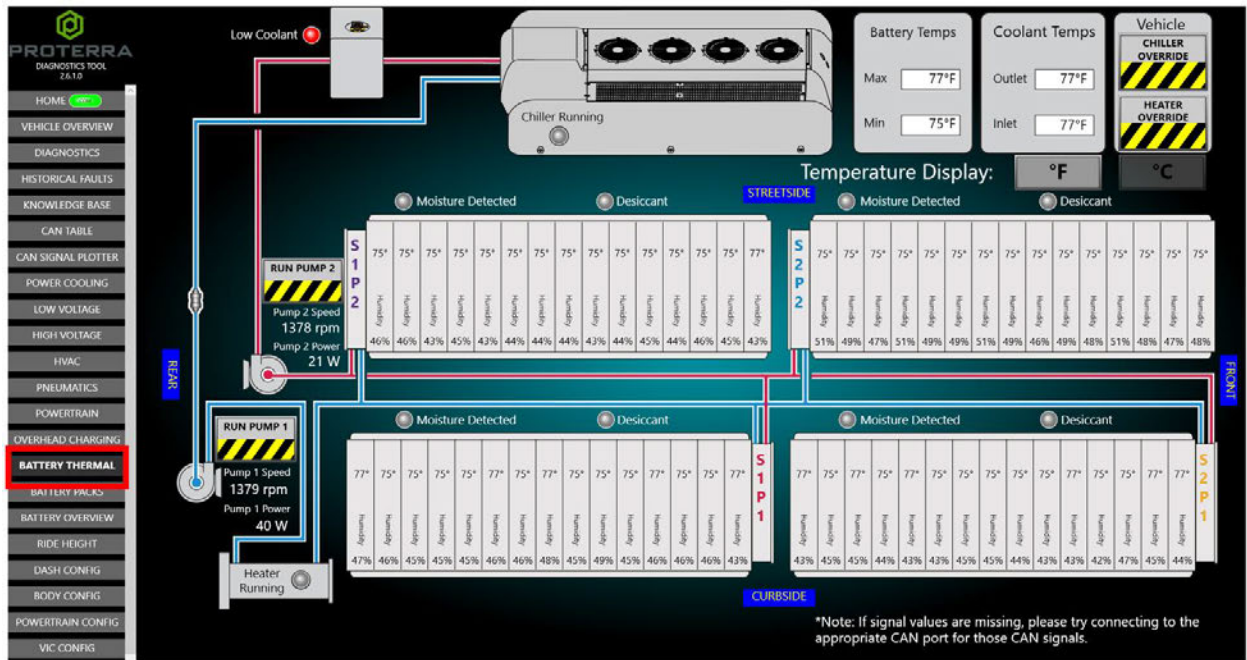
Step 3: View the humidity level of each module per battery pack; the pack ID is located on the graphic of the A-Bay. If the module humidity levels are less than 70%, the battery pack check is complete. If there is one or more module(s) that exceeds 70% humidity, you must proceed to the next step.

- a. Condition 1:
 - Humidity greater than 90%
- b. Condition 2:
 - Humidity greater than 70% AND
 - Internal Isolation less than 20,000 Kohms

The vehicle should be promptly parked in a safe outdoor location at least 20 feet away from other objects such as buildings, trees and other vehicles, and at least 100 feet away from highly flammable items such as gas stations or propane tanks. Once the vehicle has been moved to a safe location, the operator and passengers may exit the vehicle and the vehicle should be removed from service.
