Revised January 2019

Dealer Service Instructions for:

## Safety Recall U11

### Brake Transmission Shift Interlock

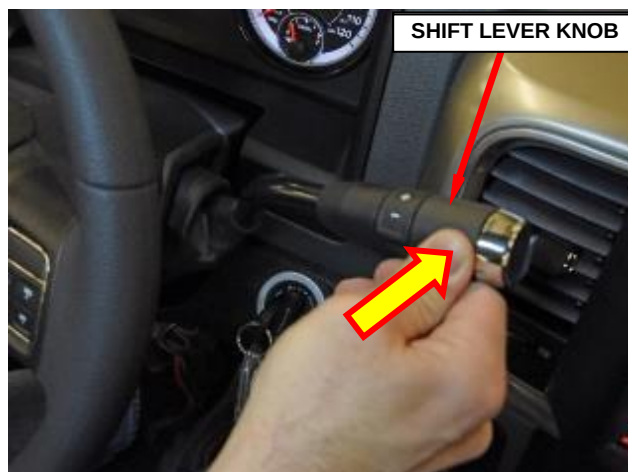
**Figure 1 – Push Lightly On Shift Lever Knob Toward Instrument Panel To Feel BTSI Solenoid Pin Movement**

5. Place your hand on the shift lever knob and push lightly on the shift lever toward the instrument panel. This will allow you to feel a click sensation from BTSI solenoid pin movement when the brake pedal is applied and released (Figure 1).
