## PETITION FOR A DEFECT INVESTIGATION

**SUBJECT:** Petition to commence a defect investigation into catastrophic Power Take-Off Unit (PTU) and Transmission spline failure in 2021–2023 Acura TLX and 2022–2023 Acura MDX vehicles.

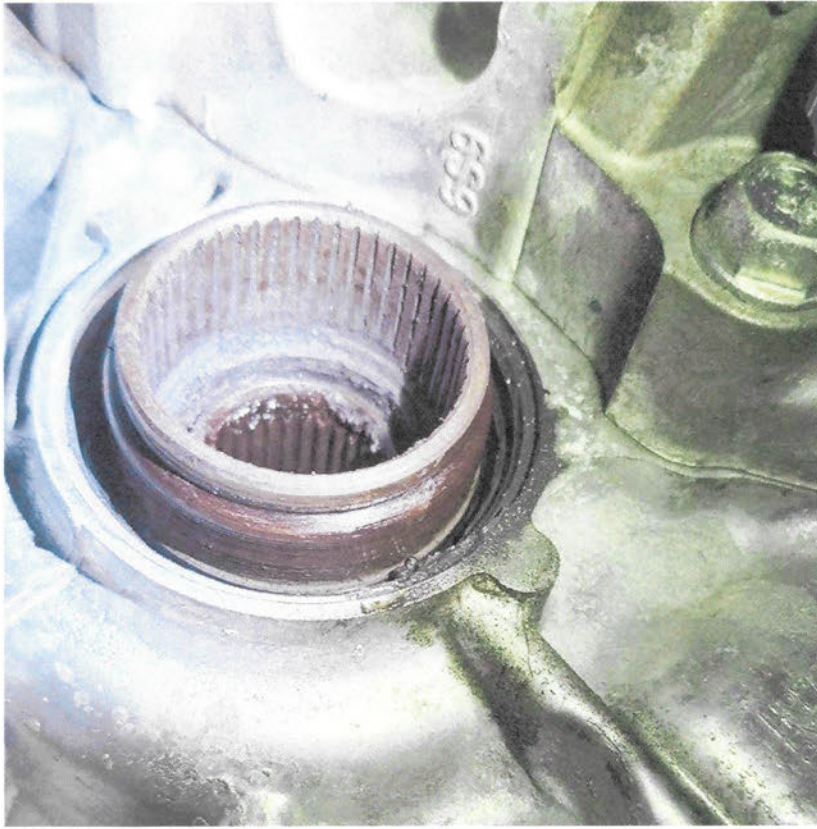
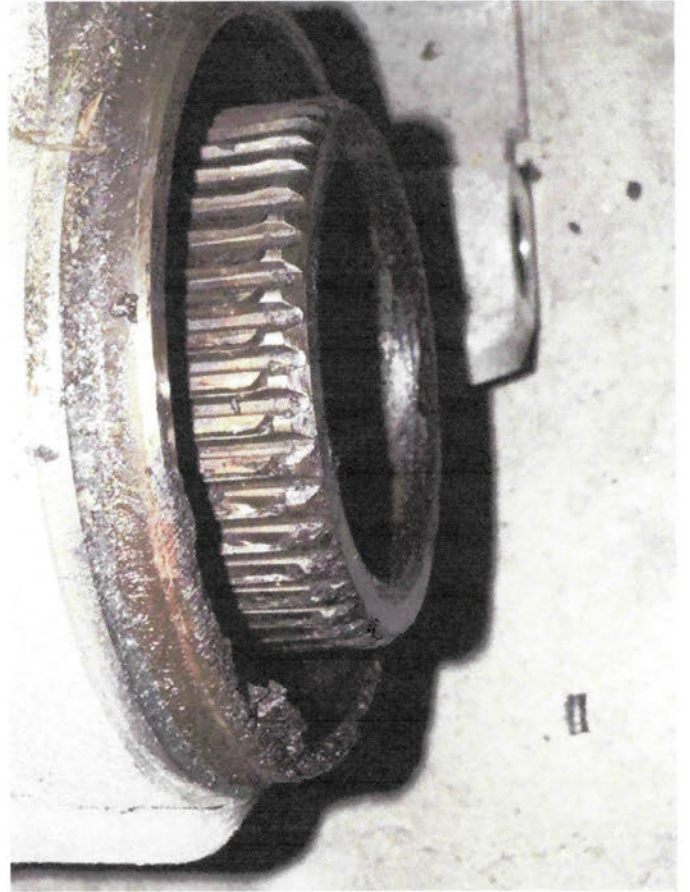
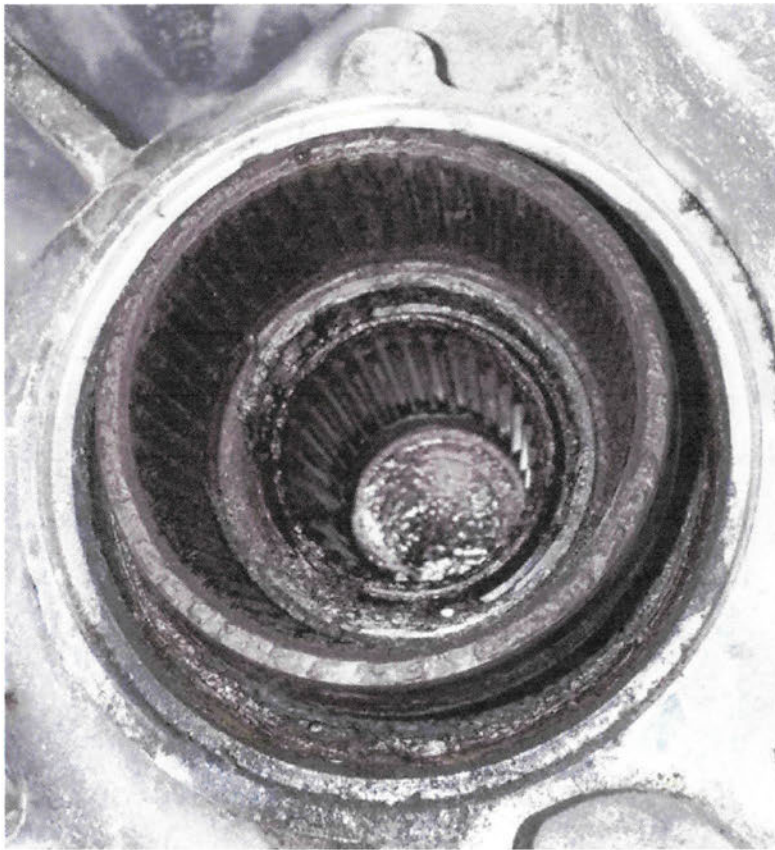
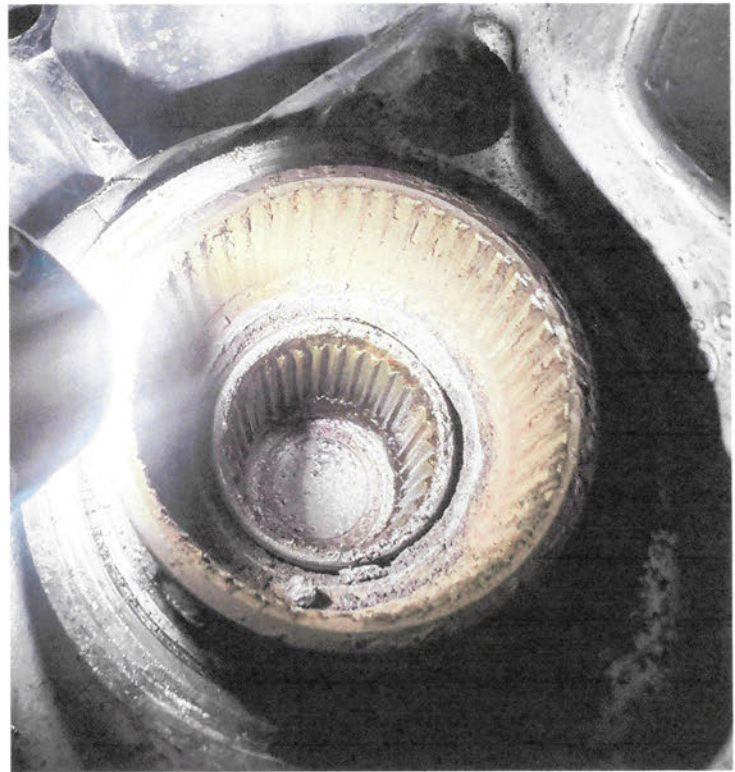
Exhibit B

- **Mechanical Shearing:** The metal splines on the transmission and PTU shafts strip or shear completely flat.
- **Contamination:** Fluid inspections by technicians frequently reveal "orange/discolored liquid" and heavy metal shavings within the PTU housing.

**Exhibit B – Photographic Evidence:** Attached are photographs of the failed components from multiple subject vehicles. These images clearly demonstrate "sheared" or "flattened" metal splines on the Transmission and PTU shaft, proving a total loss of mechanical connection that cannot be detected by the vehicle's electronic sensors.
