# Service Bulletin

Bulletin No.: 22-NA-080

**Subject: Diagnostic Tips for Engine Related Shudder Concerns**

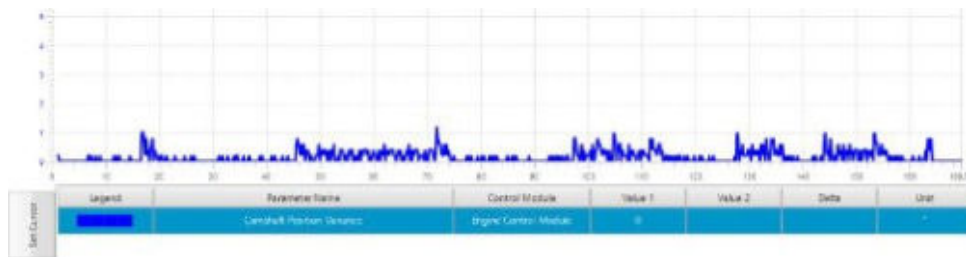
6029095

Normal operation (variance under 4 degrees)

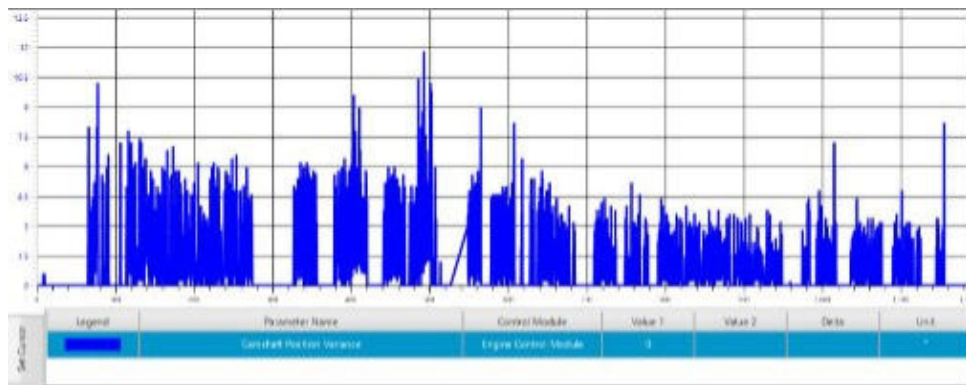
6029096

Suspect fault in camshaft actuator system (variance over 4 degrees)

Causal Part	Description	Part Number	Qty
X	MAGNET, CM/SHF POSN ACTR	12675031	1
		12670340
