Safety Recall

N252494000 L87 Engine Loss of Propulsion

Release Date: February 2026

Revision: 12

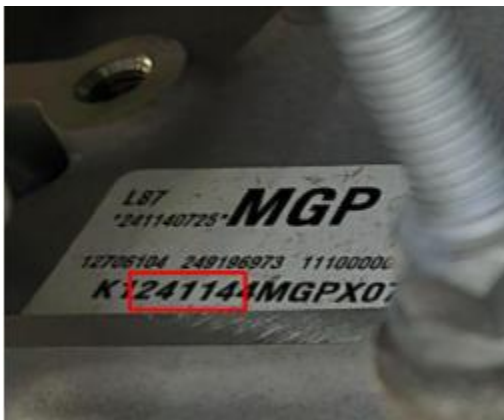
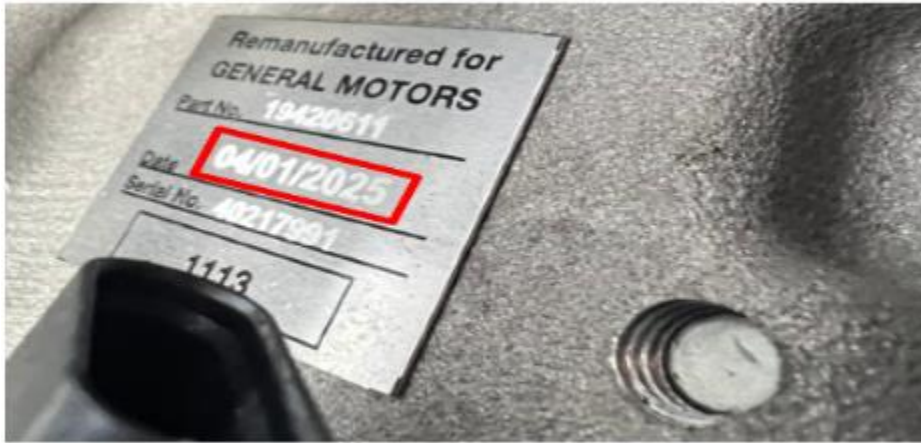
- For Replacement Engines: Looking upwards from under the vehicle towards the rear of the Left Hand cylinder head, inspect the digits indicated on the sticker above to determine the build date of the engine. The first two digits circled are the build year ('24 in this example), and the next three digits are the build day (day 114 in this example).

- For Remanufactured Engines: Looking upwards from under the vehicle towards the lower left side of the engine block, inspect the date indicated on the remanufactured engine tag pictured above.

- If the engine was built ON or BEFORE day 153 or 6-1-2024, proceed to Step 3.
- If the engine was built AFTER day 153 or 6-1-2024 no further action is required. Submit inspect-only labor operation 9107967. **BE SURE TO RECORD THE NEW ENGINE SERIAL NUMBER IN THE CORRECTION FIELD OF THE REPAIR.** The new engine serial number MUST be included in the warranty information.
