I am writing to formally request that the following customer statement be added as an addendum to the permanent service record associated with Repair Order # [REDACTED] for my 2022 GMC Yukon XL Denali.

Dan Perrington  
2022 GMC Yukon XL Denali  
VIN: [REDACTED]

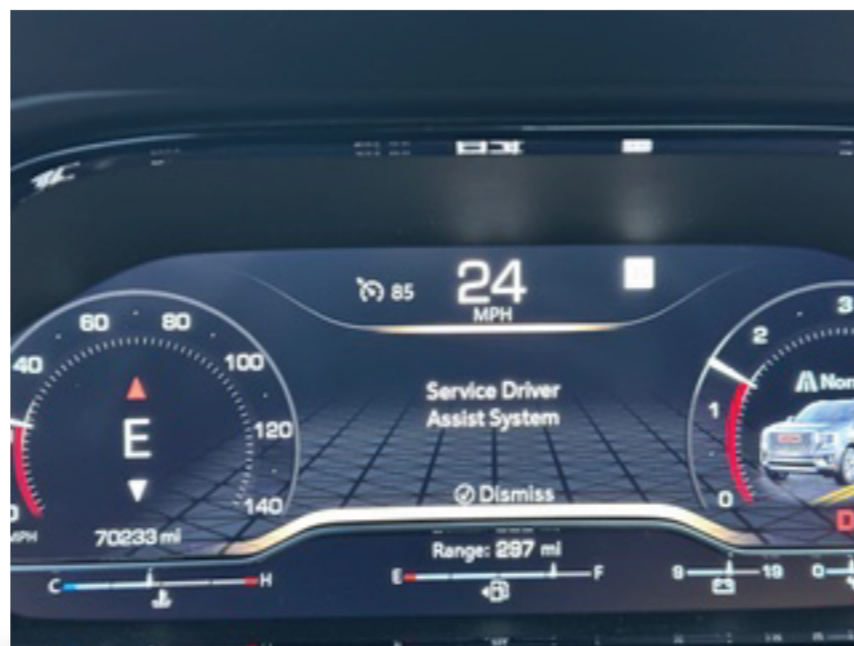
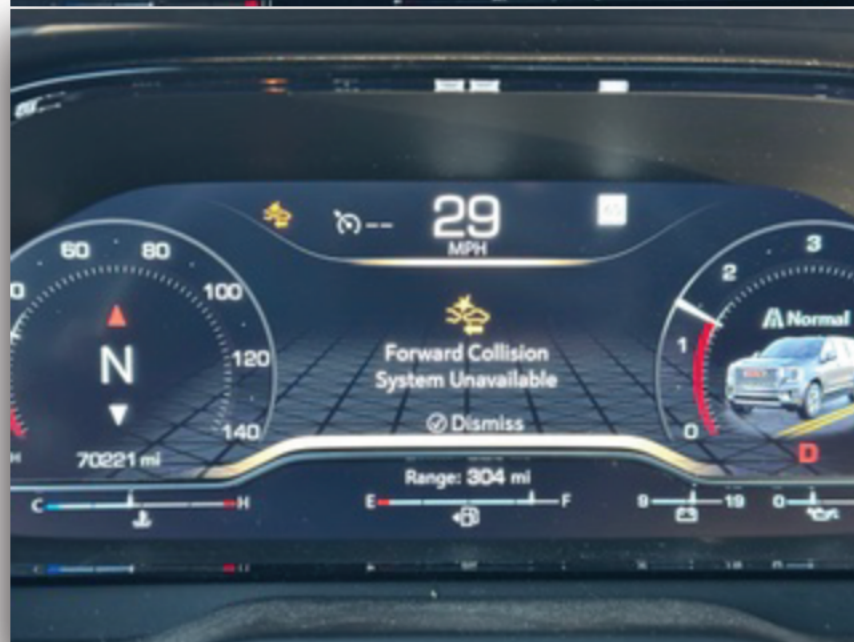
Although the repair order states that the Driver Assistance / Forward Collision warning could not be duplicated, within approximately three miles of leaving the dealership following vehicle pickup, the instrument cluster displayed “Service Driver Assist System” and “Forward Collision System Unavailable.” Photographs showing these warnings and the corresponding odometer readings were taken immediately and are available for attachment to the service file.

This demonstrates that the safety system fault remains present and is intermittent, rather than resolved.
