**SUBJECT: NEW VEHICLE DEMONSTRATION / DELIVERY HOLD**

**Safety Recall 97S88 - *Supplement #2***

All 1994-1996 Model Year Mustang and 1995-1996 Model Year Windstar Vehicles with Sheet Molded Compound (SMC) hoods built prior to 12/31/95  
Hood Separation

Certain 1994-1996 Model Year Mustang and 1995-1996 Model Year Windstar Vehicles  
Hood Panel Delamination

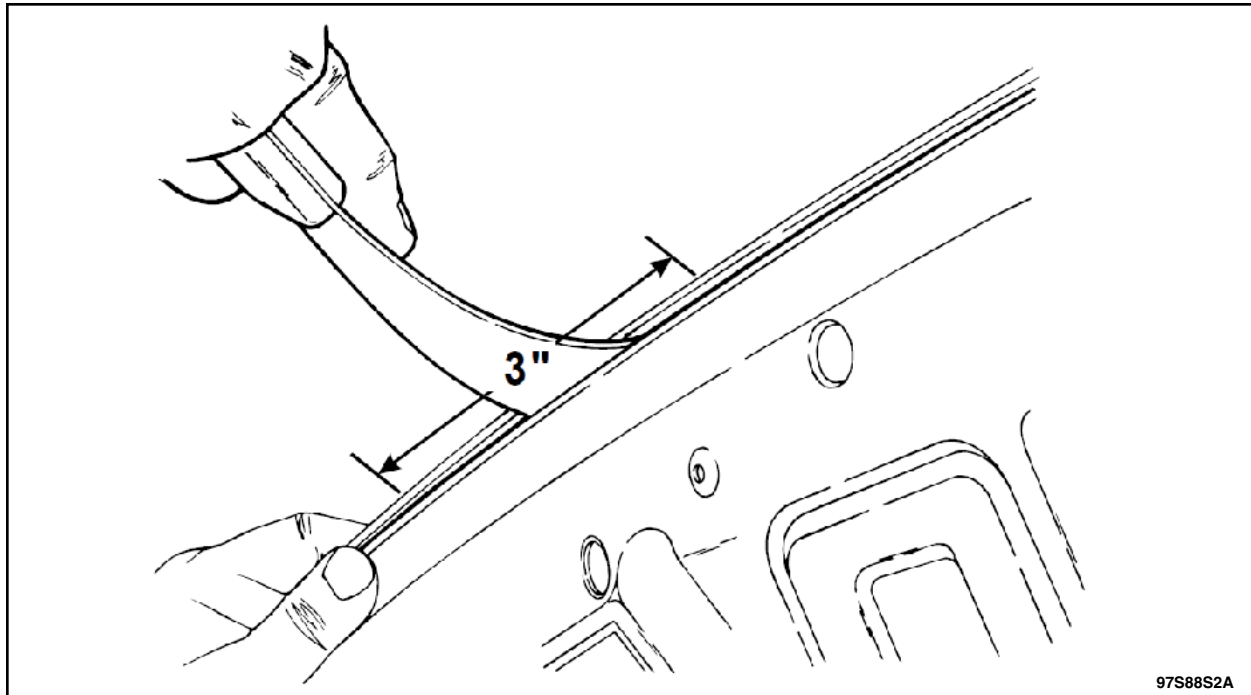
**FIGURE 1**

Starting at one side of the leading edge of the hood, insert the blade of the putty knife between the upper and lower halves of the hood panel. Refer to Figure 1.

Lift up on the handle of the putty knife to apply a moderate separating force to the hood panels. Note that the blade of the putty knife will flex as force is applied. See Figure 1.

4. While applying force with the putty knife, if separation occurs more than one inch on each side of the putty knife contact the SSSC for further repair directions.

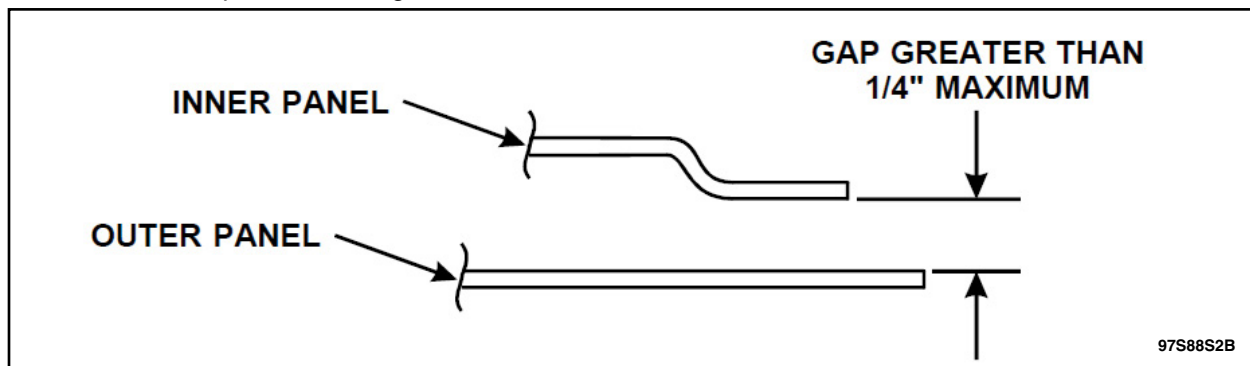
FIGURE 2

1. Check for front end collision and hood damage. This recall will not cover the cost of hood replacement if there is hood damage caused by a collision. See Attachment I.
2. If there is no collision damage, measure the gap between the upper and lower hood panels where the adhesive should be applied.
  - If gap (where adhesive should be applied) is  $\frac{1}{4}$  inch or more without the dowel pins installed, contact the SSSC for hood replacement approval. See Figure 2.
  - If gap is less than  $\frac{1}{4}$  inch, perform the repairs as described in the repair procedure. Make sure that the adhesive makes a good contact with the upper and lower hood panels. See Figure 3.

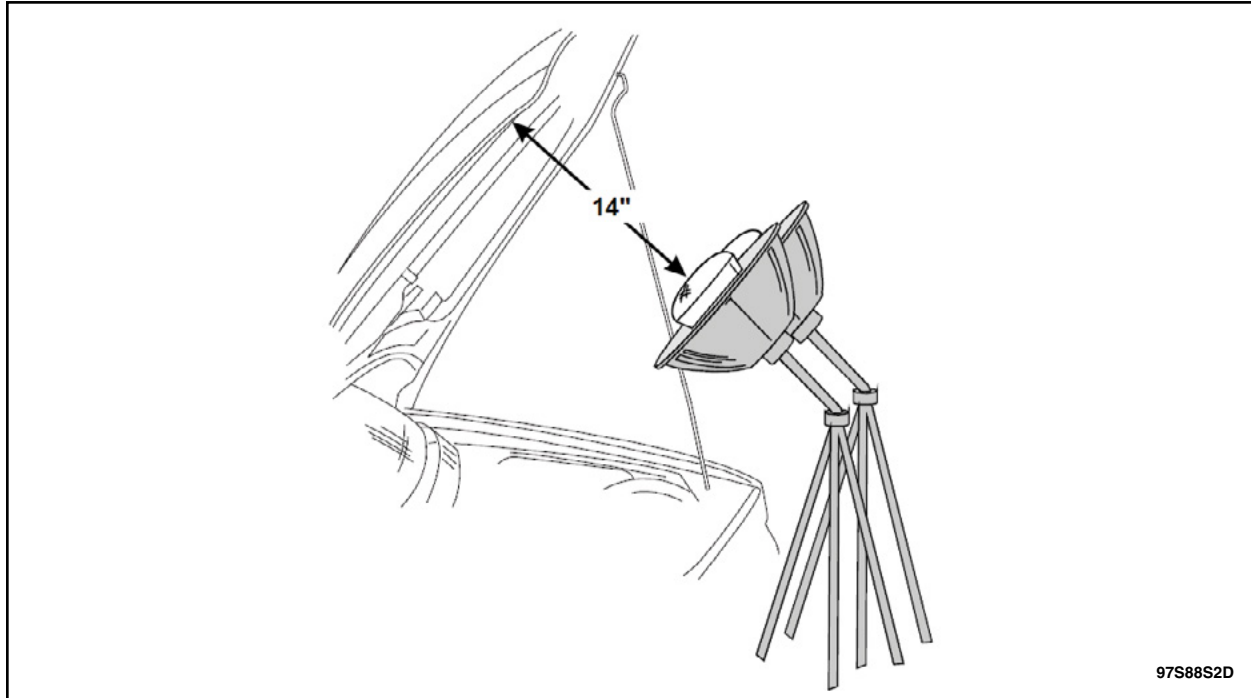
**FIGURE 4**

1. After applying adhesive between hood panels, leave the hood open and obtain two (2) 250 Watt Infra Red heat lamps.
2. Position both heat lamps so that the heat from the bulbs is 90 degrees (perpendicular) to the hood.
3. Adjust the distance between the hood and the heat lamps. The face of the heat lamp bulbs should be 14 inches from the bond area. See Figure 4.

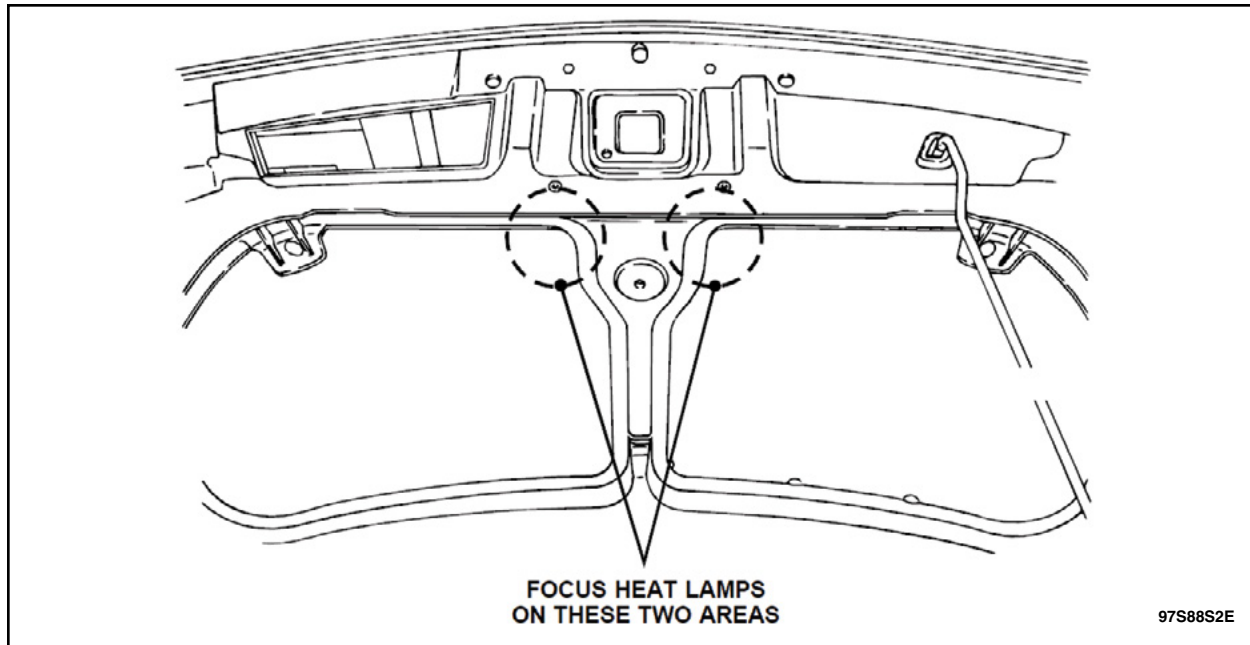
**FIGURE 5**

4. Aim the heat lamps so that the heat is centered on the curved section of the lower hood panel where the adhesive is applied. See Figure 5.

5. After 30 minutes, remove heat lamps and install hood insulator.
6. Close hood completely and return vehicle to customer.
