98V-192 (01)

SUBJECT OF RECALL : SPEED CONTROL CABLE

SUBJECT: Safety Recall 98S22 - Certain 1998 Model Year F-Series Trucks -
Speed Control Cables

SPEED CONTROL CABLE LOCKING PIN

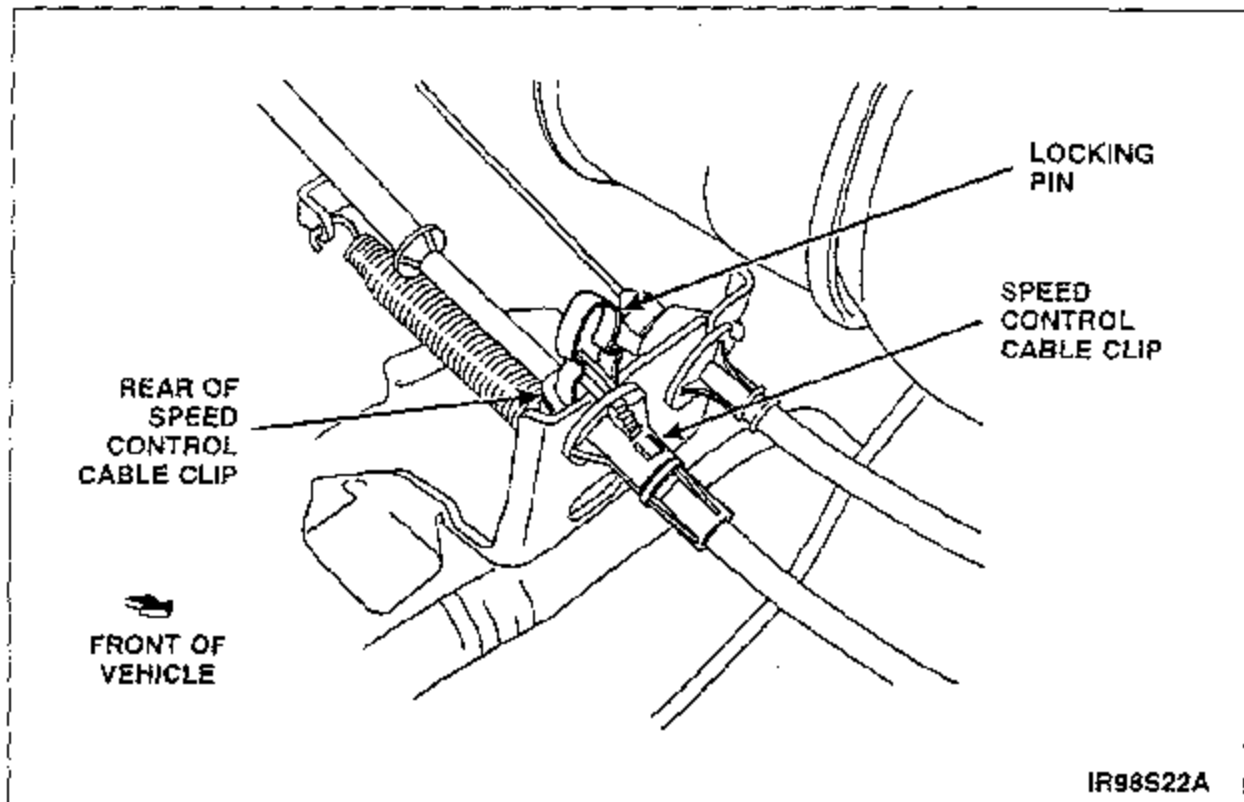
FIGURE 1

A safety defect may exist on the affected trucks as a result of speed control cables that may not have been fully engaged into the accelerator bracket. If the speed control cable is not fully engaged the throttle may not return to full engine idle.

1. Open hood.
2. Remove shield covering throttle body assembly.
3. Locate accelerator cable bracket on intake manifold.
4. Install secondary retaining clip on rear of speed control cable clip. See Figure 1.
