AMERICAN HONDA MOTOR CO., INC.

99V-227 (01)

On July 28, 1999, Honda Motor Co., Ltd. (HMC) determined that a defect relating to motor vehicle safety exists in the transmission of certain 1996-1999 model Acura 3.5RL and 1996-1998 3.2TL vehicles. The following information is submitted pursuant to the requirements of 49 CFR 573.5.

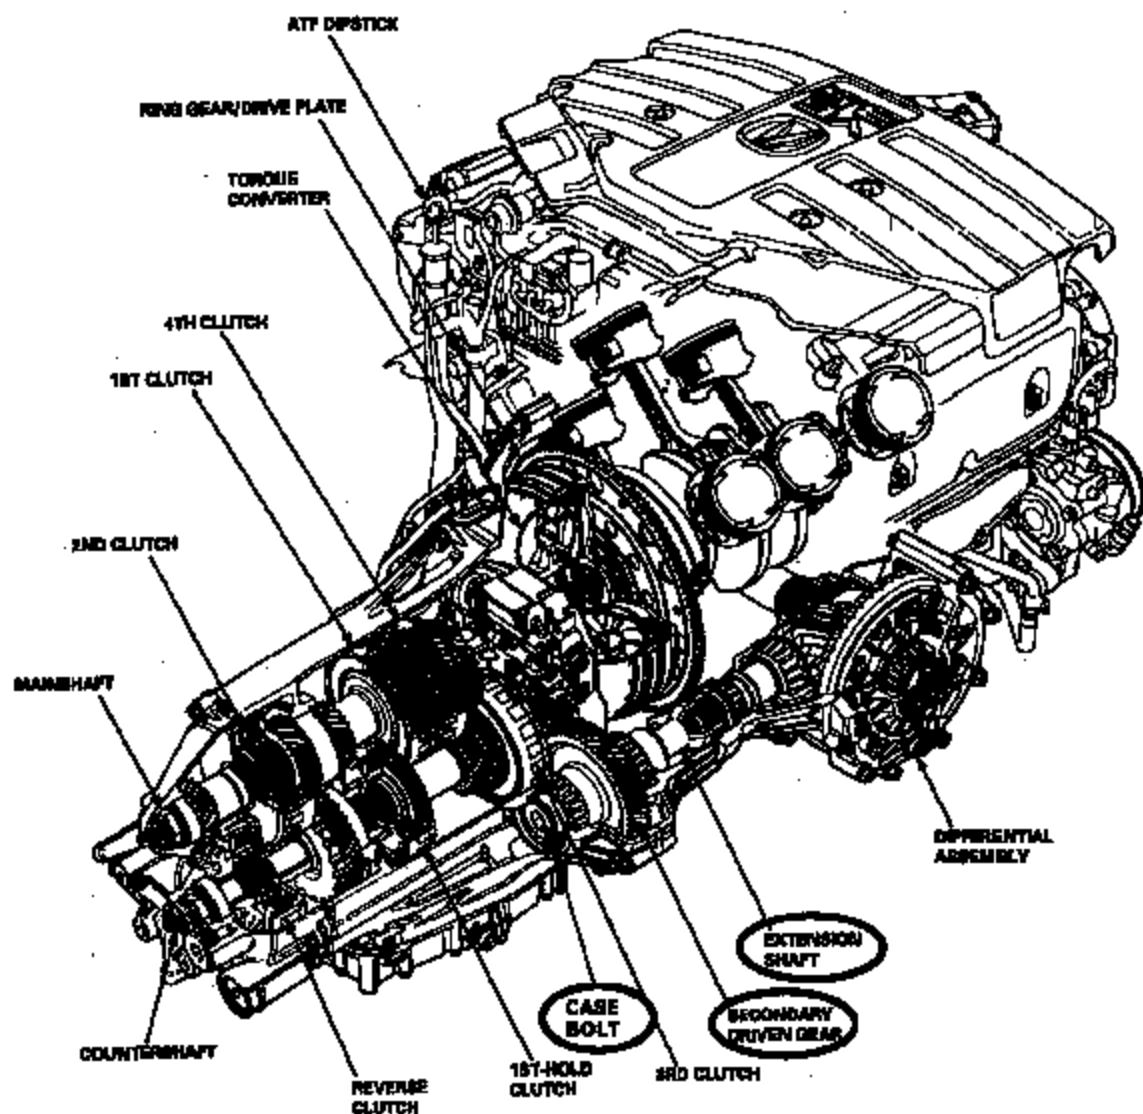
Assembly Drawing

A transmission case bolt can loosen and fall out, allowing the transmission to disengage from the differential. If this condition occurs, the vehicle would lose power to the drive wheels without warning. Also, shifting the transmission into the Park position would not lock the wheels, and a parked vehicle could move unexpectedly if the parking brake is not set.

A large (36 mm) transmission case bolt allows service access to disconnect the differential from the transmission (see attached drawing). A change to the secondary driven gear, to reduce transmission noise, increased the likelihood of contact between the extension shaft (connecting the transmission and differential) and this bolt. The bolt is installed with a thread lock/sealer. In time, the repeated contact of the shaft against the bolt can cause the sealer to lose its effectiveness, and the bolt may loosen and fall out. If the bolt falls out, the extension shaft could disengage from the differential, disconnecting the drive train between the transmission and the differential.

Dealers will install an updated transmission case bolt, free of charge, in all affected vehicles. The thread lock/sealer previously applied to the bolt will be eliminated. The new bolt will use an o-ring as the seal.
