99V-227

DATE: August 18, 1999  
TO: All Sales, Service & Parts Managers  
FROM: American Honda Service Division  
RE: Recall Announcement and Stop Sale order.

### RECALL Repair Parts: 36mm Sealing Bolt Set 1996-98 3.2TL and 1996-99 3.5RL

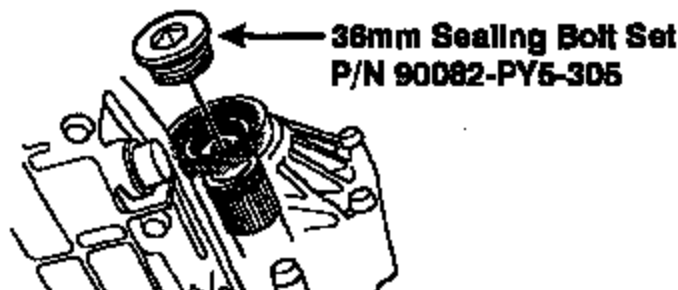
The 36mm sealing bolt on the side of the transmission housing on affected vehicles may loosen and fall out. If this occurs, the extension shaft may back out and disconnect from the differential. This condition causes the vehicle to lose power to the drive wheels without warning. Also, shifting the transmission into Park would not lock the wheels, and a parked vehicle could move unexpectedly if the parking brake is not set. The Sealing Bolt Set listed below is available to upgrade affected vehicles.

DESCRIPTION	P/N	D/N	S/R
36mm Sealing Bolt Set <sup>(1)</sup>	90082-PY5-305	\$1.71	\$2.85

(1) The Set consists of one 36mm Sealing Bolt and an O-ring.
