Re: Recall Number 99V-333

# MEDIA UPDATE SAFETY RECALL BULLETIN

<b>SUBJECT: BATTERY CABLE HARNESS — SAFETY RECALL CAMPAIGN</b>			No: <b>SR-00-001</b>
			DATE: <b>January, 2000</b>
			MODEL: <b>See below</b>
CIRCULATE TO:	<input checked="" type="checkbox"/> GENERAL MANAGER	<input checked="" type="checkbox"/> PARTS MANAGER	<input checked="" type="checkbox"/> TECHNICIAN
<input checked="" type="checkbox"/> SERVICE ADVISOR	<input checked="" type="checkbox"/> SERVICE MANAGER	<input checked="" type="checkbox"/> WARRANTY PROCESSOR	<input checked="" type="checkbox"/> SALES MANAGER

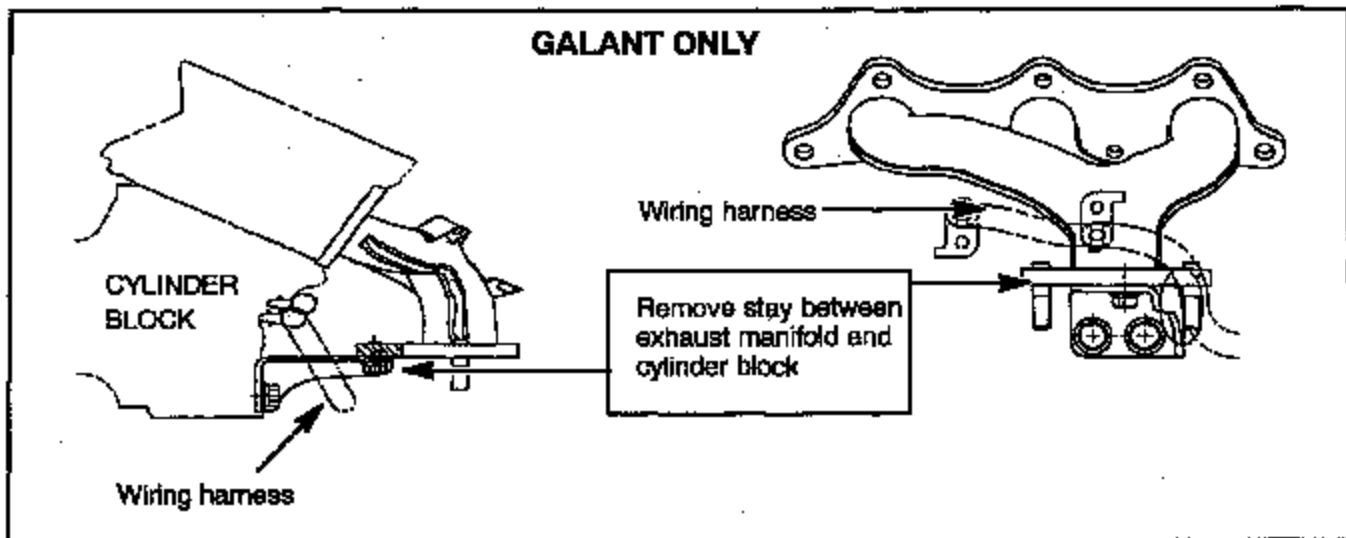
- (1) **GALANT ONLY:** Remove the 3 bolts securing the stay (bracket) to the cylinder block and exhaust manifold. Unbolt the stay from the engine block. Remove and discard the stay.

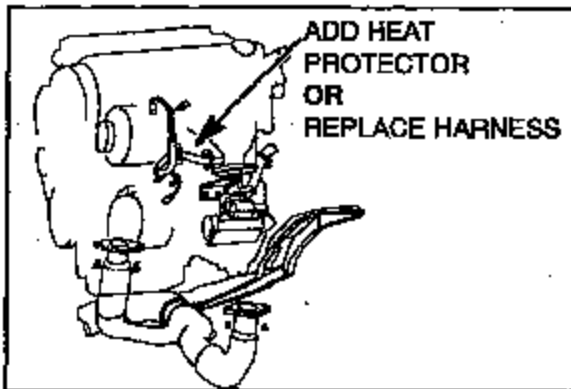
- If the harness wiring is not exposed through any holes in the corrugated tubing, install the Heat Insulator Kit. Go to Step 2 for Heat Insulator Kit installation instructions.
- If the harness wiring is exposed through holes in the corrugated tubing, **replace** the battery cable harness with the new harness listed in the PARTS INFORMATION section of this bulletin. Go to Step 3 for battery cable harness replacement instructions.

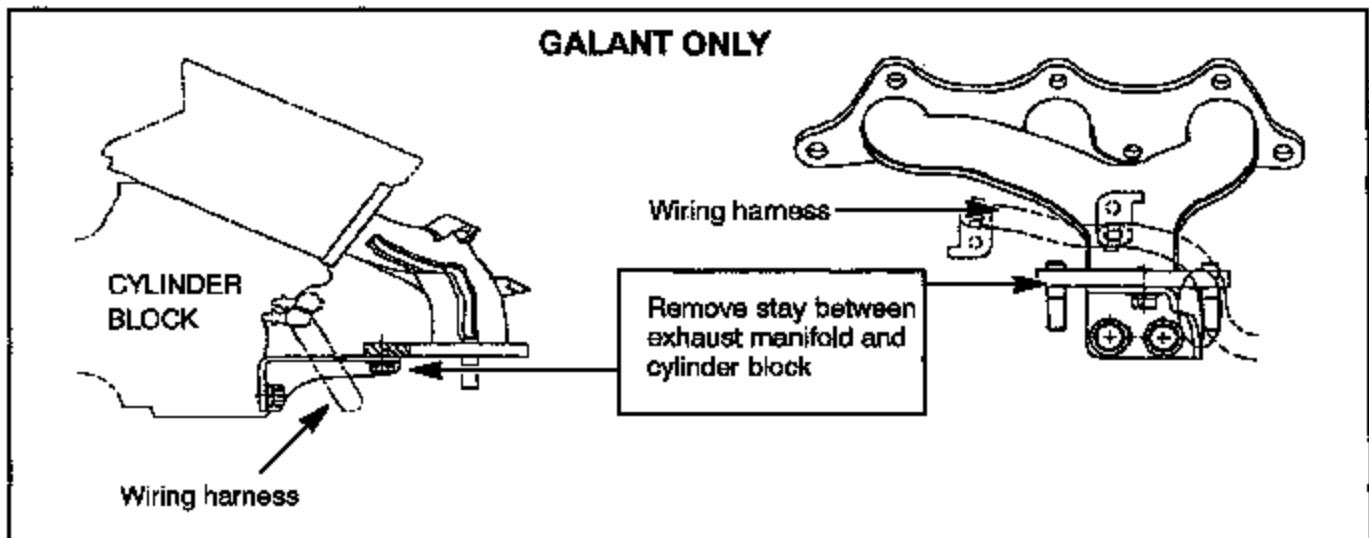
- (1) **GALANT ONLY:** Remove the 3 bolts securing the stay (bracket) to the cylinder block and exhaust manifold. Remove the stay from the engine block and discard it.

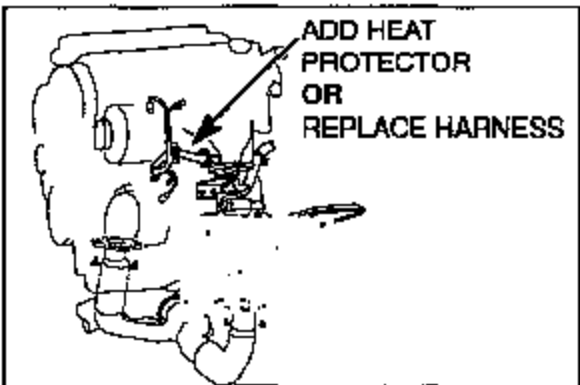
#### INSPECTION CRITERIA

- If the harness wiring is **not** exposed through any holes in the corrugated tubing, install the Heat Insulator Kit. Go to Step 2 for Heat Insulator Kit installation instructions.
- If the harness wiring is **exposed** through holes in the corrugated tubing, **replace** the battery cable harness with the new harness listed in the PARTS INFORMATION section of this bulletin. Go to Step 3 for battery cable harness replacement instructions.
