YEAR
1996-99
1996-98

MODEL
3.5RL
3.2TL

BULLETIN NO.
99-036

Safety Recall: Extension Shaft Sealing Bolt

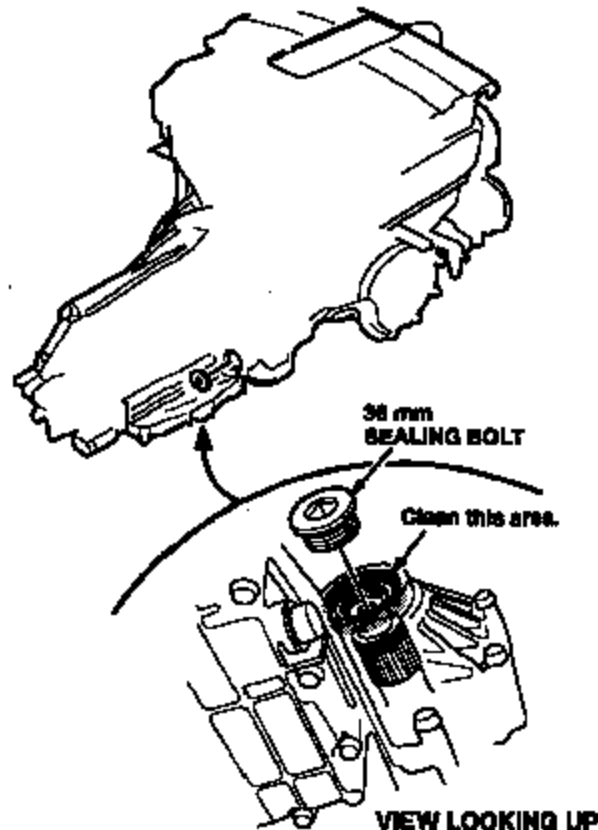
The 36 mm sealing bolt on the side of the transmission housing may loosen and fall out. If this occurs, the extension shaft may back out and disconnect from the differential. If this happens while driving, the car loses power to the drive wheels without warning. If the car is stopped with the transmission in Park and the parking brake not engaged, the car could move unexpectedly.

1. Make sure the vehicle is in Park, then raise the vehicle on a hoist.
2. Use brake cleaner and compressed air to clean the area around the 36 mm sealing bolt. Wear eye protection.

3. Remove the 36 mm sealing bolt.
4. Use brake cleaner and compressed air to clean the threads in the transmission housing. Wear eye protection.
5. Install the O-ring on the new sealing bolt.
6. Install the new 36 mm sealing bolt. Do not use any thread lock or thread sealer. Torque the bolt to 78 N-m (58 lb-ft).
7. Lower the vehicle.
8. Center-punch a completion mark above the third character of the engine compartment VIN.
