**GENERAL MOTORS NORTH AMERICA**  
**Safety Center**

00V-085 (01)

**SUBJECT: 000XX - POWER STEERING COOLER HOSE SEPARATION**

**MODELS: 1999-2000 CHEVROLET AND GMC G-VANS**

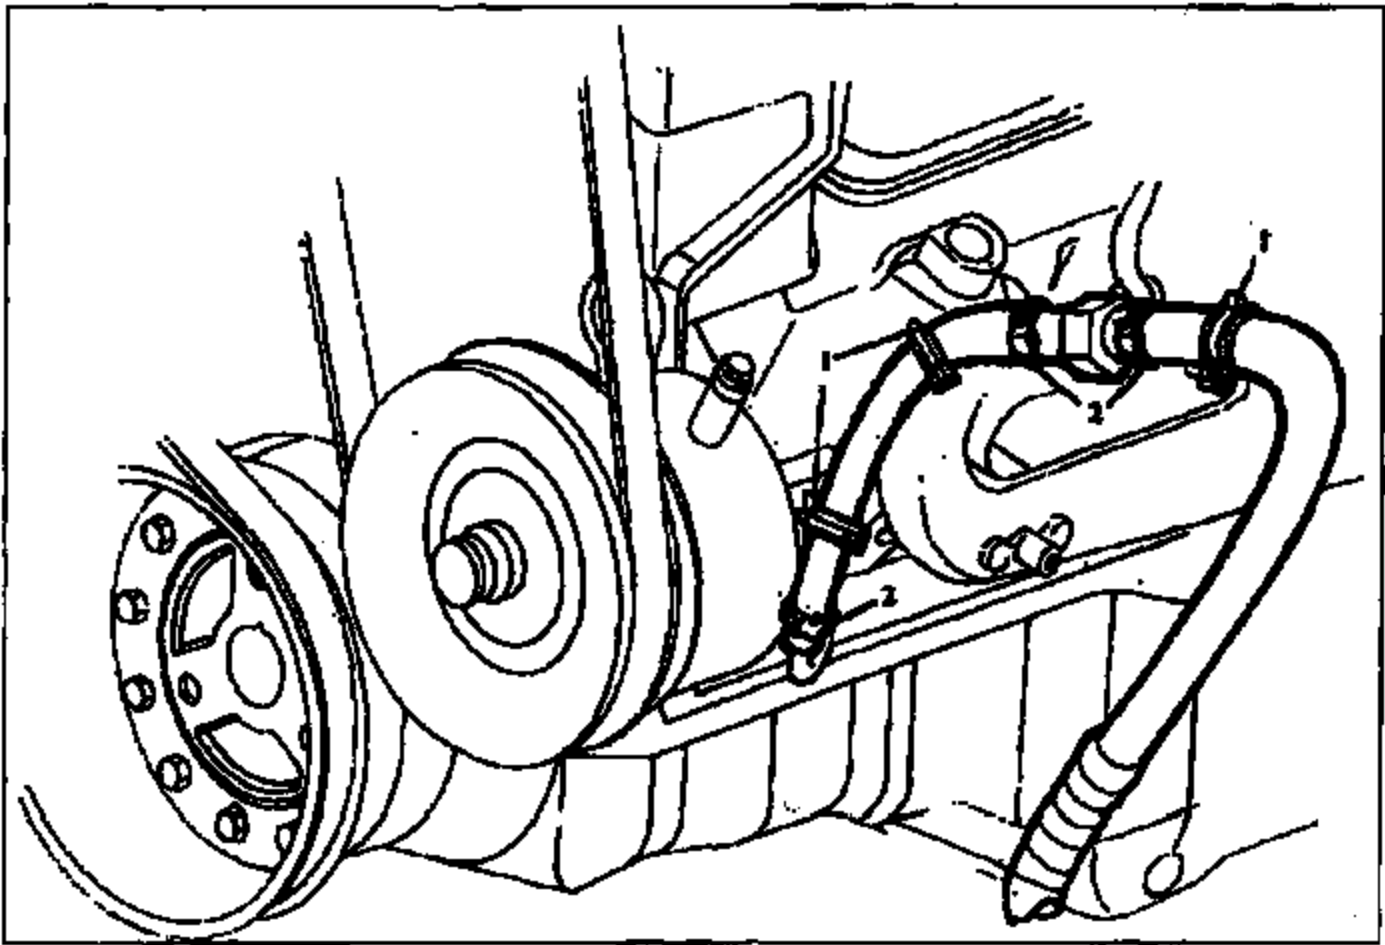
**Figure 1**

General Motors has decided that a defect which relates to motor vehicle safety exists in certain 1999-2000 Chevrolet Express vans and GMC Savana vans equipped with a brake warning indicator. Some of these vehicles have a power steering cooler hose that can separate from the power brake booster fluid flow switch assembly. If this occurs, power steering fluid could flow onto hot engine parts and an engine compartment fire could occur.

1. Raise the hood.
2. Inspect for the type of clamp used on the hoses for the fluid flow switch (Figure 1, Item 2), located directly behind the steering intermediate shaft assembly.
  - If the clamps are screw clamps, no further action is required. Install the GM Campaign Identification Label.
  - If clamps are not screw clamps, proceed to step 3.
3. Disconnect and remove the air cleaner and duct assembly.

**Important:** Care must be taken when relocating the existing spring clamps to ensure that the hoses are not rotated, twisted, or stretched in any way that may change the position of the hose in relationship to the power steering pump fitting or the fittings on the fluid flow switch. **DO NOT DISCONNECT THE HOSES.**
4. Carefully expand and position the existing spring clamps (1) on the hoses as shown in Figure 1.
5. Completely unscrew the three new clamps (2) and install them onto the hoses where the original spring clamps were located.
6. With the new clamps (2) positioned 4 mm (5/32 in) from the end of the hose joint at which they were installed, tighten the clamps to 2 Nm (18 lb in).

7. Ensure that the electrical wiring harness connector is properly seated on the fluid flow switch and that the wire harness is not in contact with the hose clamps.
8. Install and connect the air cleaner and duct assembly.
9. With the engine running just off of Idle, the transmission in Park, and the service brake applied, complete a full right and full left turn until the end stop is reached. Repeat this step three times. Turn engine off.
10. Inspect for proper hose and clamp positions and for possible leaks. Correct as required.
11. Install the GM Campaign Identification Label.
