July 12, 2000

00V-184 (2)

On June 28, 2000, Honda Motor Co., Ltd. (HMC) determined that a defect relating to motor vehicle safety exists in the motor vehicles listed below, and is furnishing notification to the National Highway Traffic Safety Administration in accordance with 49 CFR Part 573 Defect and Noncompliance Reports.

The rear suspension lower arm or control arm could break due to improper welding. Although there is no danger of losing the wheel if a rear suspension arm breaks, vehicle handling and control would be reduced.

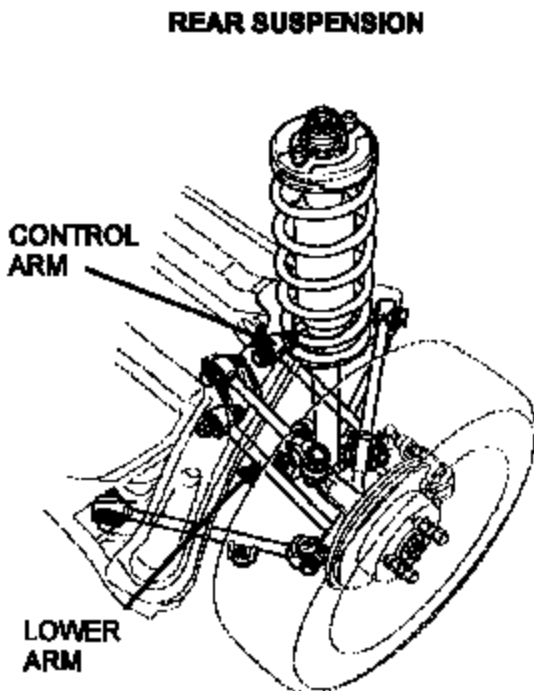
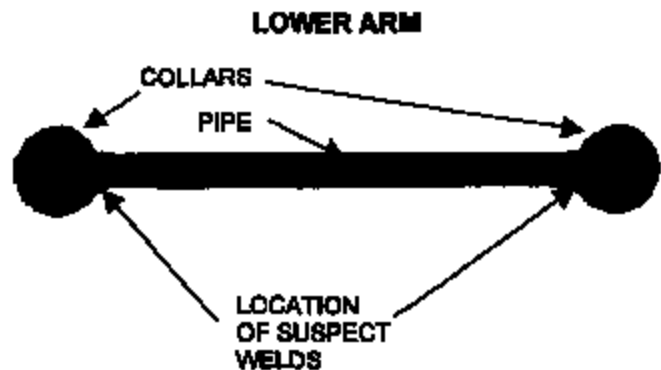
A misaligned welding tip on an automatic welding machine caused inadequate weld penetration between the pipe and collar of rear suspension lower arms or control arms. Inadequate weld penetration can allow the collar to separate from the pipe. Lower arm or control arm separation can result in an extreme amount of toe and noticeable handling instability.

The owners of all affected vehicles will be notified by mail and asked to take their vehicle to an authorized Honda dealer. The dealer will inspect the rear lower arms and rear control arms on both sides of the vehicle for applicable lot codes. Suspension parts with an affected lot number will be replaced, free of charge.
