**Q&A Regarding Concerns on Ball Joint Recall Campaign
(Dealer/Call Center)**

**** ADVANCE TECHNICAL INFORMATION NOTICE ****99V-066.002
00V-421.001

DATE: February 14, 2001
TO: Mitsubishi Motors Service Managers
FROM: Dave McKenzie, Vice President, Product Support
RE: Safety Recall SR-99-002 – New Inspection Procedure And Expanded Model Years
ATIN NO. ATIN-01-SR-005

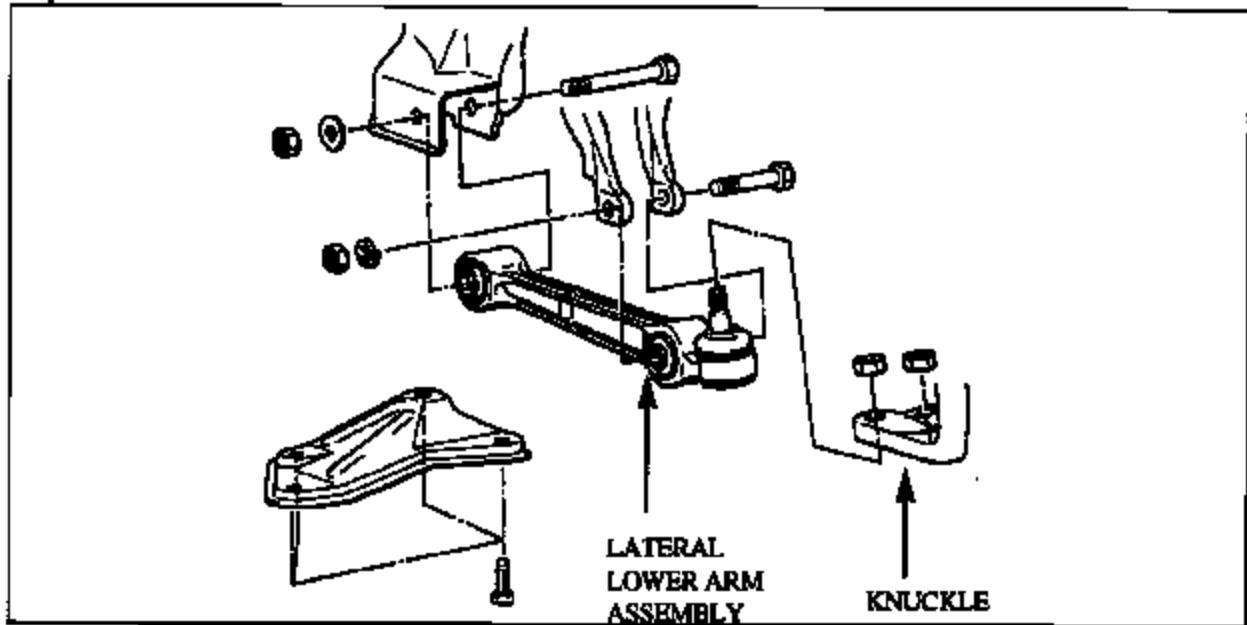
2. Inspect the lateral lower arm ball joint rubber boot on both sides for cracks and damage. Gently push the boot in with your fingers. Do not remove any parts for the inspection. Damage to the boot is evident if any cuts or tearing are observed or if grease comes out when it is pushed in.
 - a. If the rubber boot is not damaged on either side of the vehicle, go to Steps 3 and 4 for ball joint inspection.

- b. If the rubber boot is damaged, replace the lateral lower arm assembly, using the parts listed in the PARTS INFORMATION section of this notice. Go to Step 5 for lateral lower arm replacement instructions.
