Campaign Bulletin

File In Section: Product Campaigns
Bulletin No.: 00028
Date: April, 2000

SUBJECT: 00028 - POWER STEERING COOLER HOSE SEPARATION

MODELS: 1999-2000 CHEVROLET AND GMC G-VANS

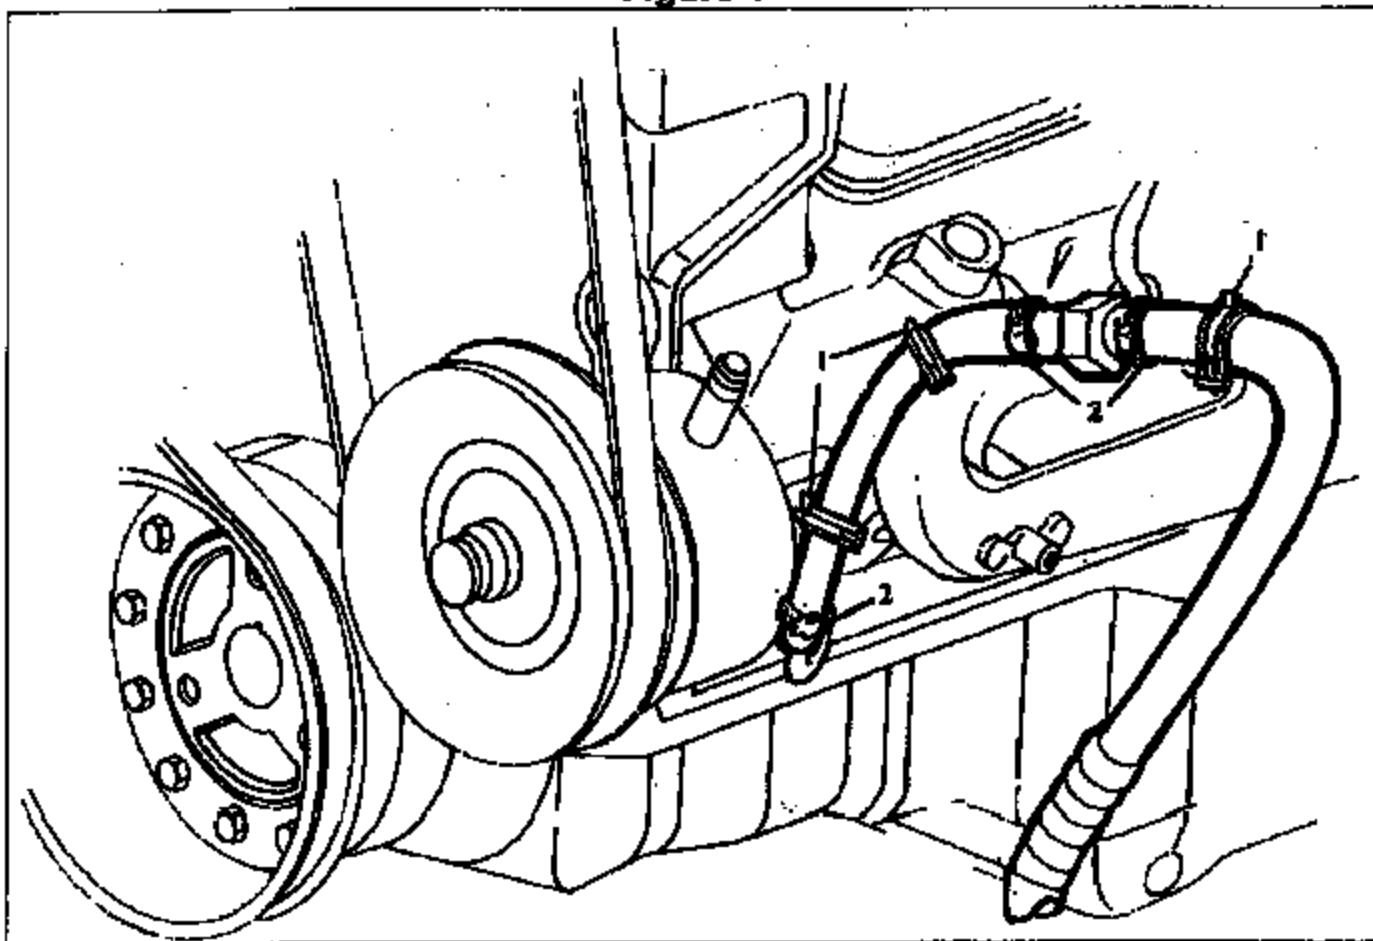
Figure 1

1. Raise the hood.
2. Inspect for the type of clamp used on the hoses for the fluid flow switch (Figure 1, Item 2), located directly behind the steering intermediate shaft assembly.
 - If the clamps are screw clamps, no further action is required. Install the GM Campaign Identification Label.
 - If clamps are not screw clamps, proceed to step 3.
3. Disconnect and remove the air cleaner and duct assembly.

Important: Care must be taken when relocating the existing spring clamps to ensure that the hoses are not rotated, twisted, or stretched in any way that may change the position of the hose in relationship to the power steering pump fitting or the fittings on the fluid flow switch. **DO NOT DISCONNECT THE HOSES.**
4. Carefully expand and position the existing spring clamps (1) on the hoses as shown in Figure 1.
5. Completely unscrew the three new clamps (2) and install them onto the hoses where the original spring clamps were located.
6. With the new clamps (2) positioned 4 mm (5/32 in) from the end of the hose joint at which they were installed, tighten the clamps to 2 Nm (18 lb in).
