Subject: Safety Recall 00V-115 NSA-11paw
(Ford Number 00S08)

SUBJECT: **Safety Recall 00S08:** Certain 1999 and 2000 Model Year E350 Cutaway and Stripped Chassis Vehicles, With Single Rear Wheels – Dana 70 Rear Axle Wheel Stud Replacement

Safety Recall 00S08
Certain 1999 and 2000 Model Year E350 Cutaway and Stripped Chassis Vehicles,
With Single Rear Wheels – Dana 70 Rear Axle Wheel Stud Replacement

REAR WHEEL STUD REPLACEMENT

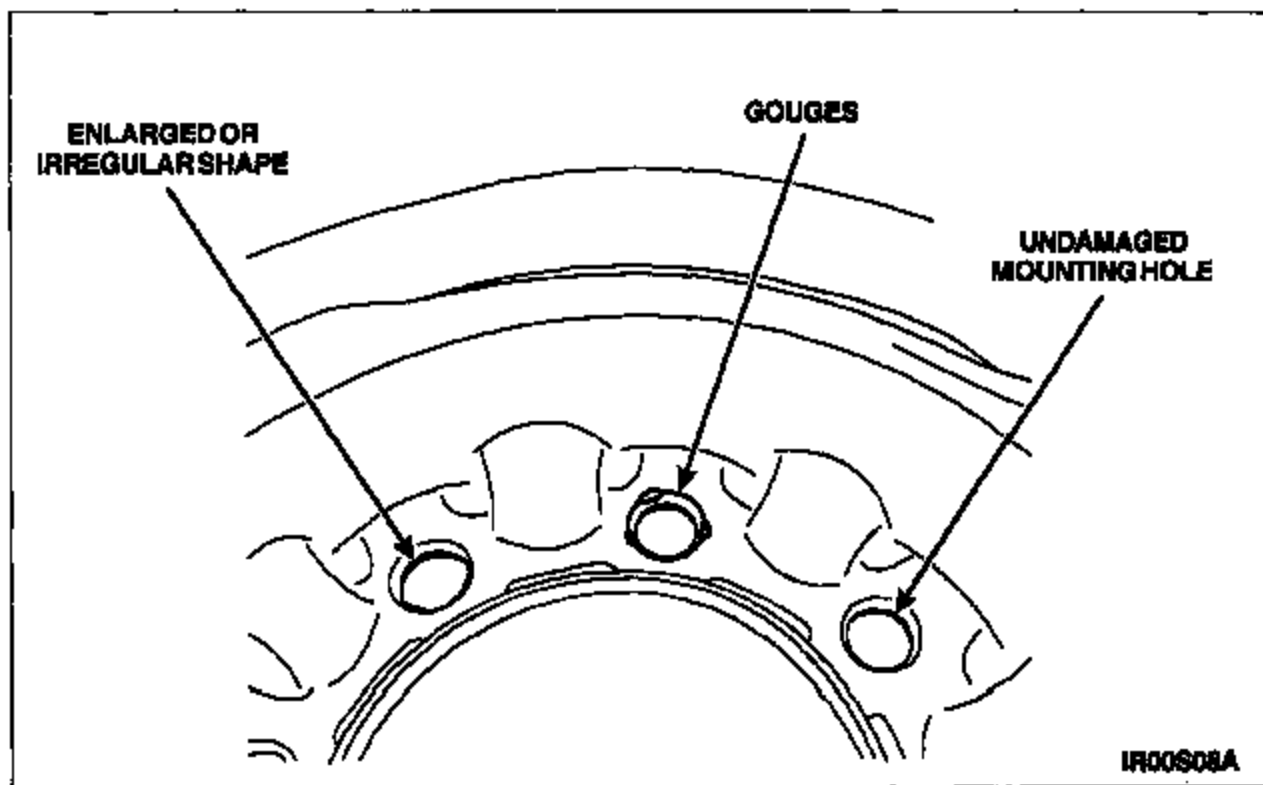
FIGURE 1

4. Inspect the wheel mounting holes for gouges, enlarged or irregular shape. Replace damaged wheels. See Figure 1.
