Subject: Safety Recall 00V-293<sup>2-001</sup> NSA-11paw  
(Ford Number 00S33)

**Safety Recall 00S33**  
**Certain 1999 and 2000 Model Year Mercury Villager vehicles – Steering Gear Retaining Bolt Torque**

# RECALL CAMPAIGN BULLETIN

## VOLUNTARY RECALL CAMPAIGN 1999-2000 QUEST STEERING RACK MOUNTING BOLTS

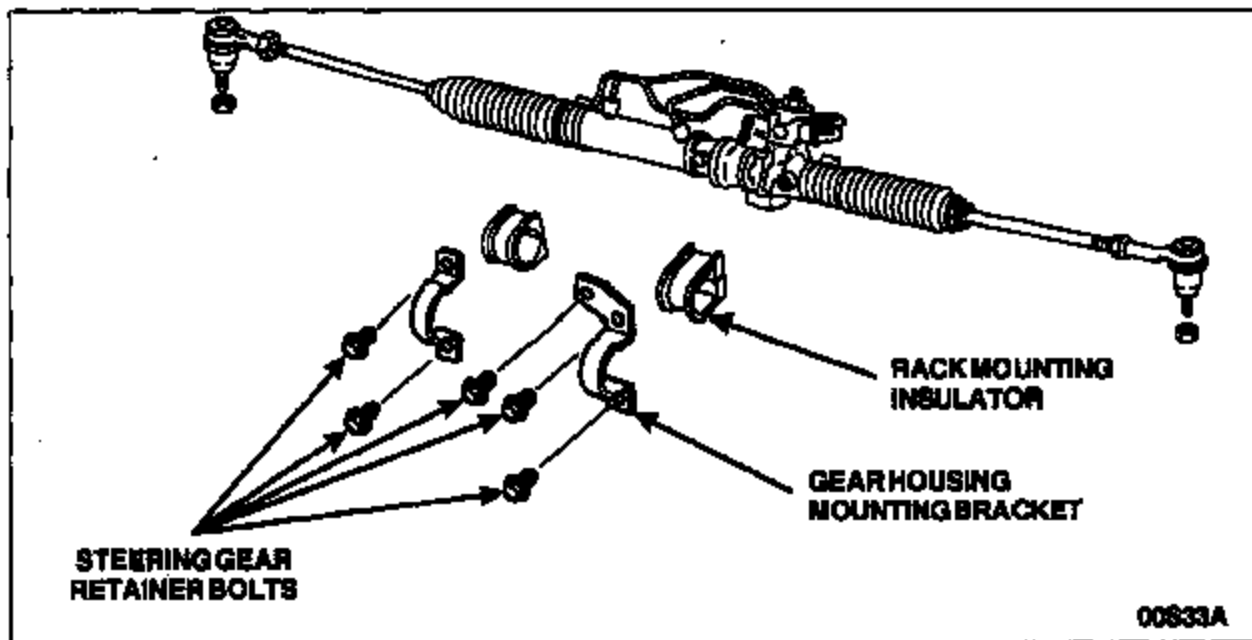
FIGURE 1

1. Raise and support the vehicle on a hoist.
2. Check the torque on each of the five (5) steering gear retainer bolts. The torque specification is 84 Nm (62 lb-ft). See Figure 1.

3. If none of the bolts were loose, no service is required. Lower and release the vehicle.
4. If any bolt is found loose or missing, remove that bolt and inspect the hole in the bracket for signs of damage (hole elongated, paint worn from inside of bolt hole indicating movement of the bracket, etc.). Please note that the right side bracket is manufactured with the upper hole slightly elongated vertically as an aid to assembly. Do not mistake this for damage.
5. If no bracket damage is found, reinstall the bolts. Replace any missing bolts. Tighten the bolts to 84 Nm (62 lb-ft). Then lower and release the vehicle.
6. If either bracket is found damaged, that bracket must be replaced. **DO NOT REMOVE BOTH BRACKETS FROM THE STEERING GEAR AT THE SAME TIME.** Replace each bracket separately with a new bracket. Replace any bolt that is damaged at the same time.
7. Lower and release the vehicle.

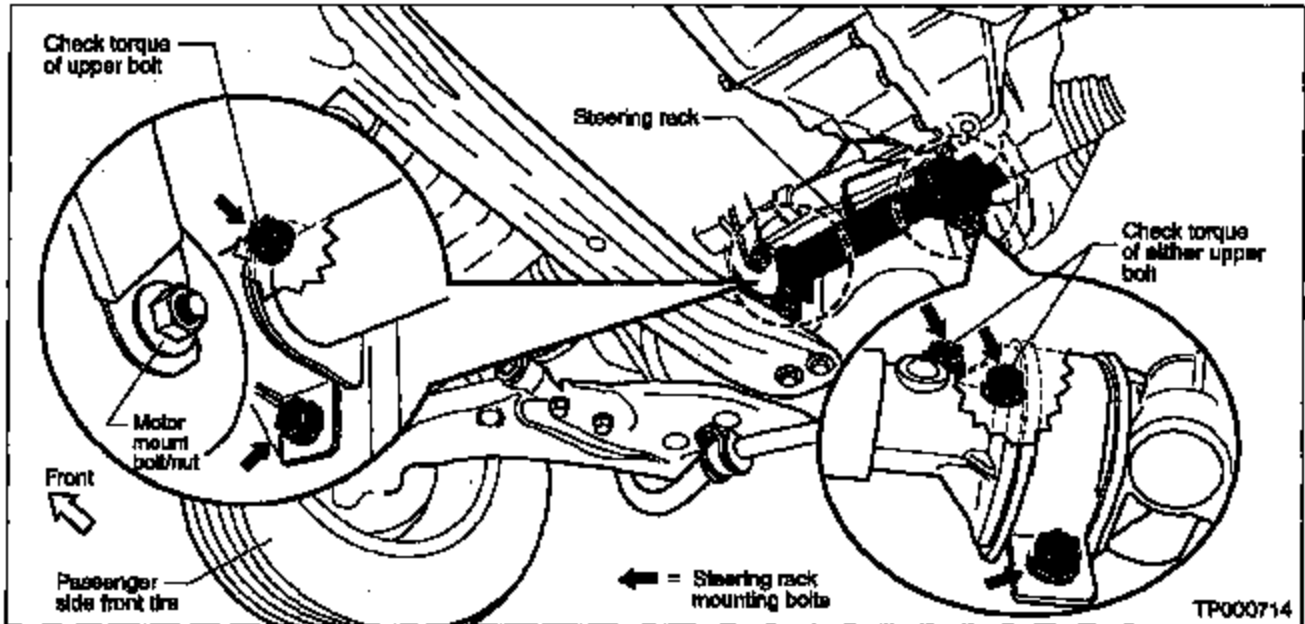
Figure 2

1. Lift the vehicle and verify that all five steering rack mounting bolts are present (see Figure 2).

- A. If all five steering rack mounting bolts are present, proceed with step 2 below.
  - B. If all five steering rack mounting bolts are not present, replace the five steering rack mounting bolts with the new ones. Refer to the "Steering Rack Mounting Bolts Replacement" procedure on page 4.
2. Use a torque wrench, set at 27 Nm (2.8 kg-m, 20 ft-lbs), and attempt to tighten the upper bolt of each steering rack mounting bracket (see Figure 2).

- A. If the upper bolts do not turn, when the specified torque is applied, the inspection is complete. Return the vehicle to the customer and submit a warranty claim for the inspection.
- B. If any one of the upper bolts move (turn), replace the five steering rack mounting bolts with the new ones. Refer to the "Steering Rack Mounting Bolts Replacement" procedure on page 4.

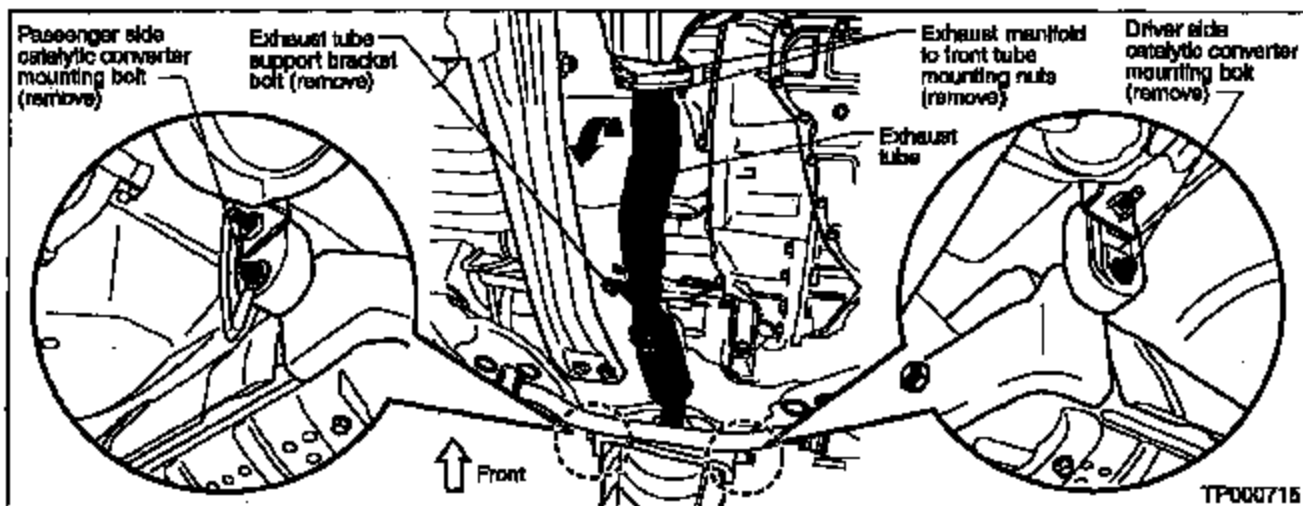
Figure 3

- A. Remove and save the two nuts that join the front exhaust tube to the exhaust manifold (see Figure 3).

- B. Remove and save the bolt that secures the exhaust tube support bracket to the vehicle (see Figure 3).
- C. Remove and save the two bolts that secure the front of the main catalytic converter to the vehicle (see Figure 3).
- D. Pull back on the front exhaust tube to disconnect it from the exhaust manifold. Then carefully lower the tube until it rests on the stabilizer bar.
2. Replace, one at a time and finger-tight ONLY, the five old steering rack mounting bolts with the new bolts. See Figure 4.

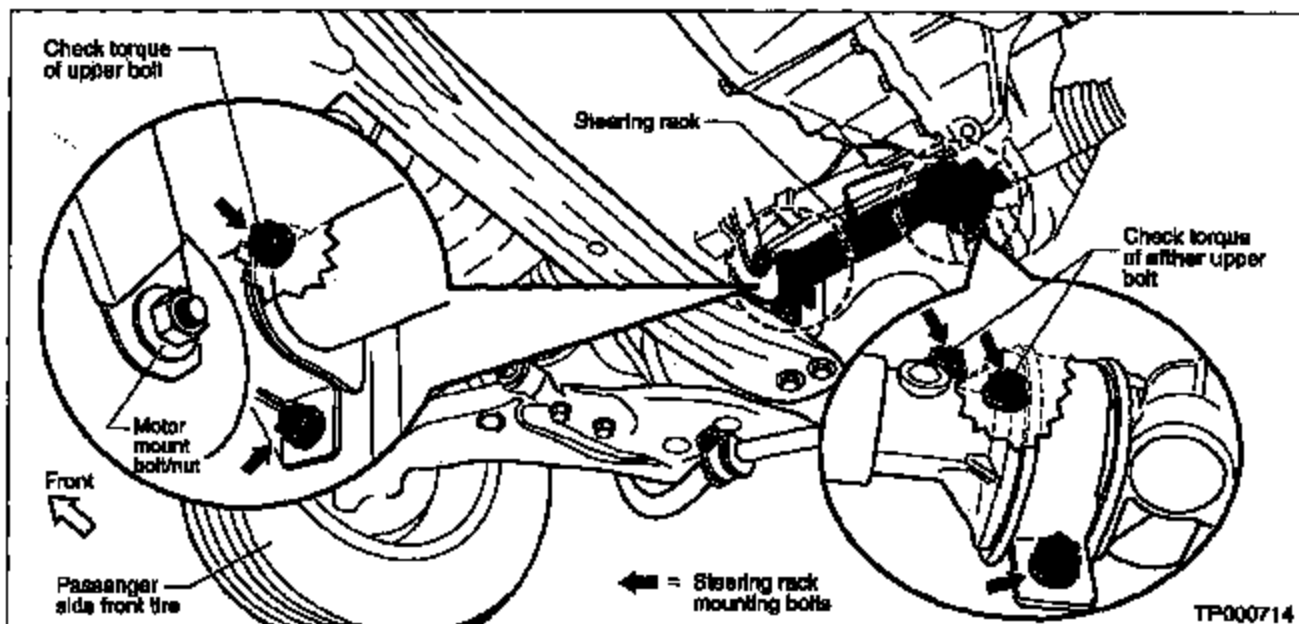
Figure 6

1. Lift the vehicle and verify that all five steering rack mounting bolts are present (see Figure 6).

- A. If all five steering rack mounting bolts are present, proceed with step 2 below.
  - B. If all five steering rack mounting bolts are not present, replace the five steering rack mounting bolts with the new ones. Refer to the "Steering Rack Mounting Bolts Replacement" procedure on page 7.
2. Use a torque wrench, set at 27 Nm (2.8 kg-m, 20 ft-lbs), and attempt to tighten the upper bolt of each steering rack mounting bracket (see Figure 6).

- A. If the upper bolts do not turn, when the specified torque is applied, the inspection is complete. Return the vehicle to the customer and submit a warranty claim for the inspection.
- B. If any one of the upper bolts move (turn), replace the five steering rack mounting bolts with the new ones. Refer to the "Steering Rack Mounting Bolts Replacement" procedure on page 7.

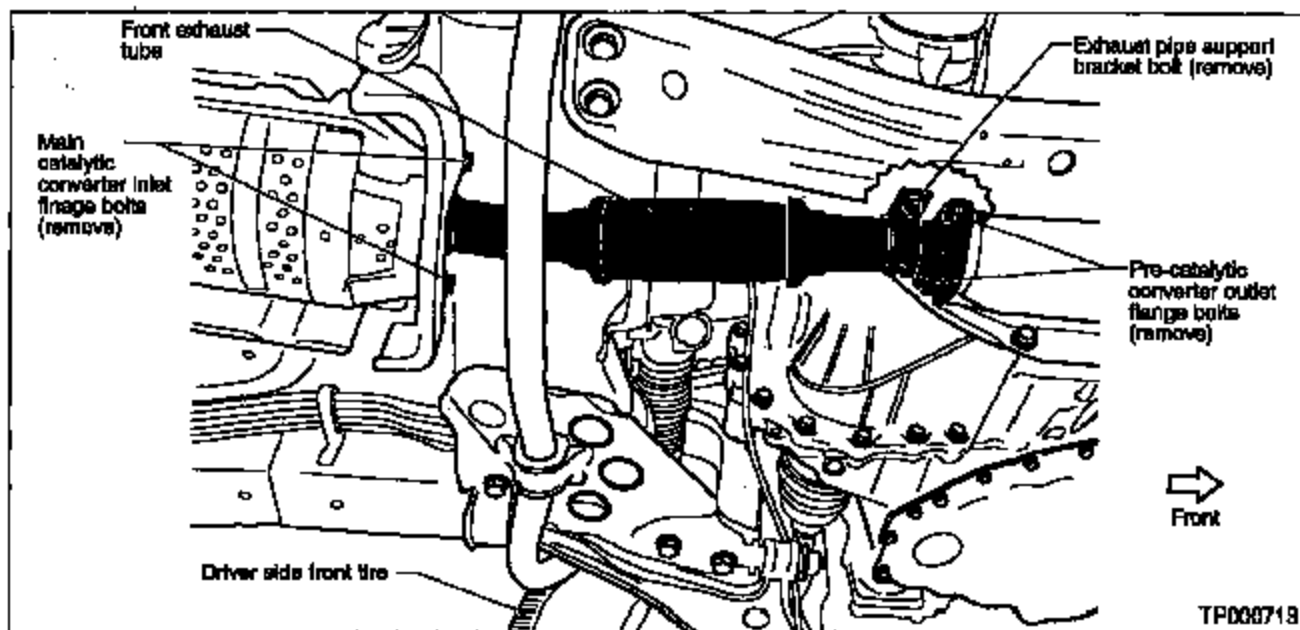
Figure 7

A. Remove and save the two bolts that secure the front exhaust tube to the pre-catalytic converter (see Figure 7).

B. Remove and save the two bolts that secure the front exhaust tube to the main catalytic converter (see Figure 7).

C. Remove the bolt that secures the front exhaust tube support bracket to the vehicle (see Figure 7).

7. Re-install the two mounting bolts that secure the front exhaust tube to the pre-catalytic converter (see Figure 7). Tighten the bolts to 60 – 70 Nm (6.1 – 7.1 kg-m, 44 – 52 ft-lbs).
8. Re-install the bolt that secures the exhaust tube support bracket to the vehicle (see Figure 7). Tighten the bolt to 20.6 – 26.5 Nm (2.1 – 2.7 kg-m, 15.2 – 19.5 ft-lbs).

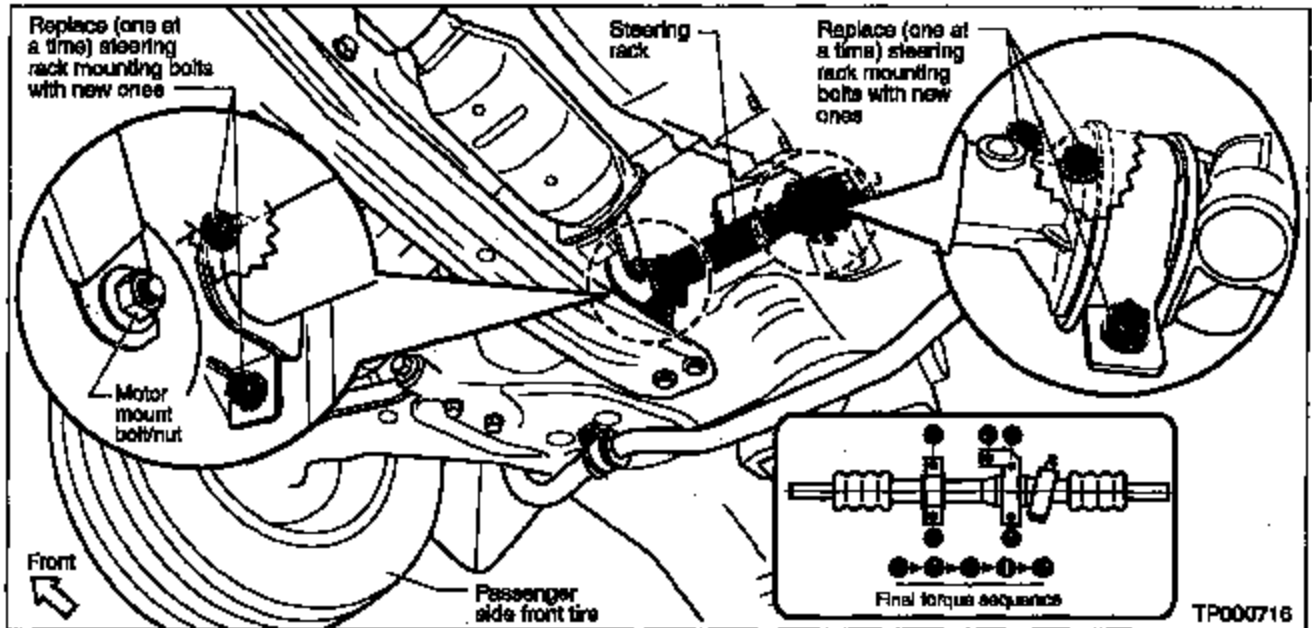
Figure 8

2. Replace, one at a time and finger-tight ONLY, the five old steering rack mounting bolts with the new bolts. See Figure 8.

3. Tighten the new steering rack mounting bolts to 78 Nm (8 kg-m, 58 ft-lbs) according to the "Final torque sequence" in Figure 8.
