File In Section: Product Campaigns
Bulletin No.: 00093A
Date: February, 2001

Campaign Bulletin

PRODUCT SAFETY CAMPAIGN

SUBJECT: 00093A – FRONT BRAKE PIPE CONTACT WITH BODY CROSS SILL

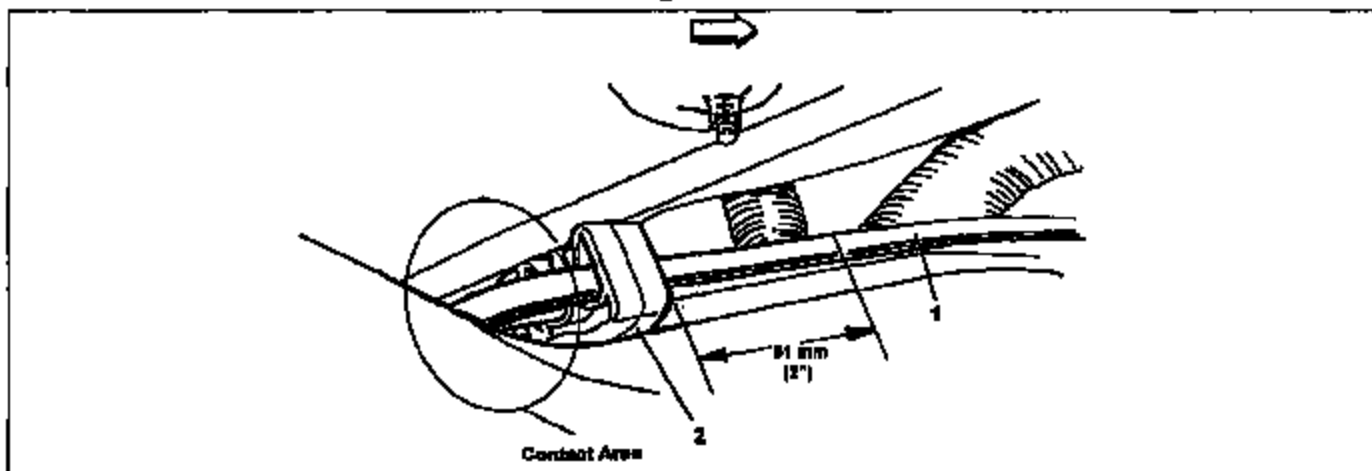
Figure 1

2. Locate the area just rearward of the driver side front-wheel-well opening, where the brake pipes leading from the Brake Pressure Modulator Valve (BPMV) crossover from the outboard to the inboard side of the frame rail, Figure 1.

3. Inspect the brake pipe (1) that leads to the right front brake caliper for any indication that it has been contacted by the body in the area where it is routed over the frame rail.

- Brake pipe **contacted** by body - Proceed to Step 5 and replace the brake pipe section, and then install a new additional brake pipe bracket.
5. Measure and mark a point on the brake pipe (1) that is 50 mm (2 in) forward of the brake pipe clip (2), as shown in Figure 1.

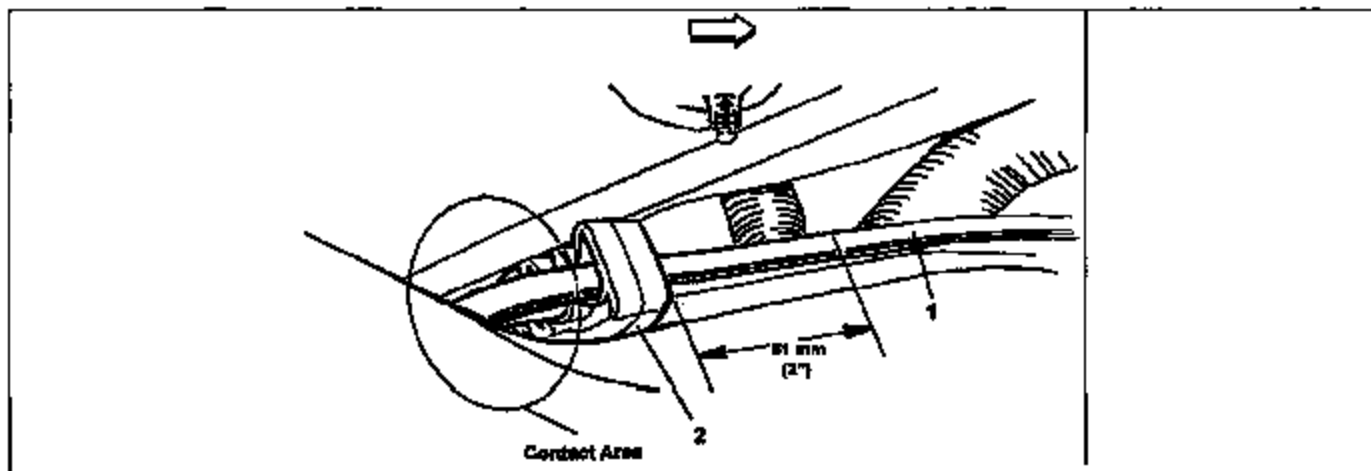
Figure 1

2. Locate the area just rearward of the driver side front wheel well opening, where the brake pipes leading from the brake pressure modulator valve (BPMV) cross over from the outboard to the inboard side of the frame rail (Figure 1).
3. Inspect the brake pipe (1) that leads to the right front brake caliper for any indication that it has been contacted by the body in the area where it is routed over the frame rail.
4. Based on the results of the inspection performed in Step 3, proceed as indicated below:
 - **No brake pipe to body contact** – Proceed to Step 5 and install new additional brake pipe clip.
 - **Brake pipe contacted by body** – Proceed to Step 8 and replace the brake pipe section.

7. Insert the brake pipe (1) into the inboard retaining feature of the new brake clip (3) and snap the clip closed. Proceed to Step 22.
8. Measure and mark a point on the brake pipe (1) that is 50 mm (2 in) forward of the brake pipe clip (2) as shown in Figure 1.
