Subject: Safety Recall 00V-350 NSA-11paw
(Ford Number 00S38)

SUBJECT: Safety Recall 00S38: Certain 1998-2000 Model Year Contour Bi-fuel Vehicles – Fuel Filler Grommet

GASOLINE TANK FILLER NECK GROMMET REPLACEMENT

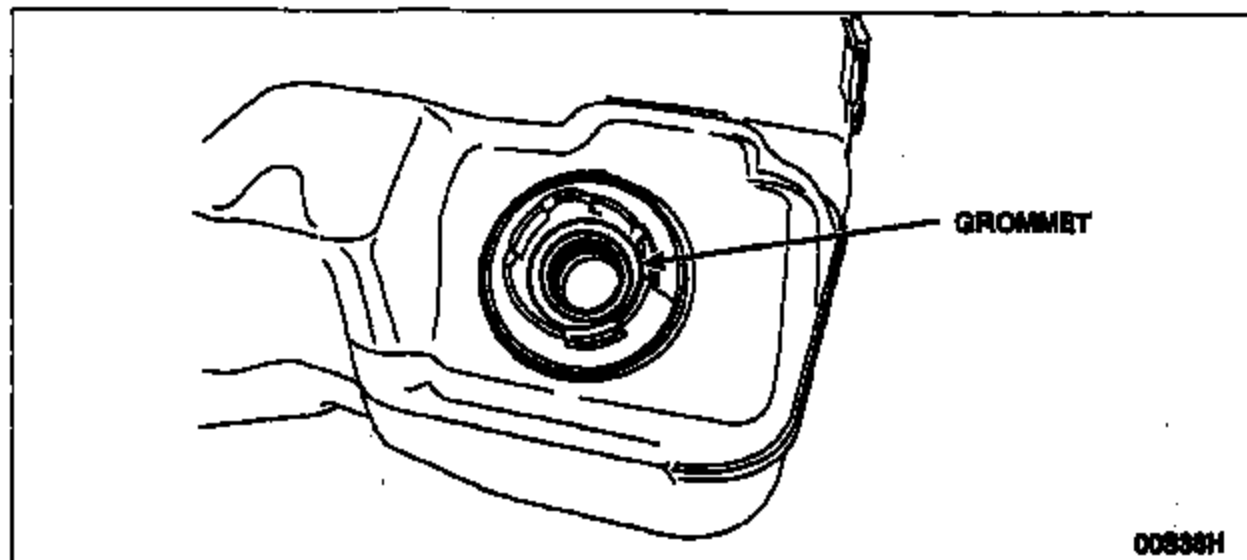
FIGURE 8

Certain 1998-2000 model year Contour vehicles that were modified for Bi-fuel may have a fuel filler grommet that was damaged during the modification process.

If the fuel filler grommet is damaged, it may leak. An accumulation of fuel in the presence of an ignition source could potentially result in a fire.

14. Remove the fuel filler neck grommet. See Figure 8.

15. Clean any fuel or dirt present in the grommet seating area.
16. Install a new grommet, making sure it is fully seated.
17. LIGHTLY LUBRICATE THE GROMMET AND THE FUEL FILLER PIPE WITH PETROLEUM JELLY TO HELP EASE FILLER PIPE REINSTALLATION. Make sure the inner fuel tank filler seal is in position and that it does not become dislodged during fuel tank filler pipe installation.
