Campaign Bulletin

File In Section: Product Campaigns
Bulletin No.: 00100A
Date: August, 2001

SUBJECT: 00100A – CONSOLE/ARMREST CAM LATCH COMPLIANCE

**MODELS: 1998-2001 GMC ENVOY
2000-2001 GMC JIMMY DIAMOND EDITION**

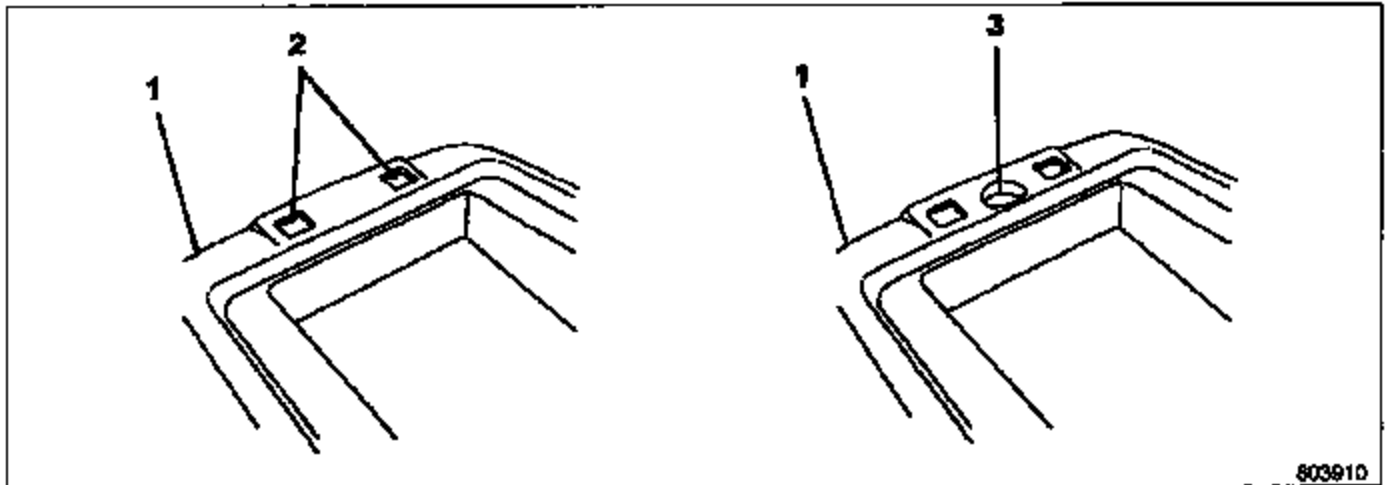
Inspection - 1998 Models Only

Some early production 1998 vehicles were manufactured with an upper console plate (1) that does not have a round or D-shaped hole (3) located between the two square holes (2). In order to perform this campaign the vehicle **MUST HAVE** this additional hole (3) in the upper console plate.

1. Verify whether or not the vehicle has this additional hole by opening the console compartment cover and comparing the holes in the upper console plate to those shown in the illustration above.
 - If the upper console plate **DOES** have the hole (3) located between the two square holes (2), proceed to the service procedure titled "Inner Console Cover Replacement".
 - If the upper console plate does **NOT** have the hole (3) located between the two square holes (2), proceed to the service procedure titled "Upper Console Plate Replacement".

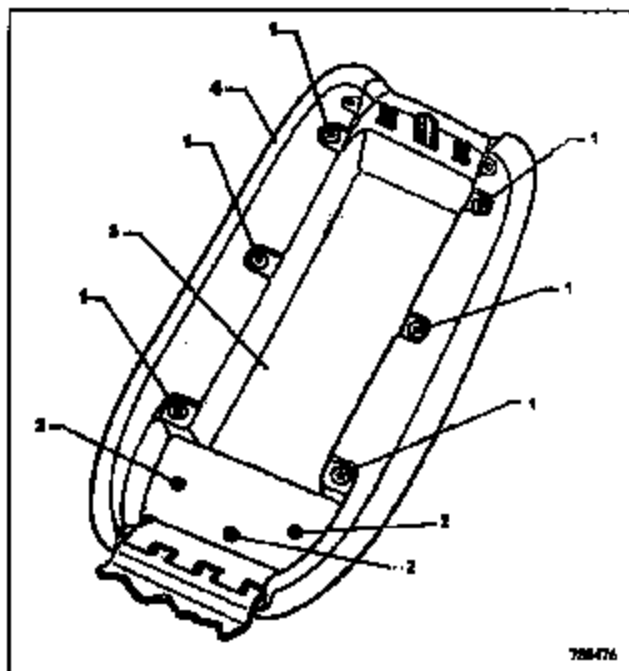
SERVICE PROCEDURE

General Motors has decided that certain 1998-2001 GMC Envoys and 2000-2001 GMC Jimmy Diamond Editions fail to conform to Federal/Canada Motor Vehicle Safety Standard 201, "Occupant Protection in Interior Impacts". These vehicles have a console cover/armrest cam latch that could release at less than the 10 g vertical load requirement of the standard. During a crash, the console cover could open and the cover or items stored under it could injure an occupant.

1. Open the floor console cover and remove the six torx head screws (1) and the three phillips head screws (2) that attach the inner console cover to the outer console cover.
2. Separate the inner console cover (3) from the outer cover (4) and discard the inner cover. It is not necessary to remove the console outer cover from the hinge assembly.
3. Install the new inner console cover to the outer console cover.
4. Install the three phillips head screws (2) and then the six torx head screws (1). Tighten all screws to 1.5 Nm (13 lb in).
5. Close the console cover and verify that the latch operates properly.
6. Install the GM Campaign Identification Label.
