Campaign No. 2001010002

January 2001

TO: ALL MERCEDES-BENZ CENTERS
 SUBJECT: **MODELS 220, 215**
REPLACEMENT OF HEATED WASHER HOSE

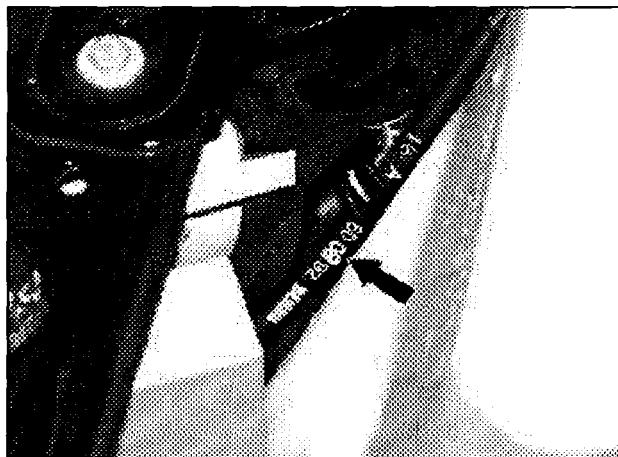
Figure 1

The **faulty** heated washer hose, which is located next to the washer water reservoir behind the right hand headlamp, is identified via both the part number 220 860 08 92 (arrow, Figure 1) **and** a single PVC tube covering both wires (arrow, Figure 2) at the electrical connector.

If a faulty heated washer hose is found, please follow the procedure on page 3, for replacing the faulty heated washer hose.

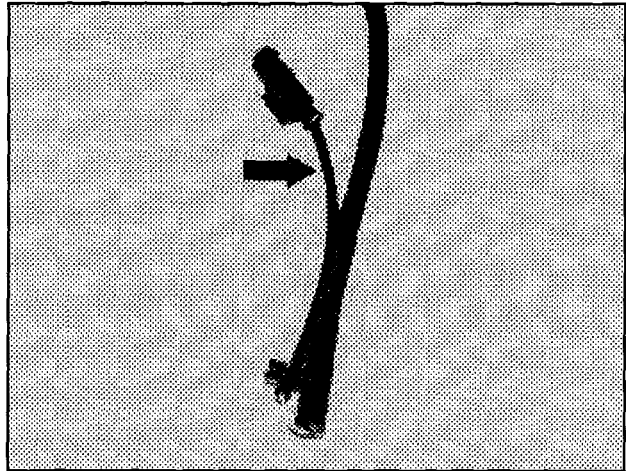
Figure 2

Single PVC tube covering both wires (arrow, Figure 2) at the electrical connector (12, Figure 3) shown.
