01V-262

SUBJECT: Safety Recall 01S26-S1:
Certain 1999, 2000 and 2001 Model Year Windstar Vehicles
Auxiliary Rear A/C Blower Wiring

REFERENCE: Safety Recall 01S26, dated August 15, 2001

AUXILIARY AIR CONDITIONING JUMPER HARNESS INSTALLATION

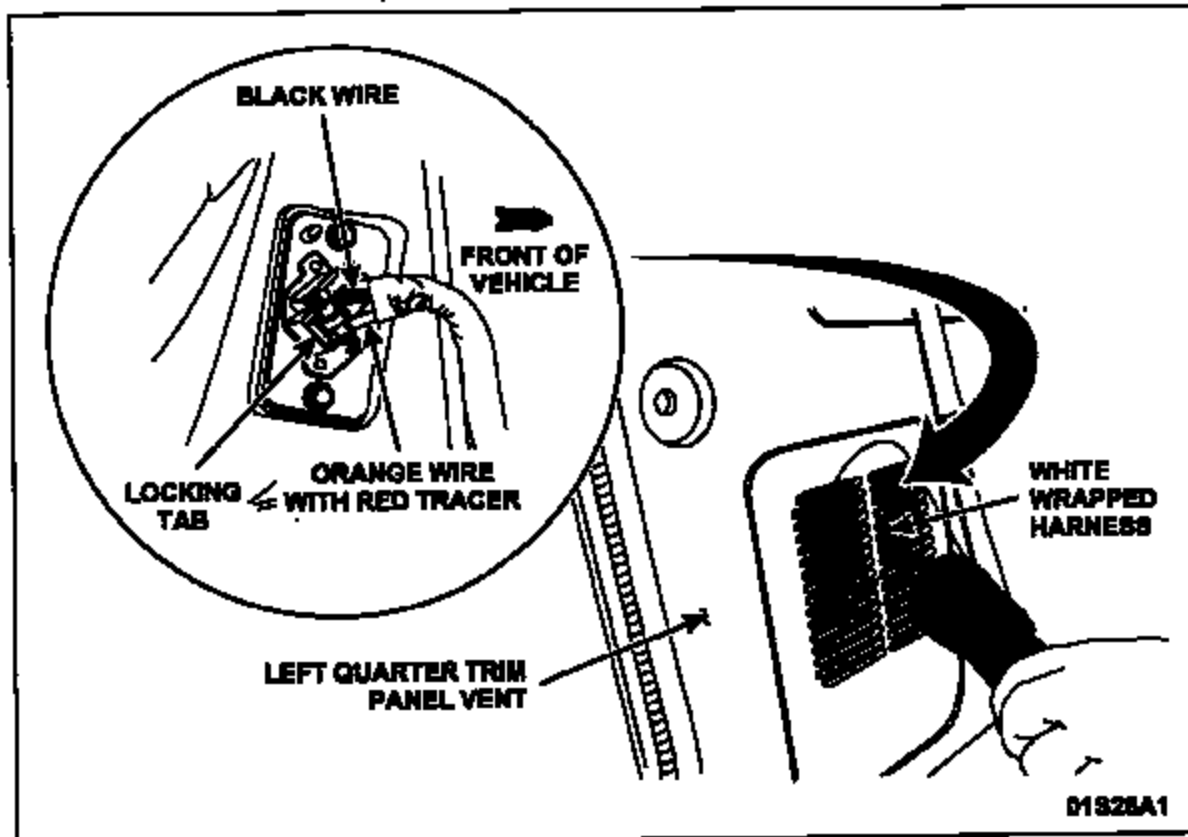
FIGURE 1

1. Open the liftgate and look through the left quarter trim panel to verify that the auxiliary blower motor wire harness has a white-colored wrapping.
 - If the white wrapping is present, the vehicle does not need to be repaired.
 - If the white wrapping is not present or not visible, use a flashlight to verify that the auxiliary blower motor electrical connector has a black wire installed to the left of the connector locking tab. There will be an orange wire with a red tracer to the right of the locking tab. See Figure 1.
 - If the black wire is present, the vehicle does not need to be repaired.
 - If the black wire is not present, the vehicle must be repaired.
