RECALL CAMPAIGN BULLETIN

NTB01-062a

VOLUNTARY RECALL CAMPAIGN REAR DOOR (HATCH) STRUT BRACKET REPLACEMENT

APPLIED VEHICLE: 1997 - 2001 Pathfinder (R50)

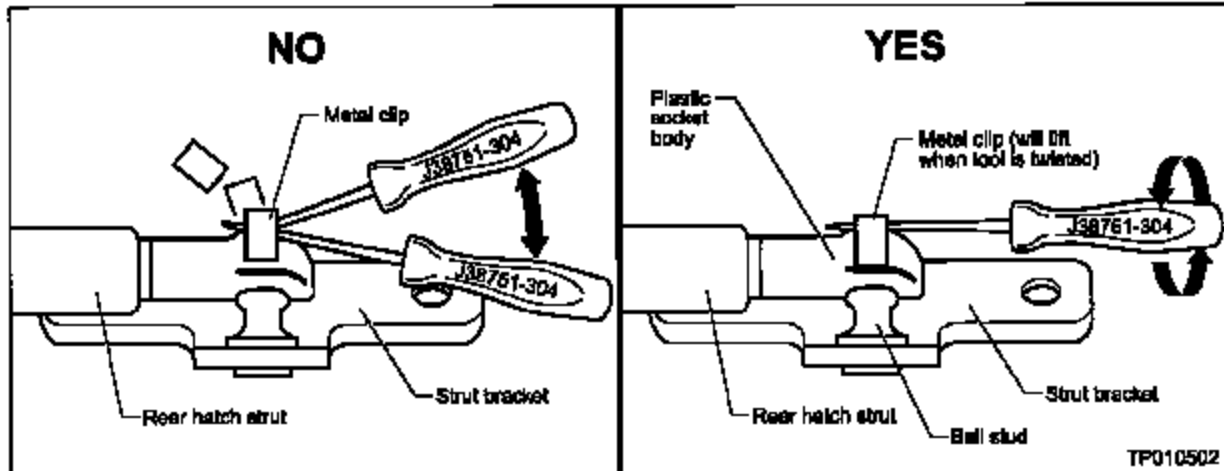
Figure 5a

CAUTION: Do not pry the metal clip off of the plastic socket as this will damage the strut (see Figure 5a).

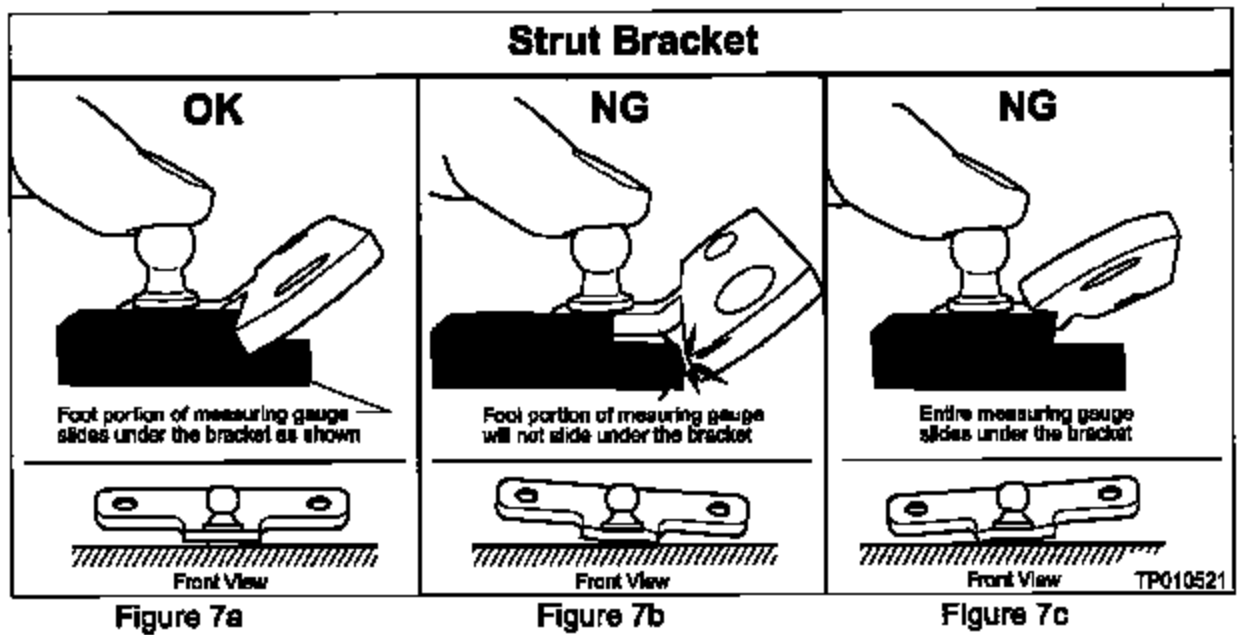
The bracket is OK if:

- The "foot" portion of the Measuring Gauge Tool can be slid (on both ends of the bracket) between the bracket and the flat surface as shown in Figure 7a
- The top of the Measuring Gauge Tool stops against the bracket (both ends of the bracket), as shown in Figure 7a

The bracket is not OK if:

- The "foot" portion of the Measuring Gauge Tool will NOT slide (on one end of the bracket) between the bracket and the flat surface (bracket bend down), as shown in Figure 7b
- The entire Measuring Gauge Tool will slide (on one end of the bracket) between the bracket and the flat surface (bracket bent up), as shown in Figure 7c

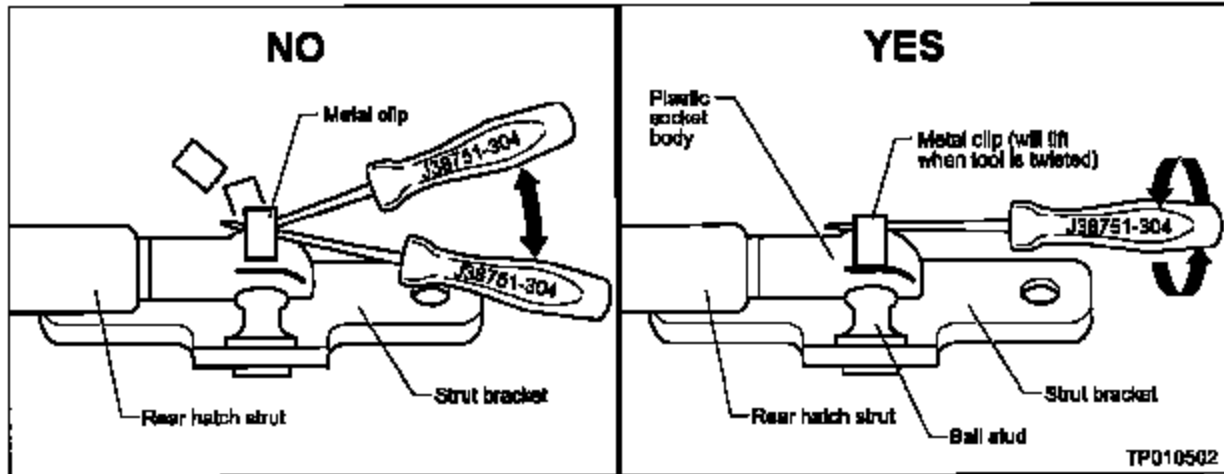
Figure 5a

CAUTION: Do not pry the metal clip off of the plastic socket as this will damage the strut (see Figure 5a).

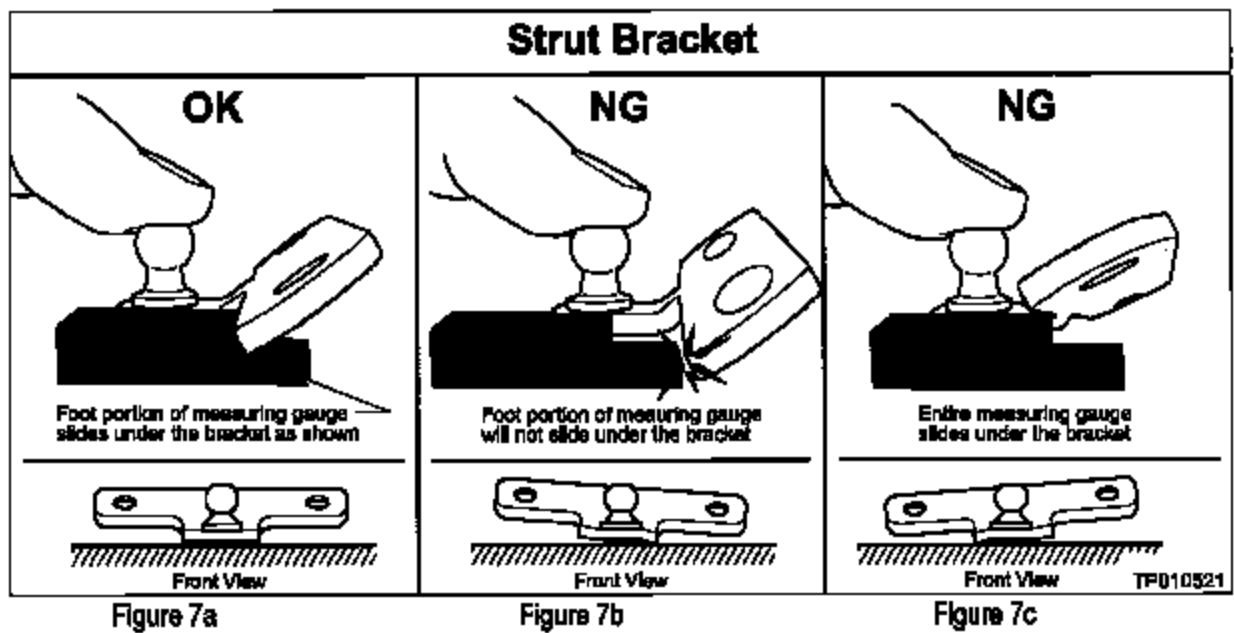
The bracket is OK if:

- The "foot" portion of the Measuring Gauge Tool can be slid (on both ends of the bracket) between the bracket and the flat surface as shown in Figure 7a
- The top of the Measuring Gauge Tool stops against the bracket (both ends of the bracket), as shown in Figure 7a

The bracket is not OK if:

- The "foot" portion of the Measuring Gauge Tool will NOT slide (on one end of the bracket) between the bracket and the flat surface (bracket bent down), as shown in Figure 7b
- The entire Measuring Gauge Tool will slide (on one end of the bracket) between the bracket and the flat surface (bracket bent up), as shown in Figure 7c
