Reference: NHTSA Identification Number 02V-042

Dealer Service Instructions for:

Safety Recall No. B04 - Power Distribution Center Cable Connections

2001 (BR/BE) Dodge Ram Truck

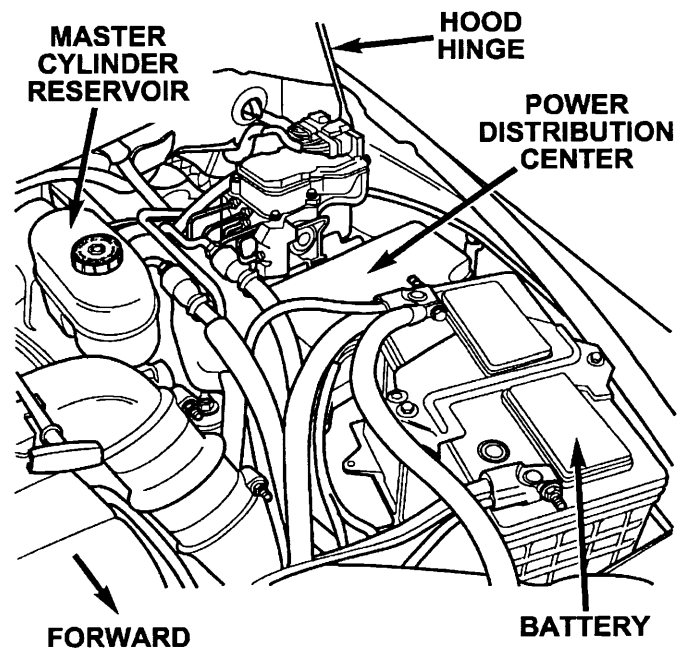
Figure 1 – Diesel Engine Shown

3. Remove the cover from the Power Distribution Center (PDC). The PDC is located on the left (driver’s) side of the engine compartment, next to the battery (Figure 1).

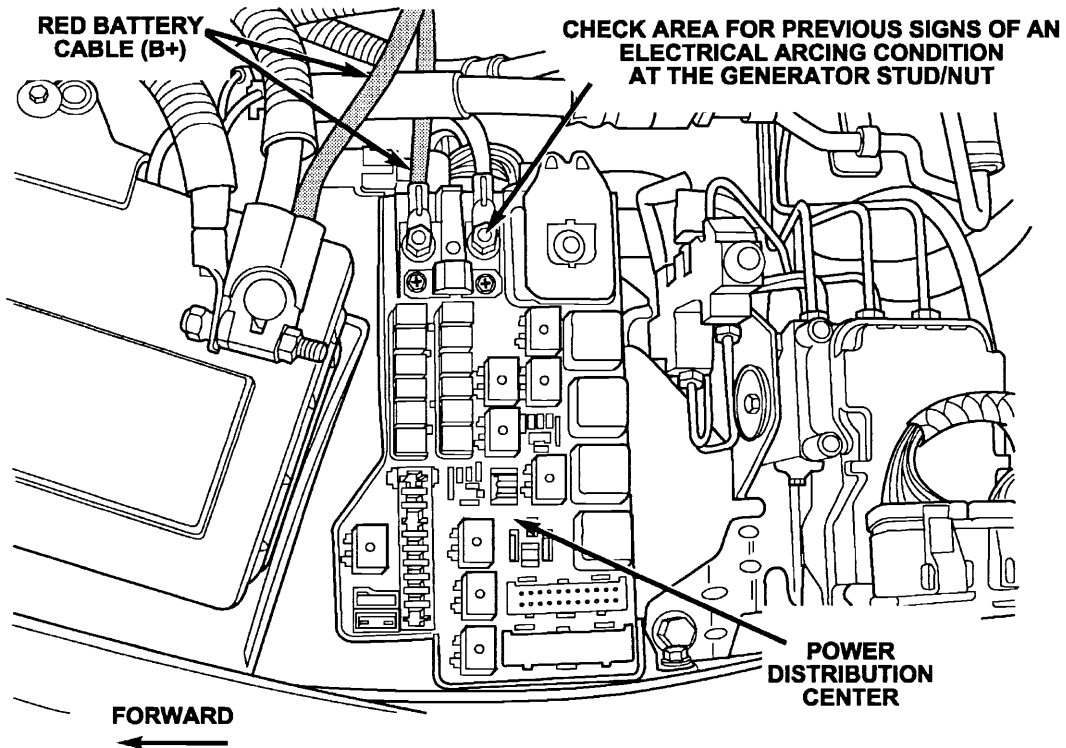
Figure 2 – Top View

4. Inspect the black generator cable connection and the surrounding area on the Power Distribution Center for signs of previous electrical arcing (Figure 2).
 - If there are **no signs of a previous electrical arcing condition** at the Power Distribution Center generator connection, continue with Step 5 of this procedure.
 - If there are **signs of a previous electrical arcing condition** at the Power Distribution Center generator connection and the buss bar, stud and/or nut require replacement, continue with Section “B – Power Distribution Center Stud Repair.” *Very few vehicles are expected to require Power Distribution Center stud repair.*

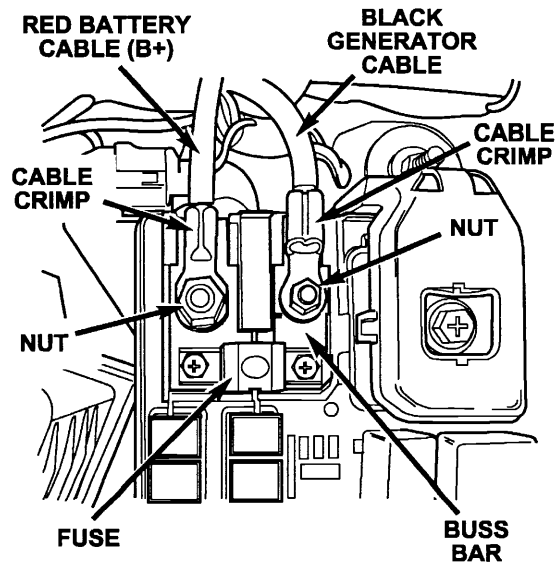
Figure 3 – Top View

5. Inspect the black generator cable and red battery cable (B+) terminals. They both must be oriented so that the cable crimp openings are facing upward, away from the PDC housing (Figure 3). If either (or both) of the terminals are installed with the crimp opening facing downward, remove the retaining nut, lift the terminal off of the stud and reinstall the cable terminal(s) onto the stud with the crimp facing up as shown in Figure 3.

6. Install the cable terminal retaining nut(s). Tighten the nut(s) to 80 in. lbs. (9 N·m).

7. If the generator and battery cable terminals are oriented correctly, verify that both retaining nuts are tight. Tighten both retaining nuts to 80 in. lbs. (9 N·m).

12. Verify that the red battery cable (B+) terminal crimp opening is facing upward (Figure 3). Remove the retaining nut and reposition the cable terminal if required. Verify that the retaining nut is tight by torquing the retaining nut to 80 in. lbs. (9 N·m).
13. Install the PDC cover onto the PDC housing.
14. Connect the negative battery cable(s).
 - **On trucks equipped with a gas engine**, tighten battery clamp nut to 35 in. lbs. (4 N·m).
 - **On trucks equipped with a diesel engine**, tighten the battery clamp nuts to 80 in. lbs. (9 N·m).
15. Close the hood.
