Reference: NHTSA Identification Number 02V-076

**Safety Recall No. B09**  
**Rear Sound Barrier/Outboard Seat Belts**

1997-1999 (NS) Dodge Caravan, Plymouth Voyager and Chrysler Town & Country Short Wheel Base Minivans

The D-pillar mastic sound barrier patches on about 410,000 of the above vehicles may loosen and drop into the rear seat (3<sup>rd</sup> row), outboard seat belt assemblies. This could cause the rear outboard seat belts to become inoperative.

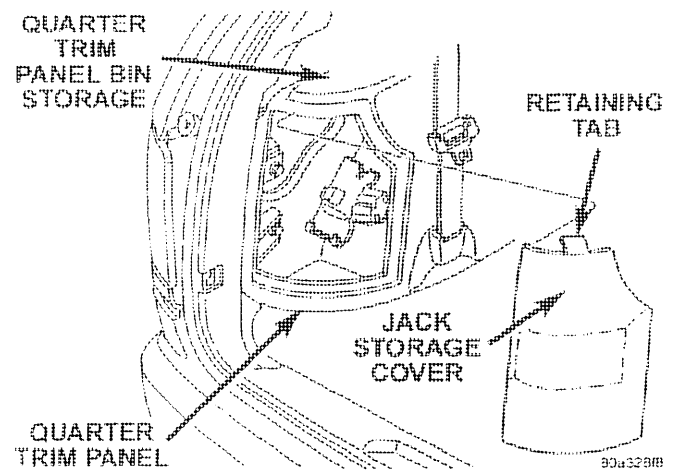
Figure 1

4. Remove the liftgate opening header trim panel.
5. Remove the liftgate sill plate.
6. Remove the left rear seat belt lower anchor bolt.
7. Open the left quarter panel storage bin cover.
8. Lift upward and rearward on the jack storage cover retaining tab to disengage it, then remove the jack storage cover (Figure 1).
9. Pull the rear of the upper rear quarter panel bolster out to access one of the D-pillar trim panel screws.

20. Install the D-pillar trim panel screws.
21. Install the rear quarter panel upper bolster.
22. Install the jack storage cover (Figure 1) and then close the storage bin cover.

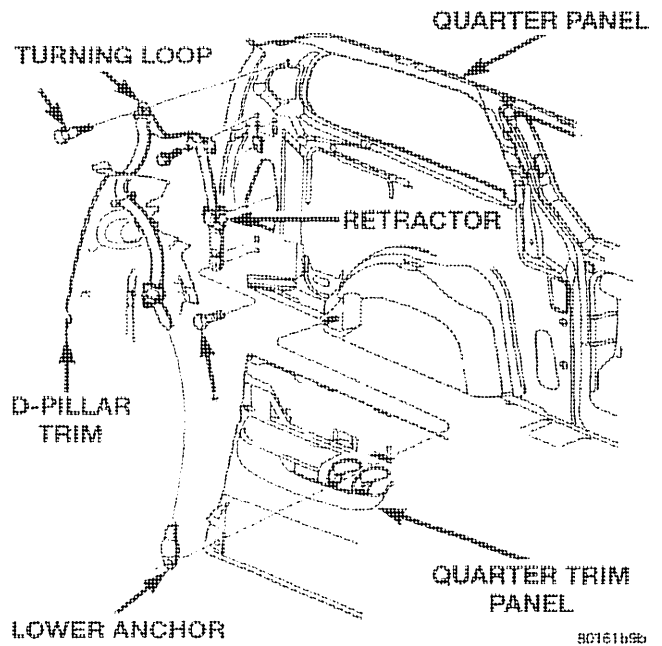
Figure 2

10. Remove the three (3) left D-pillar trim panel screws (Figure 2).
11. Disengage the hidden D-pillar trim panel clips.
12. Disconnect the speaker wiring connector (if equipped).
13. Pass the seat belt through the slot in the D-pillar trim panel and then remove the trim panel.

- a. Remove the seat belt guide loop bolts (Figure 2).
  - b. Remove the seat belt turning loop anchor bolt (Figure 2).
  - c. Remove the seat belt retractor anchor bolt and then remove the seat belt assembly from the vehicle (Figure 2).

- d. Install the new seat belt assembly into the D-pillar pocket (Figure 2). Tighten the retractor anchor bolt to 29 ft-lbs (39 N·m).
  - e. Install the seat belt turning loop anchor bolt (Figure 2). Tighten the turning loop anchor bolt to 29 ft-lbs (39 N·m).

- f. Install the seat belt guide loop onto the D-pillar (Figure 2). Tighten the guide loop bolts to 29 ft-lbs (39 N·m).
17. Pass the seat belt through the slot in the D-pillar trim panel.

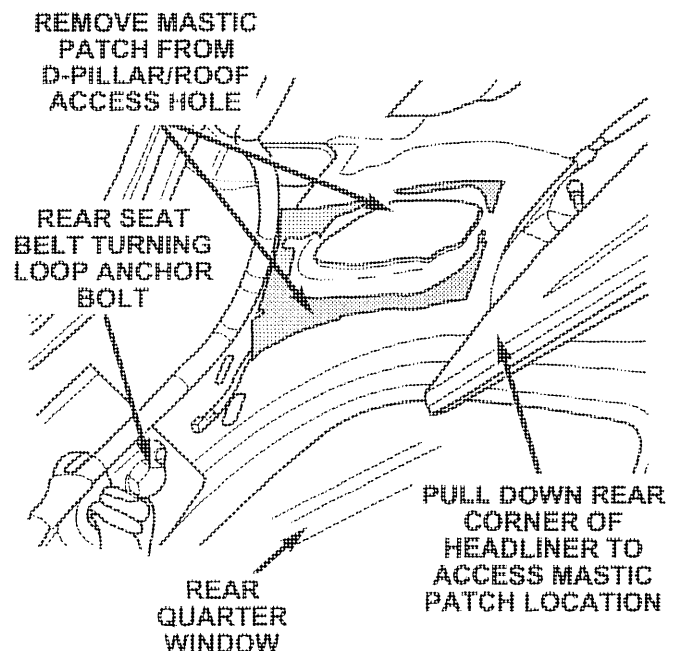
Figure 3 – Left Side Shown

14. Pull the rear corner of the headliner down and remove the mastic patch from the upper surface of the D-pillar (Figure 3) or from behind the D-pillar trim panel (if patch has already separated).

29. Pass the seat belt through the slot in the D-pillar trim panel and then remove the trim panel.
30. Pull the rear corner of the headliner down and remove the mastic patch from the upper surface of the D-pillar (Figure 3) or from behind the D-pillar trim panel (if patch has already separated).
