Re: 49 CFR Part 573; Recall of Mercedes-Benz S-Class Model 220

Subject: Voluntary Recall Campaign MY '00 and '01 – S-Class Battery Anti-Static cover installation

Campaign No.2002110014
February 2003

SUBJECT: MODEL 220 (M.Y. 2000 and 2001 [up to VIN No. 204036])
RETROFIT OF THE ANTI-STATIC INSULATION COVER ON WET CELL
STARTER BATTERY

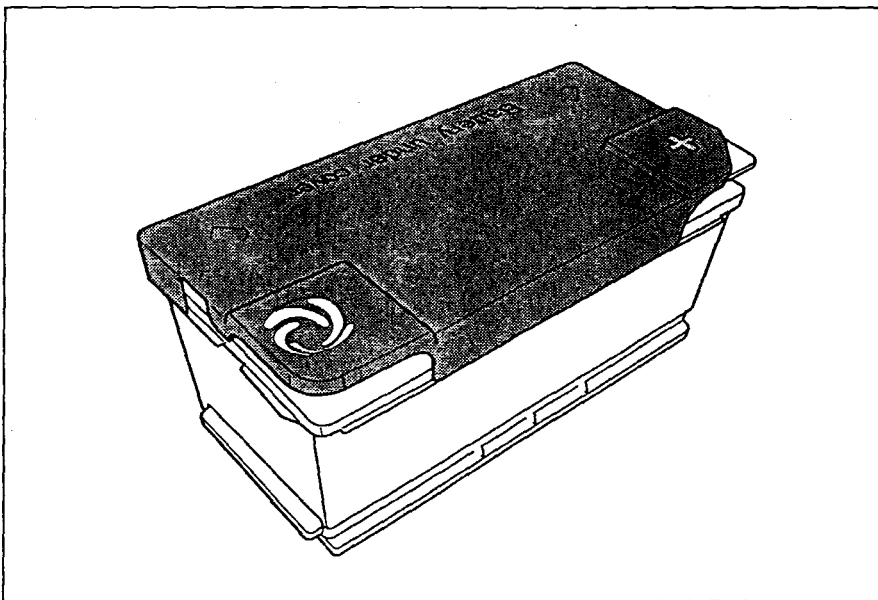
Figure 3

DCAG has determined that S-Class vehicles for Model Year 2000 and 2001 require the installation of an anti-static insulation cover (gray cover, Figure 3, page 3) over the wet cell starter battery case. Additionally, a battery electrolyte level check (b, Figure 2, page 2), must be performed as part of this Recall Campaign. The battery (G1, Figure 1) is located on the right hand side of the trunk. Attached is a sample copy of a letter which owners of the effected vehicles will receive.

9. Check bolt (1, Figure 1) of the battery mount for tightness.
10. Install battery anti-static insulation cover (Gray cover, Figure 3) onto battery by first placing cover over the top of the battery (White case, Figure 3), with the "+" marking of the cover positioned over the positive terminal of the battery. Evenly press down on the battery static insulation cover, and notice that the cover will "snap" into place (Figure 3), over the top of the battery case.
11. Visually ensure that the "spiral plastic" (gray cover, Figure 3) above the negative post area of the cover is indeed making contact with the battery negative terminal.

When performing wet cell battery maintenance on Model 220, the anti-static insulation cover must be removed to gain access to the battery cells, please ensure that the anti-static insulation cover is re-installed as necessary, by performing Steps 10 and 11 on page 3.
