03V-274 ① of ④

On July 21, 2003, Honda Motor Co., Ltd. determined that a defect relating to motor vehicle safety exists in the automatic transmission shift cable linkage in the vehicles listed below. The following information is submitted pursuant to the requirements of 49 CFR 573.5.

Identification of potentially affected vehicles:

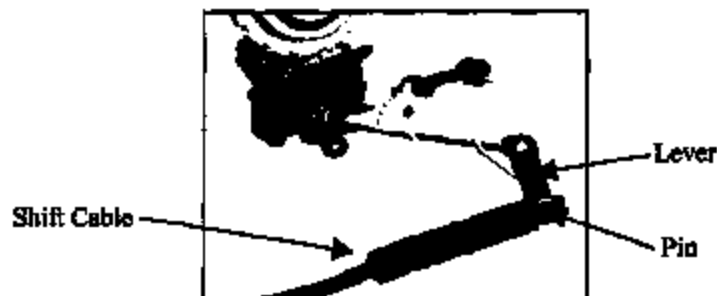
The automatic transmission shift cable pin plating did not have adequate corrosion resistance. Corrosion, which occurs more rapidly in severe winter areas, may cause the shift cable pin to seize in the linkage, preventing full movement of the shift cable lever. As a result, despite shifting the gear selector lever to the Park position, the transmission may not engage the parking pawl. If this condition exists and the vehicle operator fails to engage the parking brake, the vehicle could roll and a crash could occur.

1. Inspect the shift cable linkage for corrosion. If corrosion causes binding, replace the shift cable.
2. Install a new corrosion-resistant control pin. Apply grease to the entire joint of the shift cable and lever.
3. Some 2002 CR-Vs do not have the latest control cover so those vehicles will be updated with a new cover.
4. Foam tape will be applied to all control covers to prevent water intrusion in the shift cable linkage area.
