Re: 49 CFR Part 573: Recall of Mercedes-Benz M-Class

Subject: Voluntary Recall Campaign 1998 - 2003 MY M-Class Power Steering Fluid Cooling Hose Clamp

Campaign No.2003040005
May 2003

SUBJECT: MODEL 163.154/157/172/174/175
REPLACEMENT OF CLAMP FOR LOWER POWER STEERING HOSE DUE TO
POSSIBLE FLUID LOSS AT RADIATOR

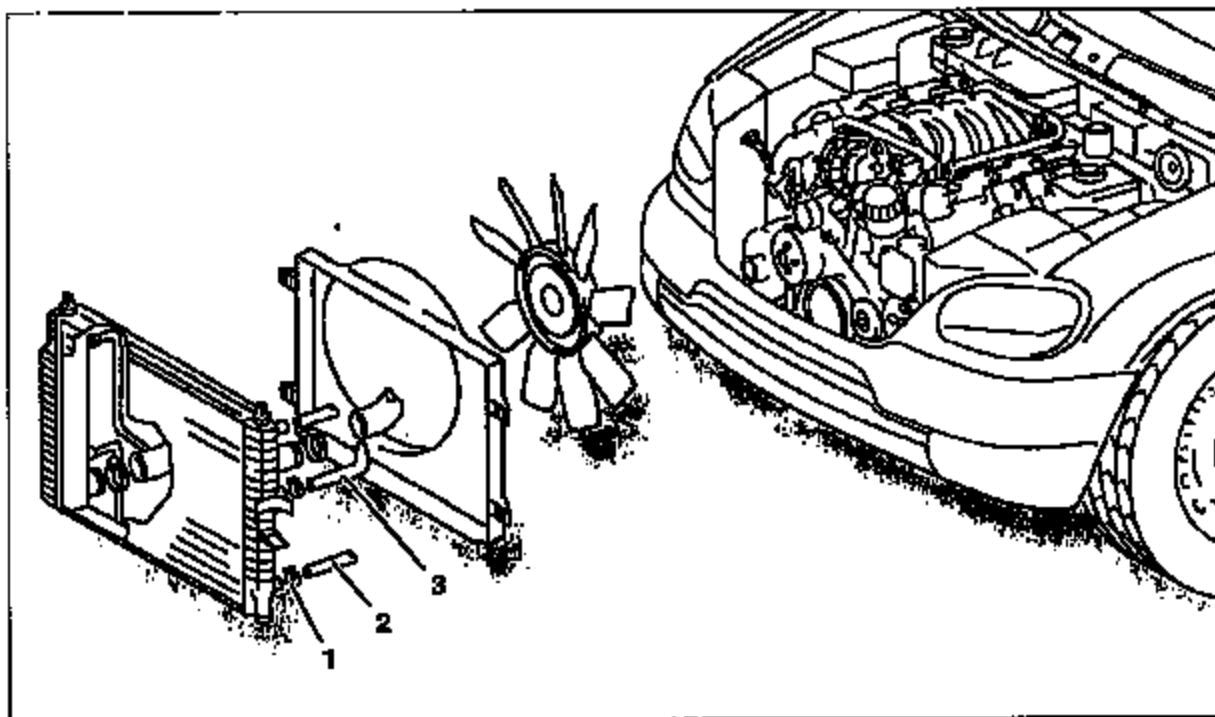
Figure 1

DCAG has determined that the lower power steering hose clamp (1, Figure 1) located on the lower power steering hose (2, Figure 1) at the lower left hand corner of the radiator must be replaced. The hose clamp may not provide sufficient clamping force for this connection and may cause fluid loss. Please review the Effective Serial Number Chart located on page 2. Attached is a sample copy of a letter which owners of the affected vehicles will receive.

1. Prior to performing this Recall Campaign, please check VMI to insure the vehicle is involved and to determine if the vehicle has been previously repaired.
2. Shut-off engine and remove ignition key from ignition lock.
3. Open engine hood.
4. Visually locate both upper (3, Figure 1) and lower (2, Figure 1) power steering hoses and then using MBUSA Special Tool: 000 598 40 37 00, clamp off (near radiator) both upper and lower power steering hoses to prevent any fluid leaks.
5. Carefully loosen only the existing hose clamp (1, Figure 1) and then slide hose clamp away from the radiator. Do not remove existing hose clamp at this point.

In order to prevent power steering fluid leak, do not disturb or remove lower power steering hose (2, Figure 1) in any way.

6. Carefully inspect the condition of the lower power steering hose (2, Figure 1) at the radiator.

7. Open replacement hose clamp just enough for clamp to fit over the outer circumference of the lower power steering hose (2, Figure 1).

8. Slide the installed new hose clamp toward the radiator and locate in the proper position on the lower steering hose (1, Figure 1) as shown and tighten hose clamp screw.
- ⑫ Observe tightening torque of: Nm 2.0 + .5 / - .1
9. Remove previously loosened old hose clamp (see step 5) from hose at this point.
10. Loosen and remove previously installed MBUSA Special Tool: 000 589 40 37 00 from both upper and lower power steering hoses.
11. Start-up engine and check for any fluid leaks from the power steering hoses at the radiator.
