Re: 49 CFR Part 573; Recall of Mercedes-Benz M-Class

NCA: ML Power Steering Hose Clamp Recall

Campaign No. 2003040005 May 2003
 Revised June 2003,
 Revised July 2003,
 Revised November 2003

SUBJECT: **MODEL 163.154/157/172/174/175
 REPLACEMENT OF CLAMP FOR LOWER POWER STEERING HOSE DUE TO
 POSSIBLE FLUID LOSS AT RADIATOR**

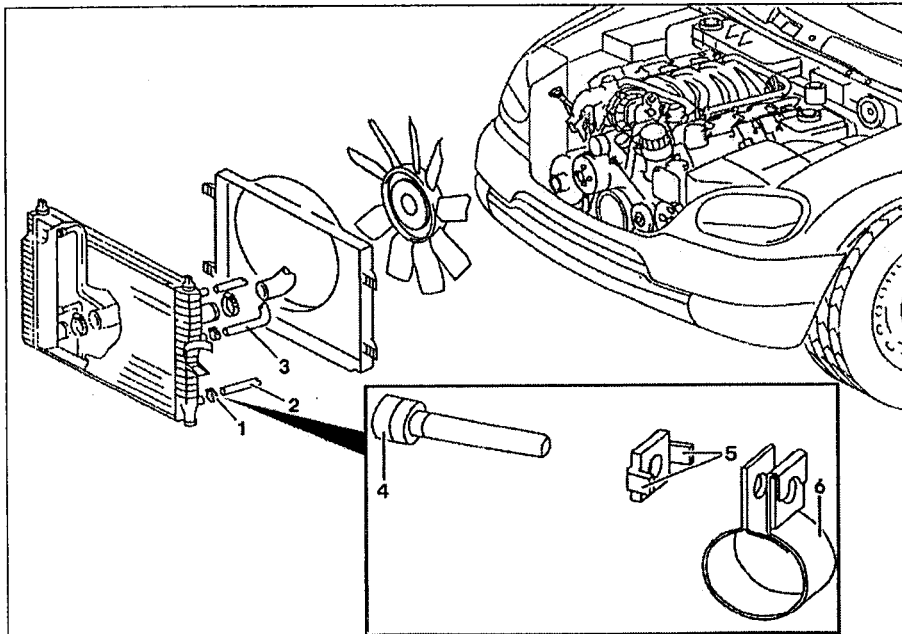
Figure 1

DCAG has determined that the lower power steering hose and hose clamp (1 and 2, Figure 1) at the lower left hand corner of the radiator must be replaced. The hose clamp may not provide sufficient clamping force for this connection and may cause fluid loss.

- 10. Install new power steering hose (2, Figure 1) in reverse order. (use new hose clamp, as provided in the repair kit).
- ⓘ Install **new** sealing rings (11, Figure 2) or rubber O-ring as applicable when installing new lower power steering hose (2)

- 11. As equipped: torque banjo bolt to 30 Nm or flare fitting with O-ring to 45 Nm, see WIS document: AR46.30-P-0500B
- 12. Slide the installed new hose clamp toward the radiator and locate in the proper position on the lower steering hose (1, Figure 1) as shown and tighten hose clamp screw (6, Figure 2).

- ⓘ Observe tightening torque of: Nm 2.0 + .5 / - 0.0 and proper orientation of the anti-rotation tabs (5, Figure 1).

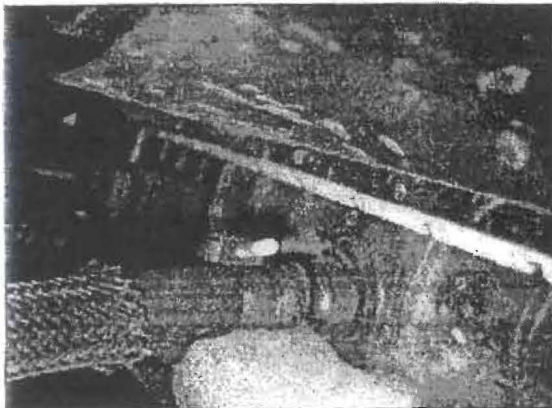
i Note: The hose could move by approximately $\frac{1}{4}$ of an inch on the nipple as depicted in Figure 1. However, if there are no signs of leakage and the hose will not slide easily by pulling on it, the tight connection is still preserved. In such a case, hose and clamp replacement is not necessary.

i Note: Figure 1 illustrates the new hose and clamp (screw type clamp) connection design listed in the parts information section. Further movement of the hose is prevented by a flare at the end of the nipple extending from the radiator.

If you receive customer reports in the above model vehicles of power steering leaks from the connection to the power steering cooler, please replace hose and clamp according to WIS document Number AR-46.25-U-0008GH with repair set.
