**Recall Campaign 03V – XXX: Retorque of Oil Drain Plug Located on Oil Filter Cover**

745i, 745Li, and 760Li produced from 5/20/2003 through 7/18/2003

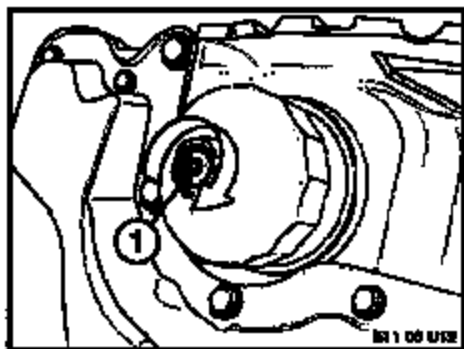
Some E65/E66 vehicles produced between 5/20/2003 and 7/18/2003 may have an insufficiently torqued oil drain plug. This Allen Head plug is located within the hex nut of the oil filter cover. A loosening of the plug could initially lead to an oil leak. If left unattended, a subsequent loss of oil would cause the illumination of the oil pressure light and a warning message in the instrument cluster. If a large amount of oil loss occurs, engine damage may result.

Raise vehicle on hoist. Utilizing an appropriate torque wrench, retorque the 6 mm Allen Head screw (shown as "1" in illustration below) to 10 Nm. Clean any residual oil from the surface of the oil pan and ensure that there is no further leakage.
