Re: 49 CFR Part 573; Recall of Mercedes-Benz M-Class

Manufacturer's Campaign Identification Number
2003040005

NHTSA Recall Number
03V-121

SUBJECT: **MODEL 183,154/157/172/174/175
 REPLACEMENT OF CLAMP FOR LOWER POWER STEERING HOSE DUE TO
 POSSIBLE FLUID LOSS AT RADIATOR**

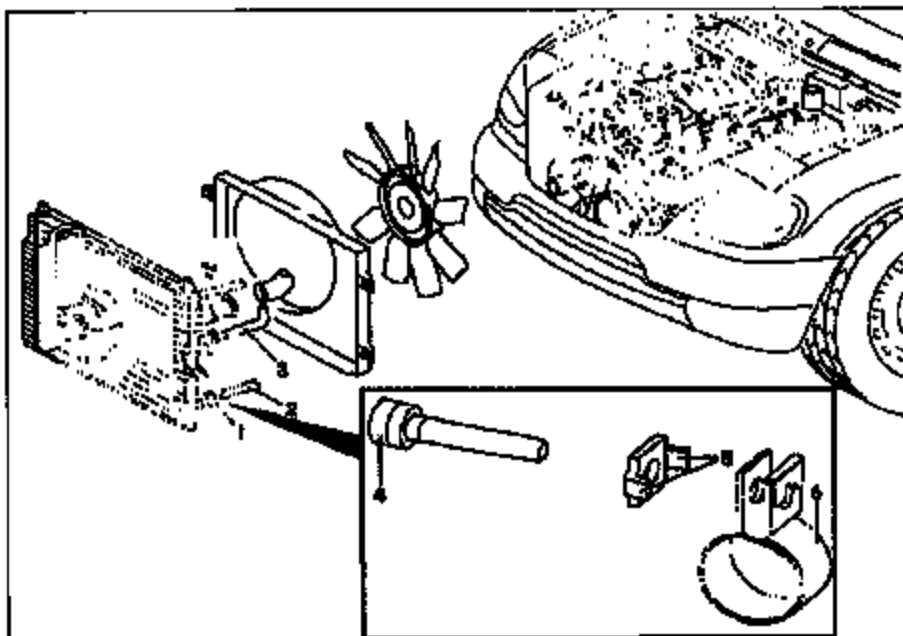
Figure 1

DCAG has determined that the lower power steering hose clamp (1, Figure 1) located on the lower power steering hose (2, Figure 1) at the lower left hand corner of the radiator must be replaced, with a new clamp (6, Insert, Figure 1). The hose clamp may not provide sufficient clamping force for this connection and may cause fluid loss.

1. Prior to performing this Recall Campaign, please check VMI to insure the vehicle is involved and to determine if the vehicle has been previously repaired.
2. Shut-off engine and remove Ignition key from Ignition lock.
3. Open engine hood.
4. Visually locate both upper (3, Figure 1) and lower (2, Figure 1) power steering hose and then using MBUSA Special Tool: 000 689 40 37 00, clamp off (near radiator) both upper and lower power steering hoses to prevent any fluid leaks.
5. Carefully loosen only, the existing hose clamp (1, Figure 1) and then slide hose clamp away from the radiator. Do not remove existing hose clamp at this point.

In order to prevent power steering fluid leak, do not disturb or remove lower power steering hose (2, Figure 1) in any way.

6. Carefully inspect the condition of the lower power steering hose (2, Figure 1) at the radiator.

NOTE: The lower power steering hose should not be replaced unless the outer casing displays any cuts or splits. If there is any evidence of fluid loss, please check and replenish fluid at power steering fluid reservoir.
