Re: 49 CFR Part 573: Recall of Mercedes-Benz M-Class

Campaign No.2003040005
June 2003

SUBJECT: MODEL 163.154/157/172/174/175
REPLACEMENT OF CLAMP FOR LOWER POWER STEERING HOSE DUE TO
POSSIBLE FLUID LOSS AT RADIATOR

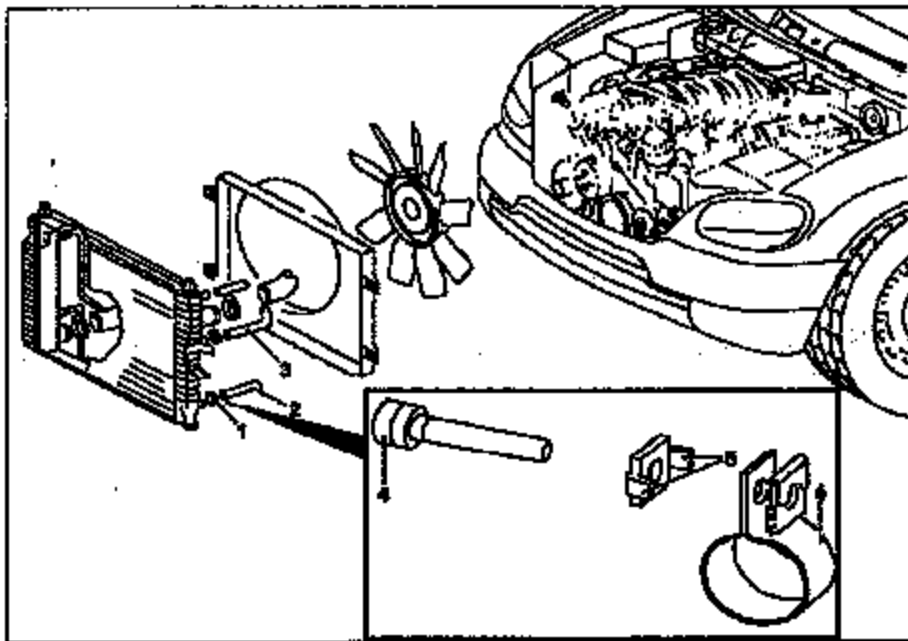
Figure 1

DCAG has determined that the lower power steering hose clamp (1, Figure 1) located on the lower power steering hose (2, Figure 1) at the lower left hand corner of the radiator must be replaced, with a new clamp (6, Insert, Figure 1). The hose clamp may not provide sufficient clamping force for this connection and may cause fluid loss.

6. Carefully inspect the condition of the lower power steering hose (2, Figure 1) at the radiator.

NOTE: The lower power steering hose should not be replaced unless the outer casing displays any cuts or splits. If there is any evidence of fluid loss, please check and replenish fluid at power steering fluid reservoir.

1. Prior to performing this Recall Campaign, please check VMI to insure the vehicle is involved and to determine if the vehicle has been previously repaired.
2. Shut-off engine and remove ignition key from ignition lock.
3. Open engine hood.
4. Visually locate both upper (3, Figure 1) and lower (2, Figure 1) power steering hose and then using MBUSA Special Tool: 000 589 40 37 00, clamp off (near radiator) both upper and lower power steering hoses to prevent any fluid leaks.
5. Carefully loosen only, the existing hose clamp (1, Figure 1) and then slide hose clamp away from the radiator. Do not remove existing hose clamp at this point.

In order to prevent power steering fluid leak, do not disturb or remove lower power steering hose (2, Figure 1) in any way.

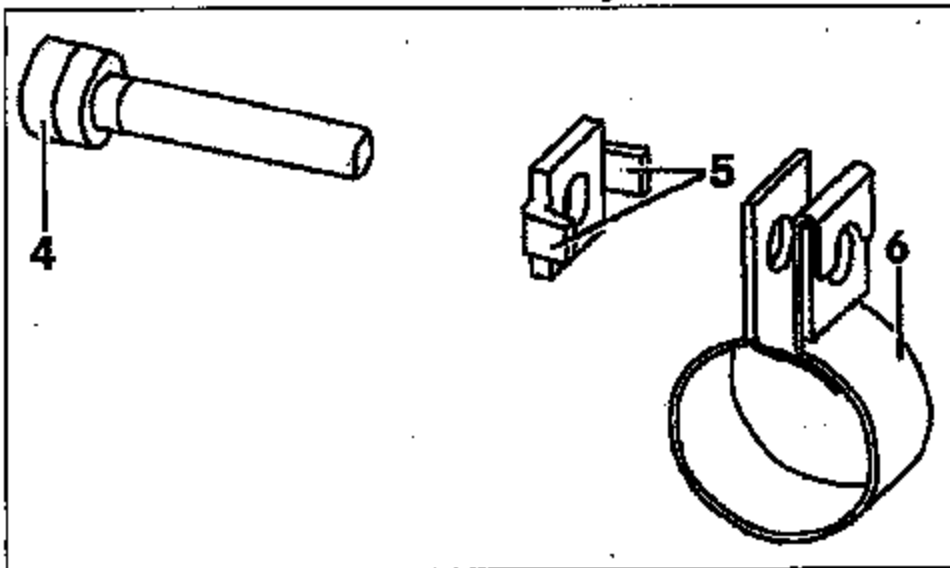
Figure 2

i NOTE: The new replacement hose clamp (6, Figure 2) must have the number "Nr St 15" stamped into the outer circumference of the hose clamp surface. Any other type of hose clamps must not be used.

7. Open replacement hose clamp (6, Figure 2) just enough for clamp to fit over the outer circumference of the lower power steering hose (2, Figure 1).

8. Slide the installed new hose clamp toward the radiator and locate in the proper position on the lower steering hose (1, Figure 1) as shown and tighten hose clamp screw (4, Figure 2).

Ⓢ Observe tightening torque of: Nm 2.0 + .5 / - 0.0 and proper orientation of the anti-rotation tabs (5, Figure 2).

i NOTE: Do not exceed the specified torque value, even if the hose can still be rotated on the fitting.
