Recall Campaign Bulletin

Campaign No. 2003040005  
 May 2003

SUBJECT: MODEL 163,154/157/172/174/175  
 REPLACEMENT OF CLAMP FOR LOWER POWER STEERING HOSE DUE TO  
 POSSIBLE FLUID LOSS AT RADIATOR

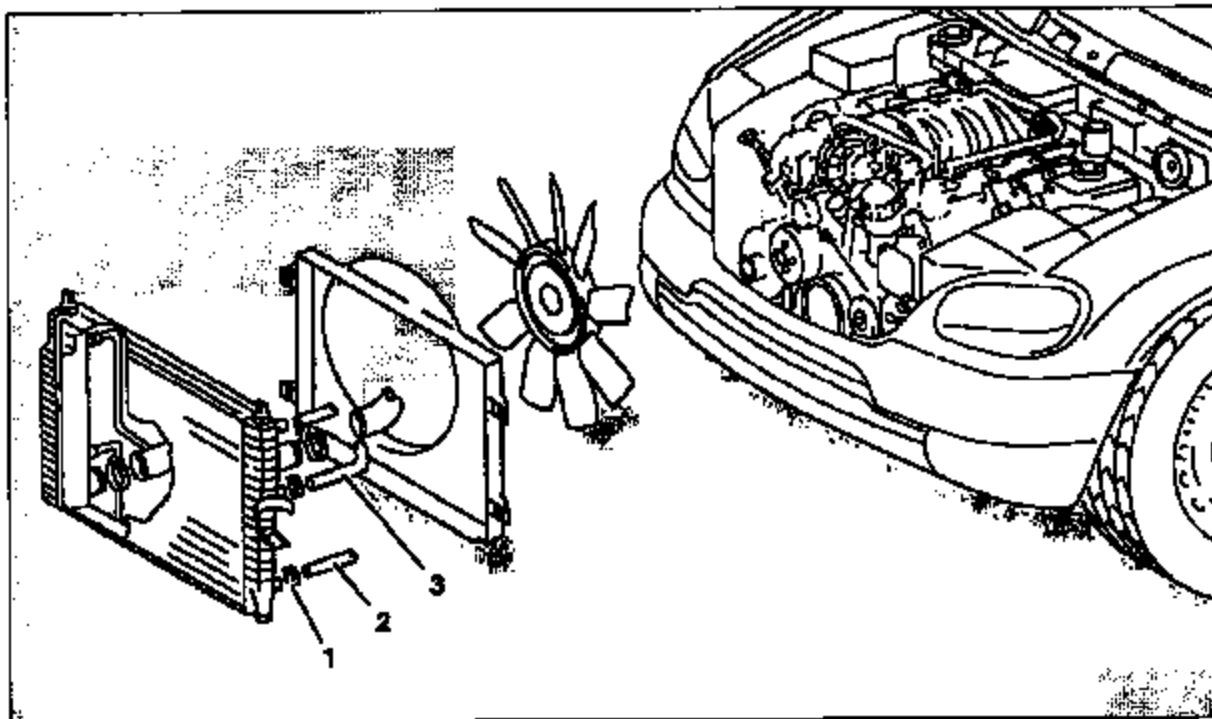
Figure 1

DCAG has determined that the lower power steering hose clamp (1, Figure 1) located on the lower power steering hose (2, Figure 1) at the lower left hand corner of the radiator must be replaced. The hose clamp may not provide sufficient clamping force for this connection and may cause fluid loss. Please review the Effective Serial Number Chart located on page 2. Attached is a sample copy of a letter which owners of the affected vehicles will receive.

6. Carefully inspect the condition of the lower power steering hose (2, Figure 1) at the radiator.

**NOTE:** The lower power steering hose should not be replaced unless the outer casing displays any cuts or splits. If there is any evidence of fluid loss, please check and replenish fluid at power steering fluid reservoir.

1. Prior to performing this Recall Campaign, please check VMI to insure the vehicle is involved and to determine if the vehicle has been previously repaired.
2. Shut-off engine and remove ignition key from ignition lock.
3. Open engine hood.
4. Visually locate both upper (3, Figure 1) and lower (2, Figure 1) power steering hose and then using MBUSA Special Tool: 000 598 40 37 00, clamp off (near radiator) both upper and lower power steering hoses to prevent any fluid leaks.
5. Carefully loosen only, the existing hose clamp (1, Figure 1) and then slide hose clamp away from the radiator. Do not remove existing hose clamp at this point.

In order to prevent power steering fluid leak, do not disturb or remove lower power steering hose (2, Figure 1) in any way.

7. Open replacement hose clamp just enough for clamp to fit over the outer circumference of the lower power steering hose (2, Figure 1).

When installing new hose clamp, do not open hose clamp any more than necessary in order for hose clamp to fit over the lower power steering hose itself, otherwise the hose clamp may be damaged.

**NOTE:** The new replacement hose clamp must have the number "15" stamped into the outer circumference of the hose clamp surface.

8. Slide the installed new hose clamp toward the radiator and locate in the proper position on the lower steering hose (1, Figure 1) as shown and tighten hose clamp screw.
- Ⓢ Observe tightening torque of: Nm 2.0 +0.05/-0.1
9. Remove previously loosened old hose clamp (see step 5) from hose at this point.
10. Loosen and remove previously installed MBUSA Special Tool: 000 588 40 37 00 from both upper and lower power steering hoses.
11. Start-up engine and check for any fluid leaks from the power steering hoses at the radiator.
