Recall Bulletin

File In Section: Product Recalls
Bulletin No.: 03025
Date: May, 2003

PRODUCT SAFETY RECALL

SUBJECT: 03025 – BRAKE PIPE SCORING

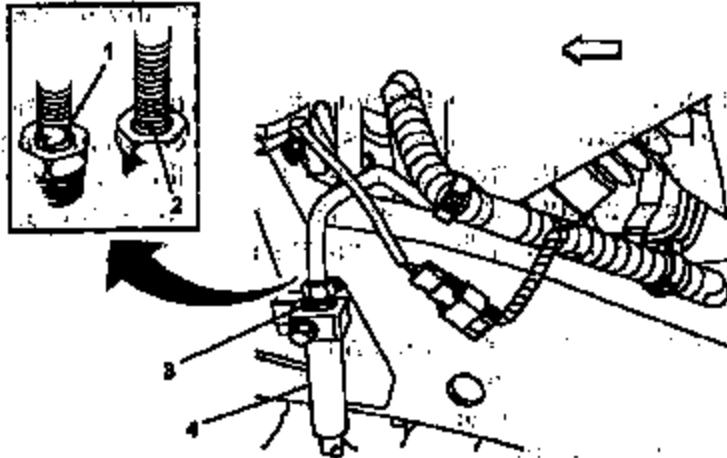
1315336

4. Clean and remove any dirt from the left front brake pipe and flare nut (3) where it connects to the left front caliper flex hose (4).
5. Carefully inspect the brake pipe where it goes into the flare nut for a tooling mark (1) as shown above. The mark may be located at any point around the circumference of the pipe and a mirror and flashlight may be required to see it. There will NOT be any of the spiral lines or grooves (2) in the tooling mark.
 - o If the tooling mark IS present (1), then the brake pipe does NOT need to be replaced. Lower the vehicle and install the GM Recall Identification Label.
 - o If the brake pipe does NOT have the tooling mark (2), proceed to the next step of the inspection.

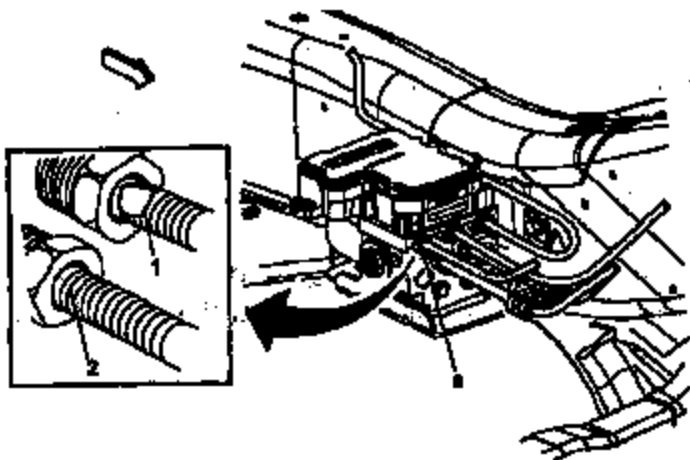
1315427

6. Clean and remove any dirt from the left front brake pipe and flare nut (3) where it connects to the ABS modulator under the vehicle. The left front pipe is on the top row and closest to the center of the vehicle.

7. Carefully inspect the brake pipe where the pipe goes into the flare nut for the same type of tooling mark (1) as shown above. The mark may be located at any point around the circumference of the pipe and a mirror flashlight may be required to see it. There will NOT be any of the spiral lines or grooves (2) in the tooling mark.
 - o If the tooling mark IS present, then the brake pipe does NOT need to be replaced. Lower the vehicle and install the GM Recall Identification Label.
 - o If the tooling mark is NOT present, then the brake pipe must be replaced. Proceed to the Replacement procedure, below.
