**Subject: Safety Recall 03V-472  
(Ford Number 03S08)**

**SUBJECT:** Safety Recall 03S08:  
Certain 1996 through 2003 Model Year Ford Crown Victoria Compressed Natural Gas (CNG) Vehicles  
Insulator Installation

## CERTAIN 1998-2003 CROWN VICTORIA NATURAL GAS VEHICLES — INSULATOR INSTALLATION

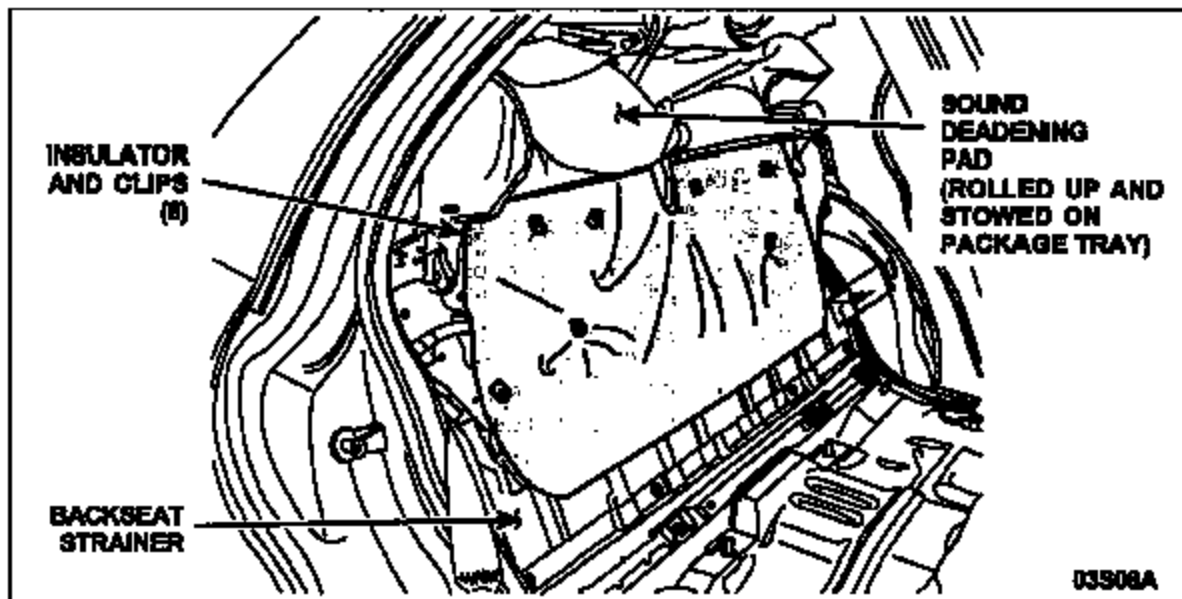
FIGURE 1

In a very rare event an interior fire may progress rearward in the vehicle through the rear seat resulting in a locally directed flame at the natural gas cylinder located immediately behind the rear seat. This may potentially damage the fiberglass wrap and reduce the tank strength. If this were to happen, the natural gas tank could potentially rupture.

Position and center the insulator on the backseat strainer. Align the retainer holes and install the eight (8) clips. See Figure 1.
