RECALL CAMPAIGN BULLETIN

NTB03-112

VOLUNTARY RECALL CAMPAIGN ELECTRONIC CONTROL MODULE (ECM) CASE HOLDER FOAM

APPLIED VEHICLES: 2000-2003 Sentra (B15)

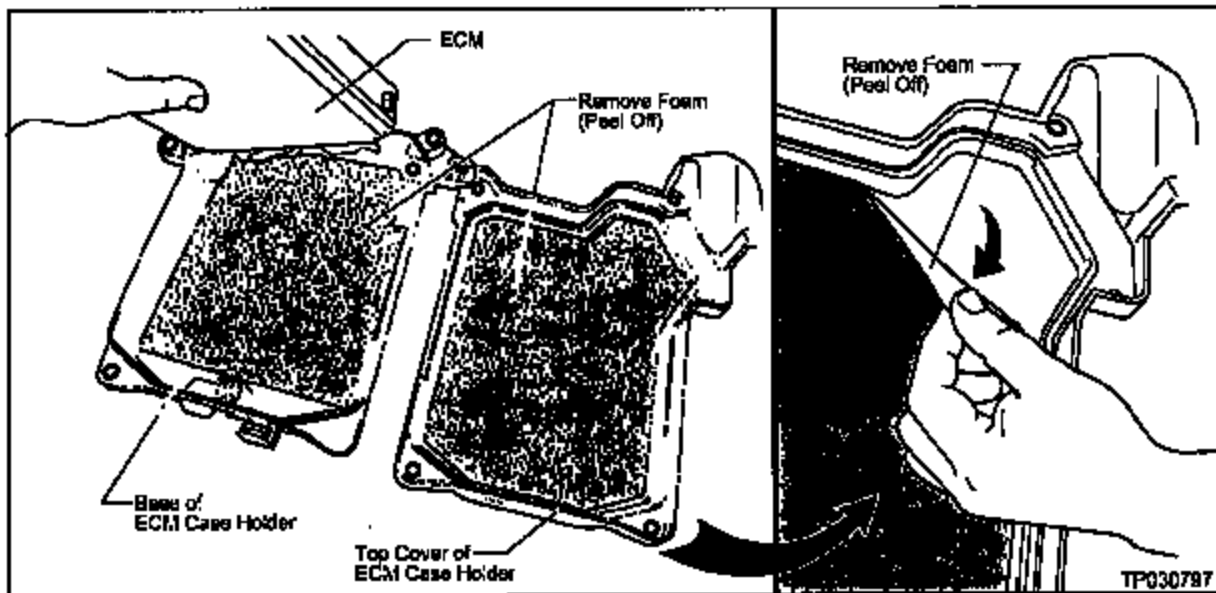
Figure 10

On some 2000-2003 model year Nissan Sentra vehicles described above, there is a possibility that the engine may stop running while being driven due to contamination of the Engine Control Module (ECM) by the inner lining material. This may also result in the "Service Engine Soon" light coming on or poor driveability. If the engine stops running while driving, this could result in a crash without warning.

10. Lift UP the ECM and remove/discard the Foam from the Base and Top Cover of the ECM Case Holder (see Figure 10).

- Make sure you remove/discard **all** the Foam and that the Base and Top Cover are clean and free of dirt, dust, and debris.
